Little Cypress Creek and Krause Springs Occurrence of Flowing Water, Burnet County, Texas: Phase 2

November 2022 | Report: 2022-06

THE MEADOWS CENTER
FOR WATER AND THE ENVIRONMENT

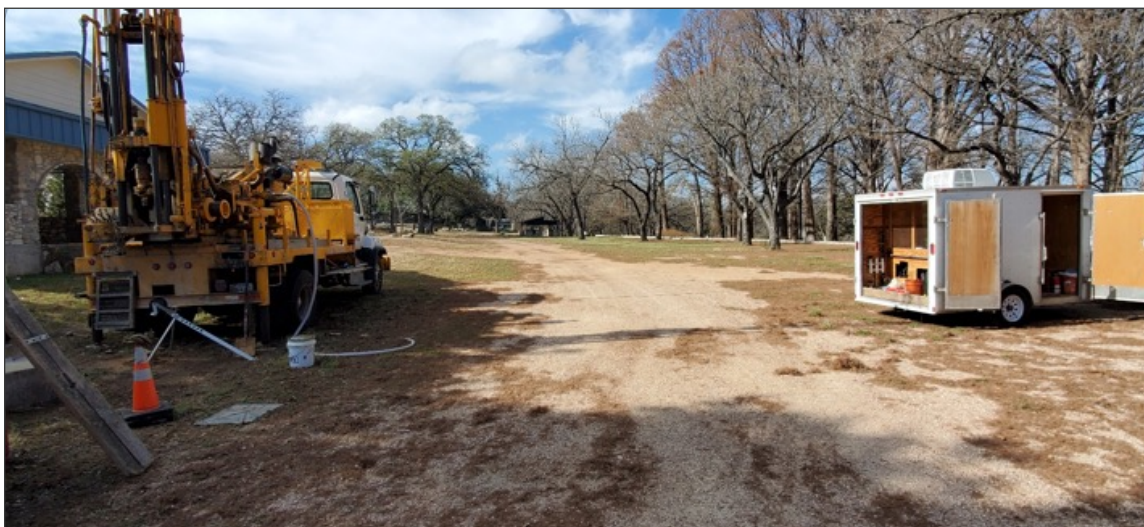
FIGURE 3. GEOPHYSICAL LOGGING AT MW4

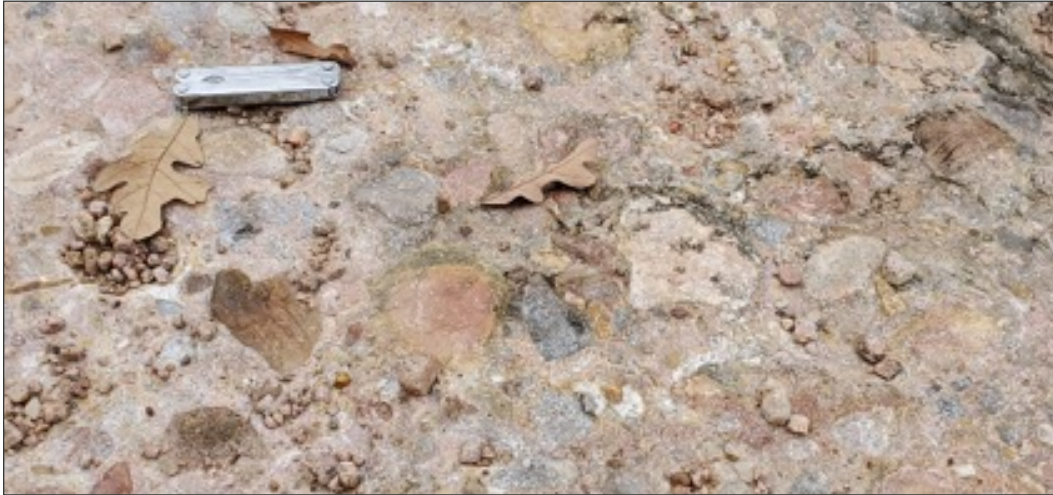
FIGURE 5. SYCAMORE CONGLOMERATE IN OUTCROP NEAR MW4

At MW4, sand and gravel unit similar to MW3 was encountered from 0 to 19.5 feet. Auger refusal occurred at 19.5 feet. From 19.5 to 25 feet, a coarse conglomerate was cored (Figure 5). The upper sand and lower conglomerate are both part of the Sycamore Formation. The conglomerate was 4 feet thick and underlain by a light brown to bluish brown clay. The clay extended 10 feet to the terminus of the boring. The clay is the Smithwick Formation (Figure 7).

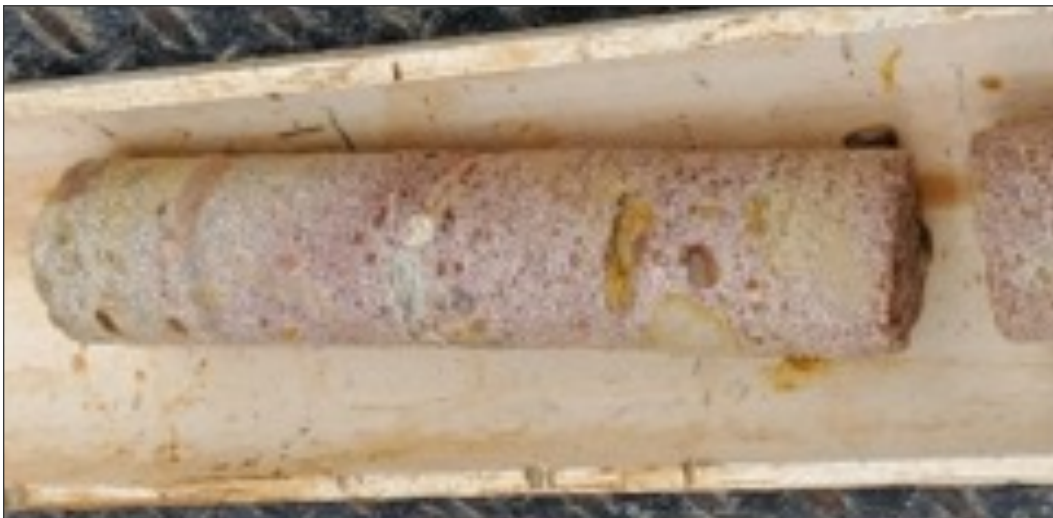
FIGURE 6. CORE SAMPLE OF THE SYCAMORE CONGLOMERATE AT MW4

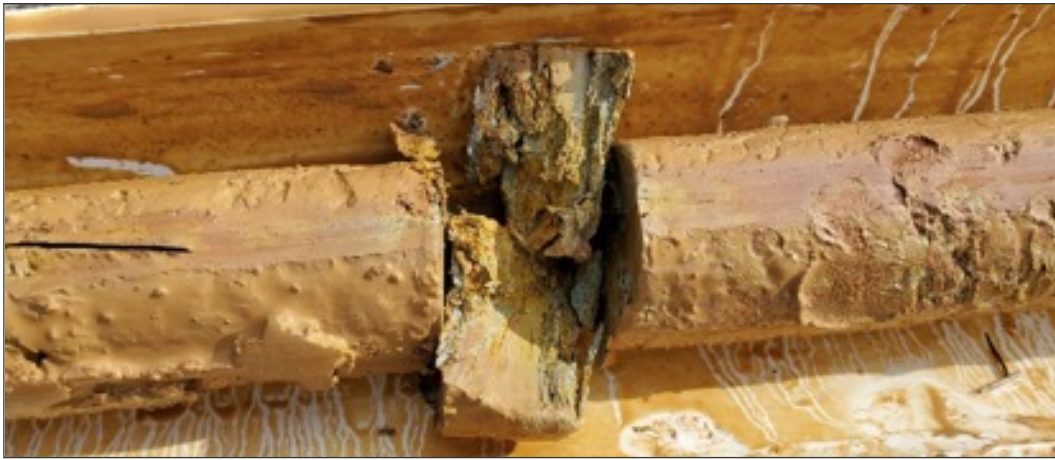
FIGURE 7. ORE SAMPLE OF THE SMITHWICK CLAY AT MW4.

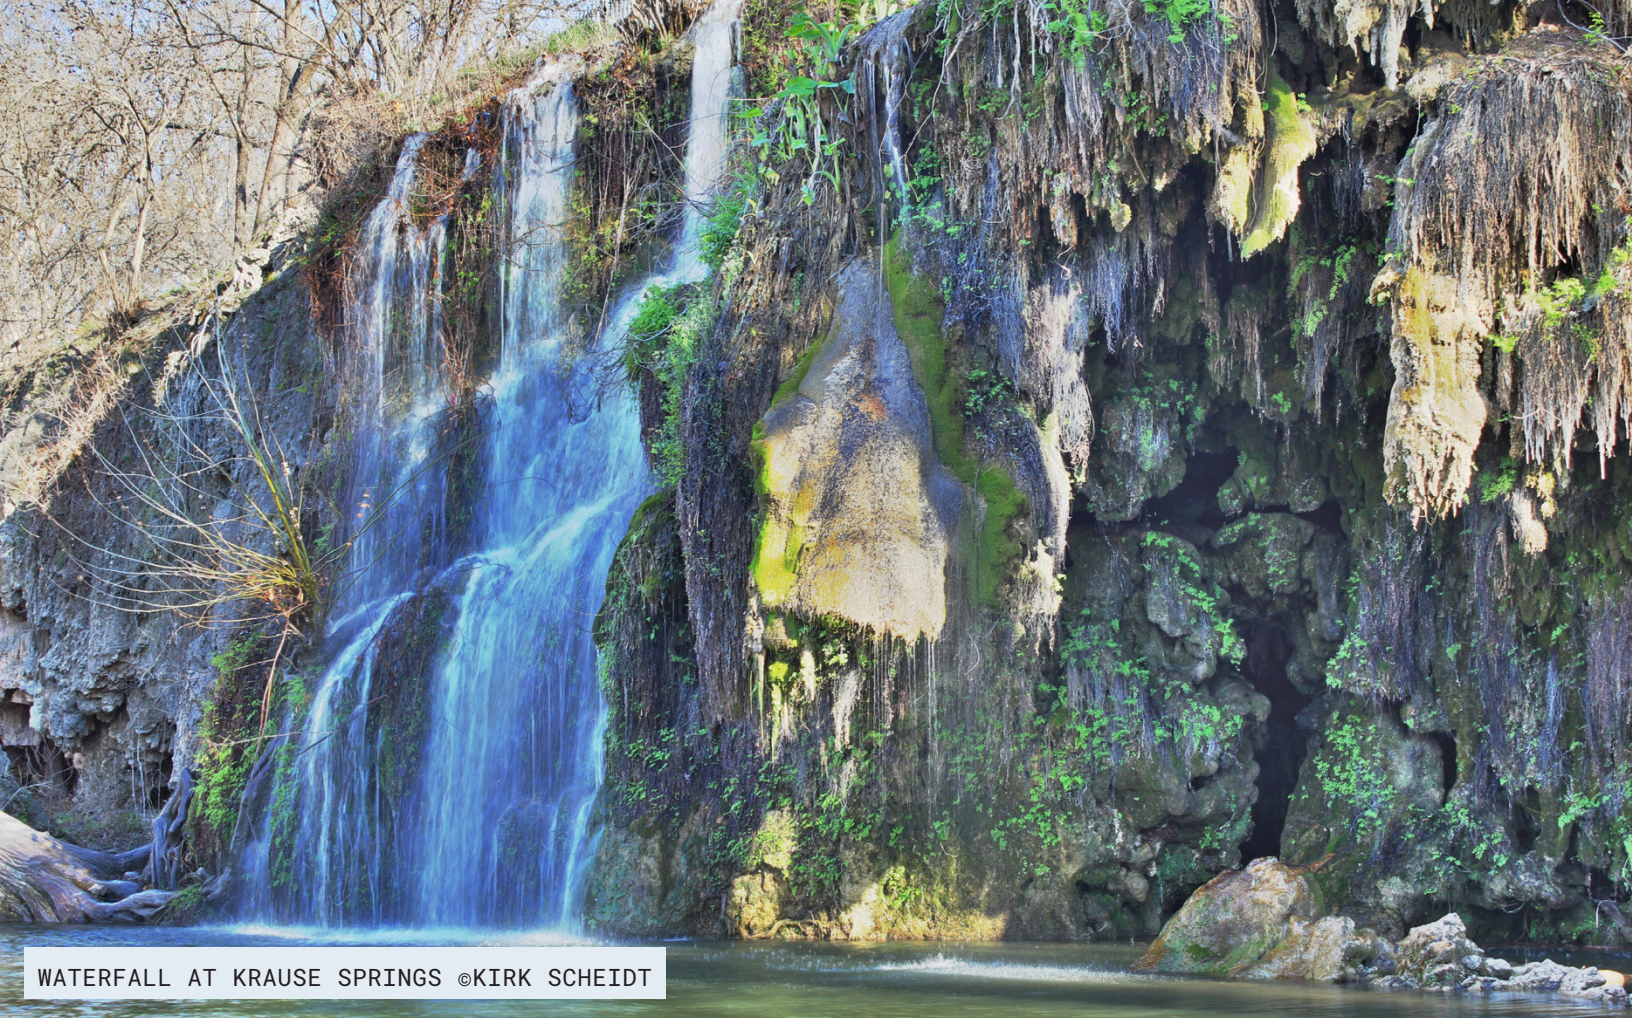
The short duration of deployment of the two new transducers precludes analysis of long-term trends. Water levels for the period of record for MW2 are shown in Figure 10.

From 2019 through 2022, there has been a steady decline in groundwater levels at MW2 (Figure 10). On a linear trend basis, there has been a 1 - 1.5-foot decline in water levels over the period of record at MW2. The decline is due to increased temperature causing increased evapotranspiration and less groundwater recharge. Changes in precipitation may be the cause, but site-specific data on precipitation is just now becoming available from the recently activated precipitation stations installed by the CTGCD. Continuation of the long-term monitoring program is necessary.

Several trends are evident from the data. Water levels fluctuate seasonally with the lowest levels at the end of the summer months, with increasing water levels during fall and winter. These fluctuations reflect increased evapotranspiration during the sweltering summer months and less evapotranspiration in the winter months. The seasonality of water levels reflects when groundwater recharge is occurring (fall and winter). Groundwater recharge is typically higher in the fall and winter months due to lower evapotranspiration and higher precipitation.

FIGURE 10. KRAUSE PARKLAND (MW2) DEPTH TO WATER 7/1/2019-7/1/2022
