# UPPER CIBOLO CREEK WATERSHED DATA REPORT

March 2023

THE MEADOWS CENTER  
FOR WATER AND THE ENVIRONMENT  
TEXAS STATE UNIVERSITY

TEXAS STREAM TEAM

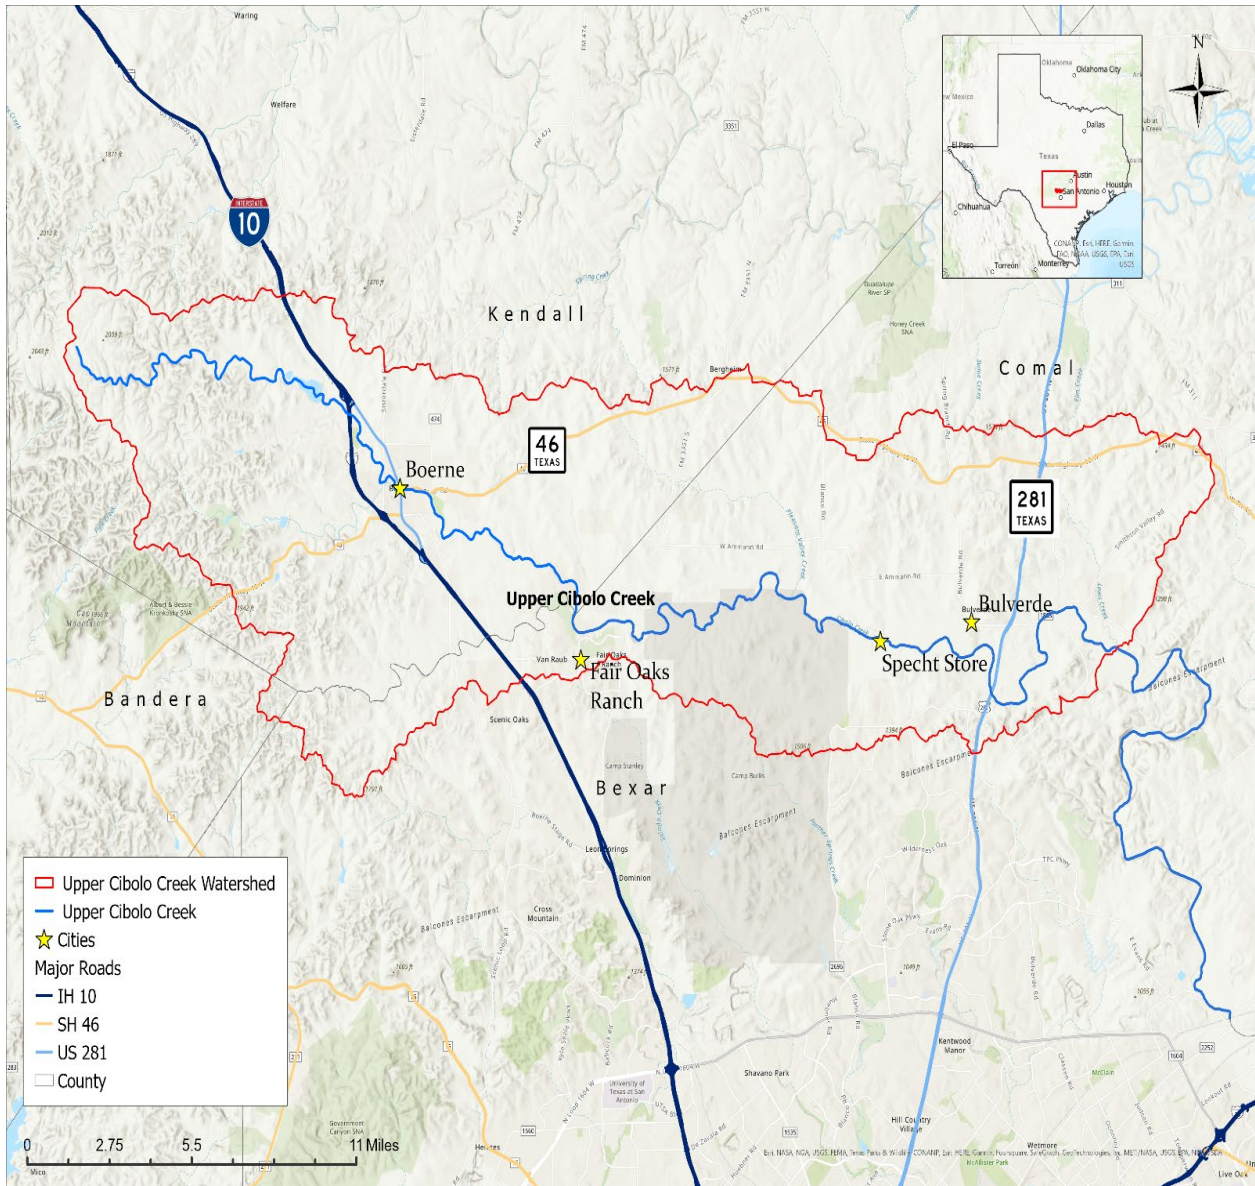
Figure 1. Upper Cibolo Creek Watershed in Bandera, Bexar, Comal, and Kendall Counties, Texas.

The Upper Cibolo Creek Watershed spans 228-square miles, is part of the larger San Antonio River Basin, and is a spring fed stream (Figure 1). The watershed encompasses the city of Boerne, the county seat of Kendall County. This area is important locally for aesthetics, recreation, and for the ecosystem it supports, but it is also historically significant and provides a variety of activities for tourists (City of Boerne, 2023).

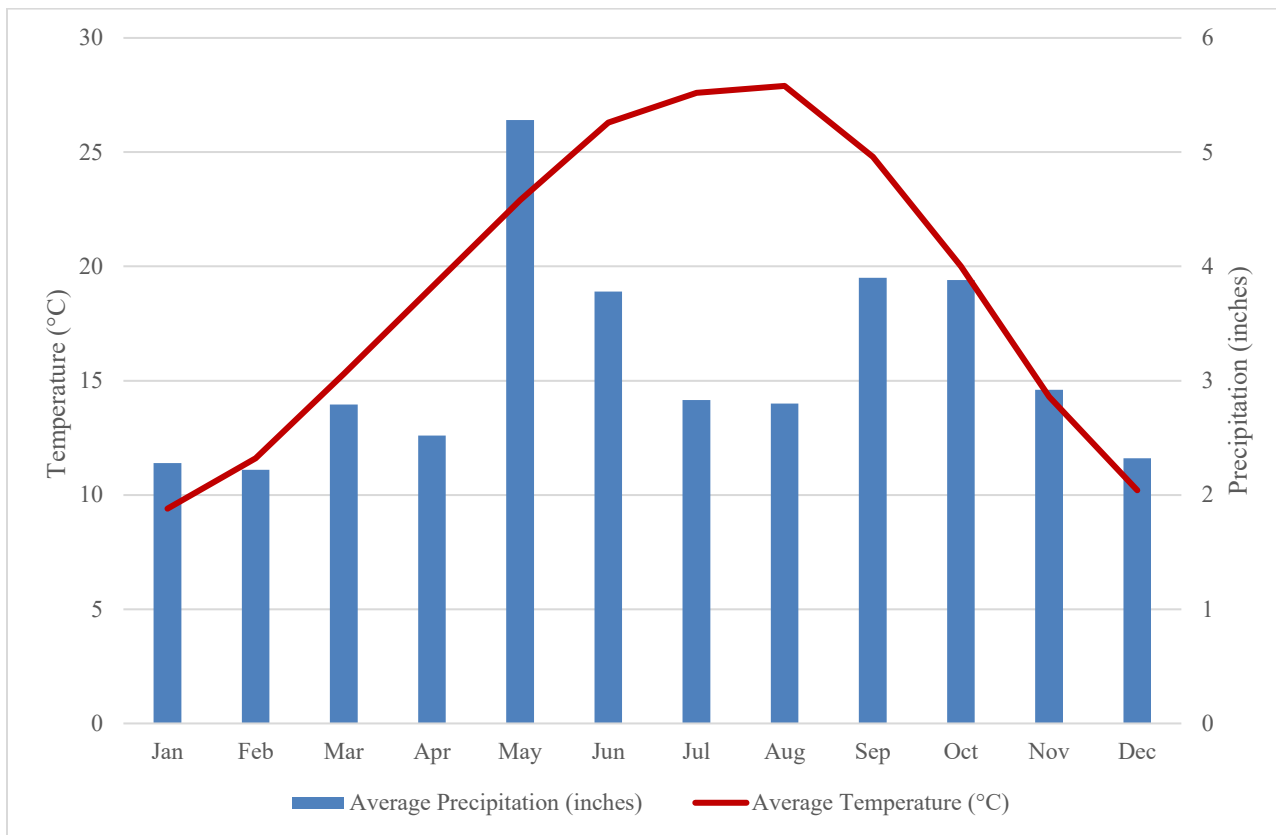
Figure 2. Long-term (1991-2020) monthly average precipitation (inches) and air temperature (°C) from Boerne, Texas (National Oceanic and Atmospheric Administration Climate Data, 2021).

The climate in this part of the state is described as subtropical-subhumid with a growing season of 231 average days annually (Smyrl, 2020). National Oceanic and Atmospheric Administration climate data from a weather station at Boerne, Texas was acquired from the National Data Center (National Oceanic and Atmospheric Administration, 2021). Average annual precipitation at Boerne is 37.52 inches and occurs year-round (Figure 2). Long-term monthly average precipitation has a bimodal distribution with peaks occurring in May and September. Average rainfall during these months is 5.28 and 3.9 inches each month, respectively. The least amount of rainfall (2.22 inches) occurs in February. The warmest and coldest months of the year are August (27.9°C) and January (9.4°C), respectively.

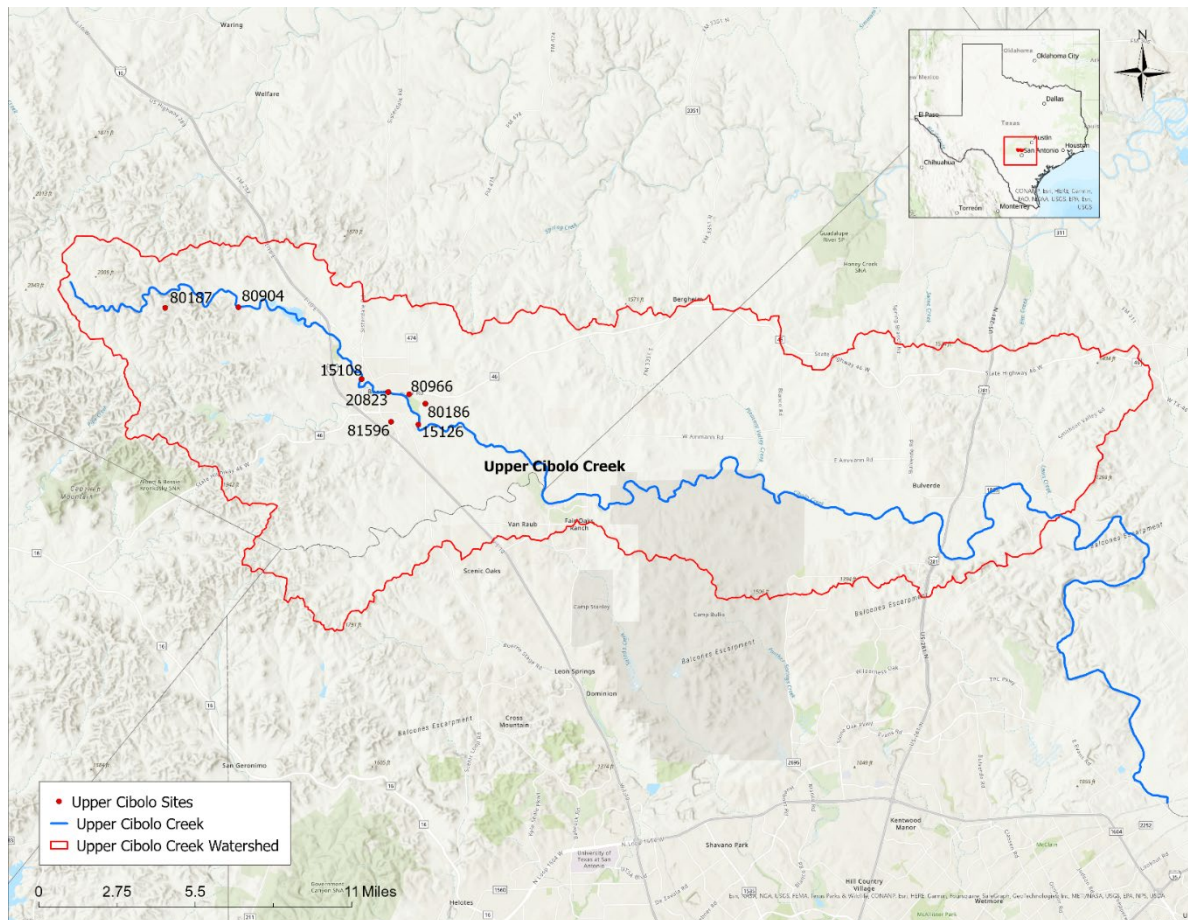
Figure 4. Texas Stream Team monitoring sites in the Upper Cibolo Creek Watershed in Bandera, Bexar, Comal, and Kendall Counties, Texas.

Water quality data from eight Texas Stream Team monitoring sites in the Upper Cibolo Creek Watershed were acquired for analysis (Figure 4). The eight sites in the Cibolo Creek Watershed were monitored sporadically beginning on December 1996 through February 2023. Trained community scientists conducted between 17 and 205 sampling events at each site, for a total of 744 monitoring events (Table 5). The period of record for the sampling events ranged from December 1999 to February 2023, with all sites experiencing temporal intermittent sampling.
