# Cypress Creek Flow Study: Blanco and Travis Counties, Texas

Report: 2021-01  
January 2021

*The Meadows Center for Water and the Environment - Texas State University*

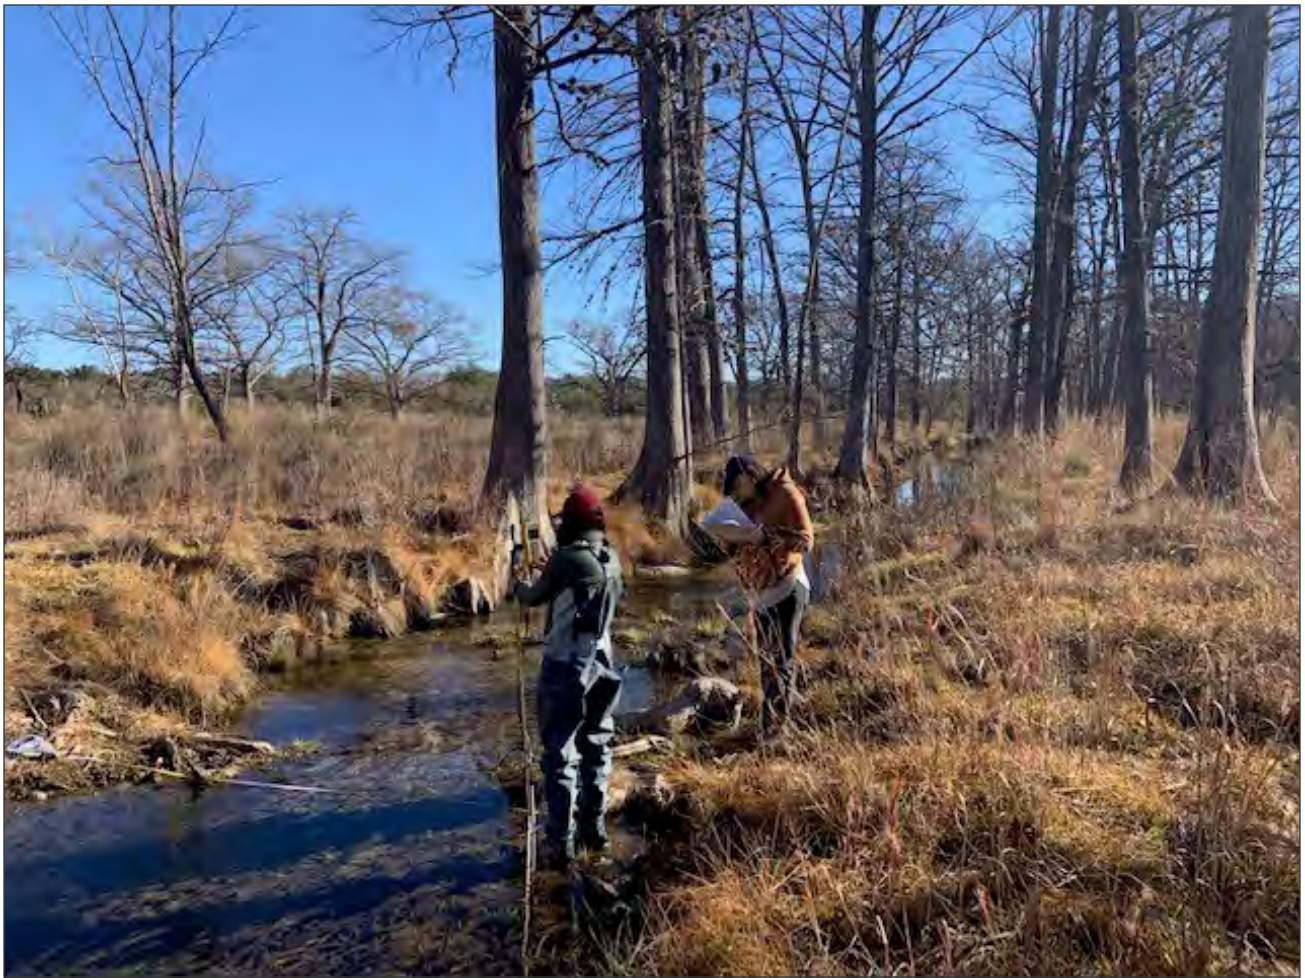
**Figure 5.** Meadows Center staff measuring flow with the Sontek FlowTracker sonde

To determine losing and gain reaches of the creek, two synoptic discharge measurement events were performed. Based on available landowner access, measurements were made at semi-regular intervals along the length of the creek with "live" water.

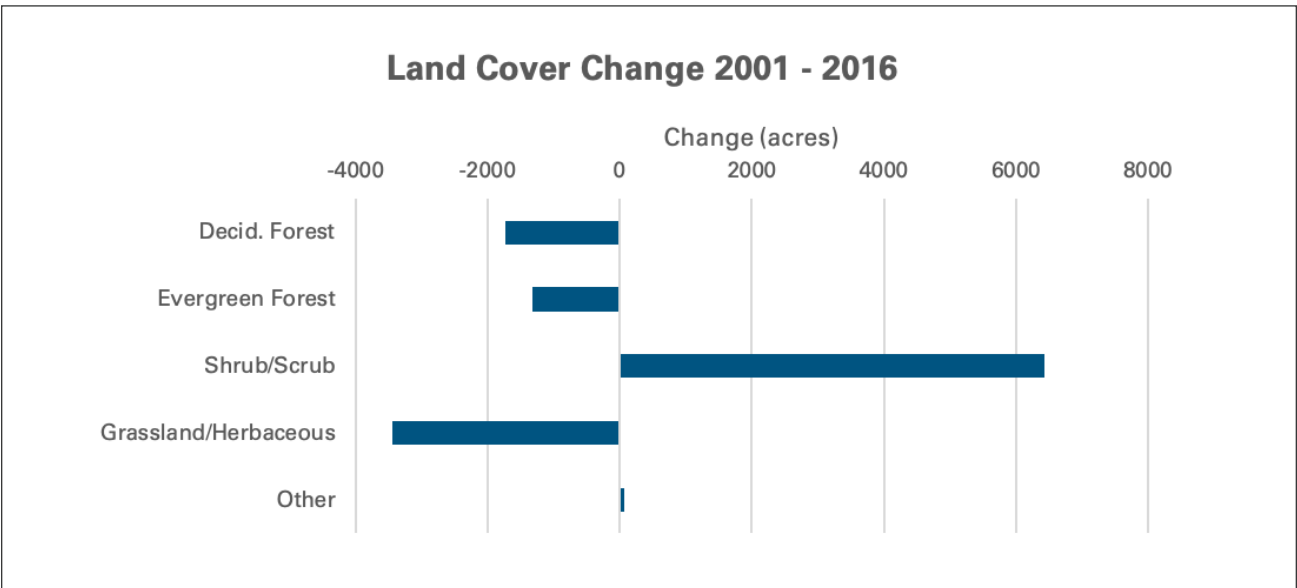
**Figure 9.** Land Cover Change 2001 – 2016

While the four major land cover types still dominate the watershed in 2016, there was a significant decline in deciduous forest, evergreen forest and grasslands, totaling approximately 6,500 acres (12 percent of the watershed). Anecdotal information indicates this decline could possibly be attributed to on the intentional removal of Ashe Juniper trees and other non-native species within the watershed in recent decades. Shrub and scrub areas increased by 6,423 acres, or 12 percent of the watershed (Figure 8). Based on Figures 6 and 7, the change from Grassland to Shrubs appears most pronounced in the western area of the watershed, west of Hwy 281 and north of the creek in the eastern areas of the watershed.

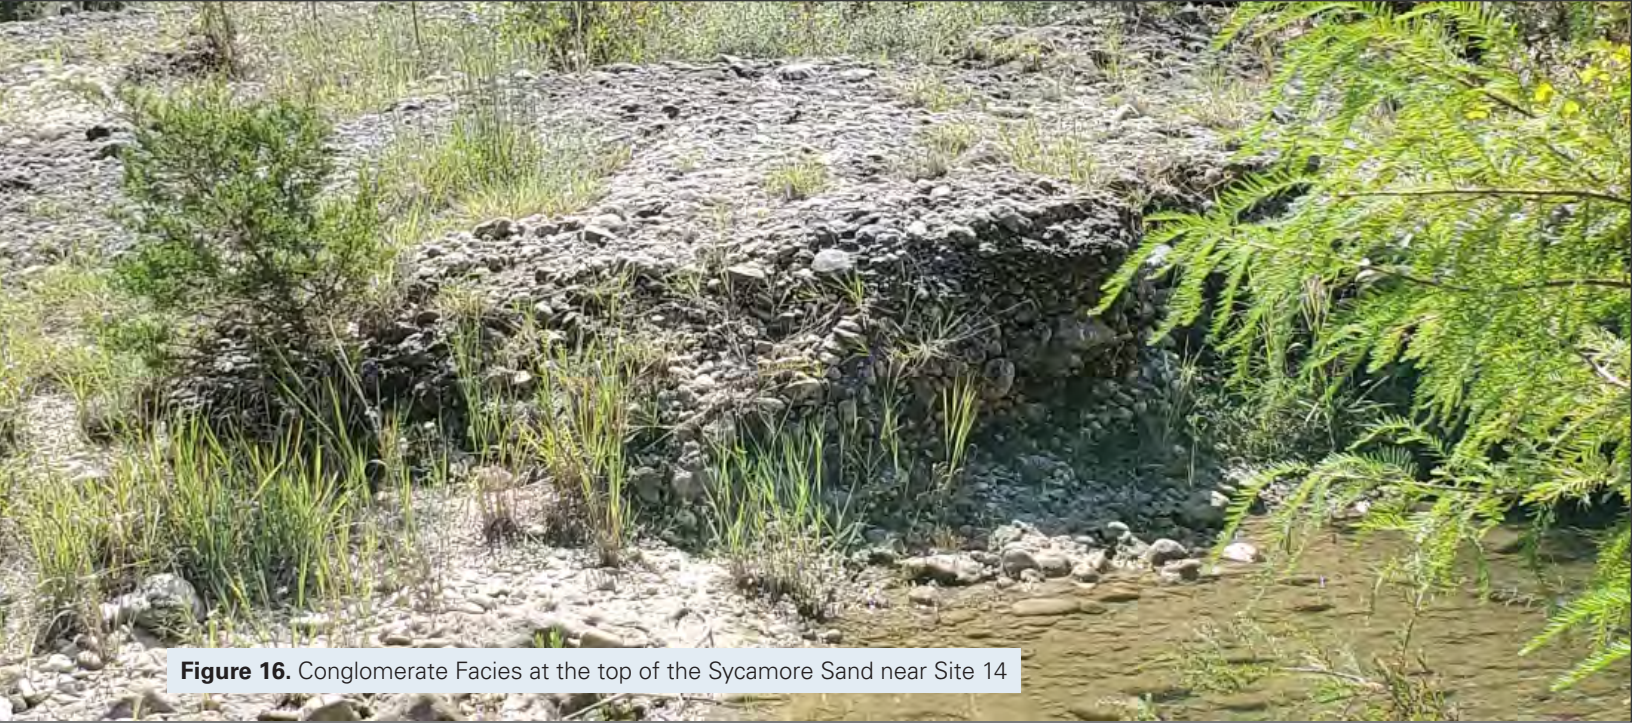
**Figure 16.** Conglomerate Facies at the top of the Sycamore Sand near Site 14

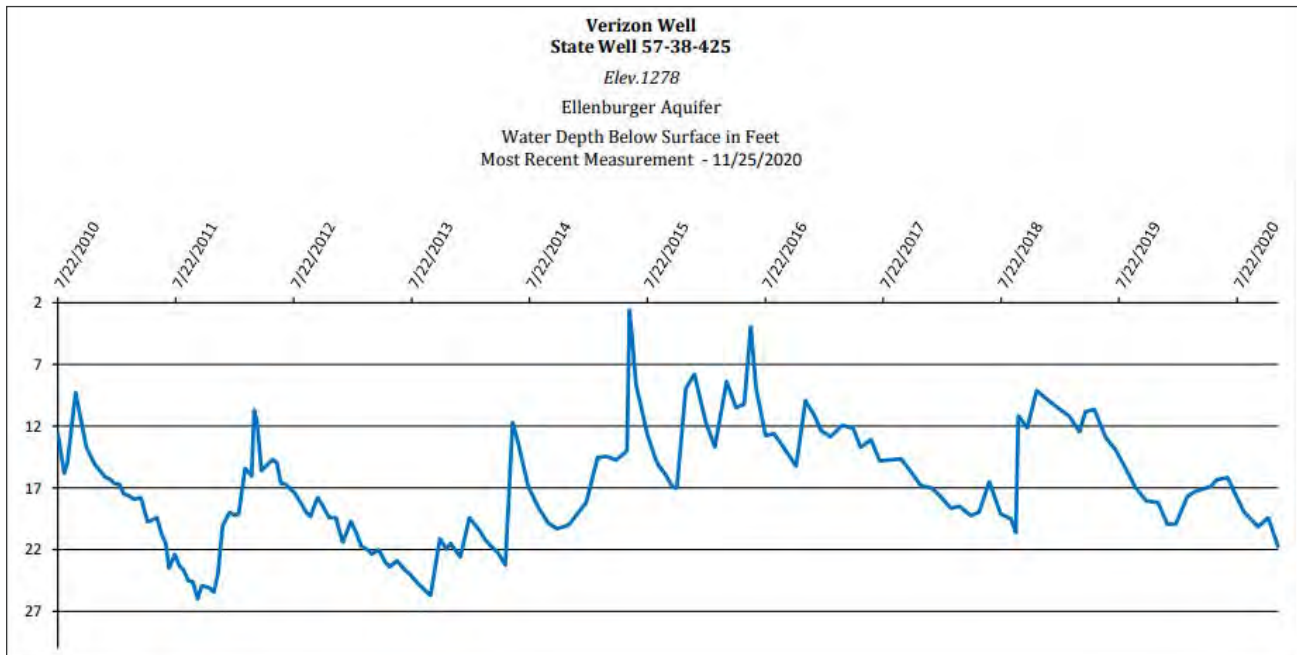
**Figure 17.** Verizon Well Water Level Monitoring Results (Source: BPGCD, 2020)

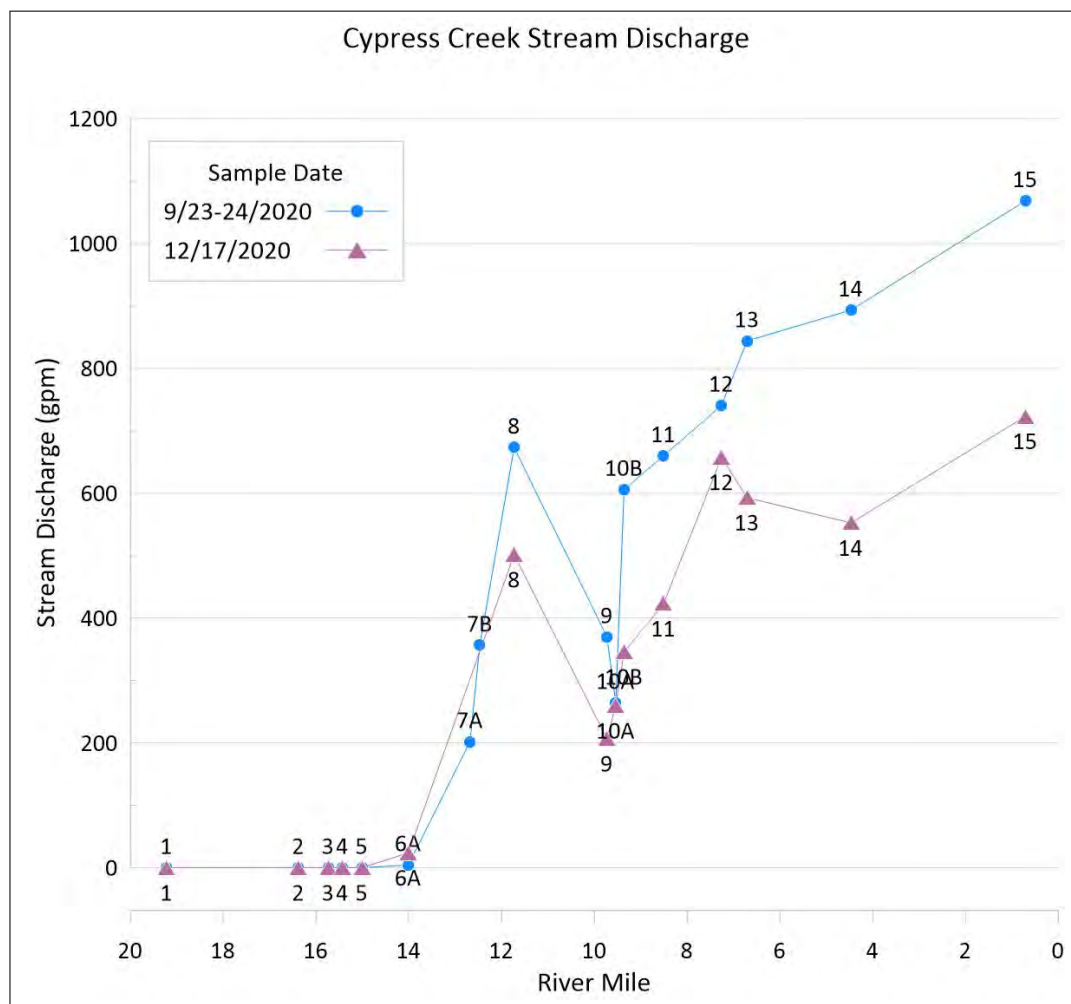
**Figure 23.** Cypress Creek Stream Discharge

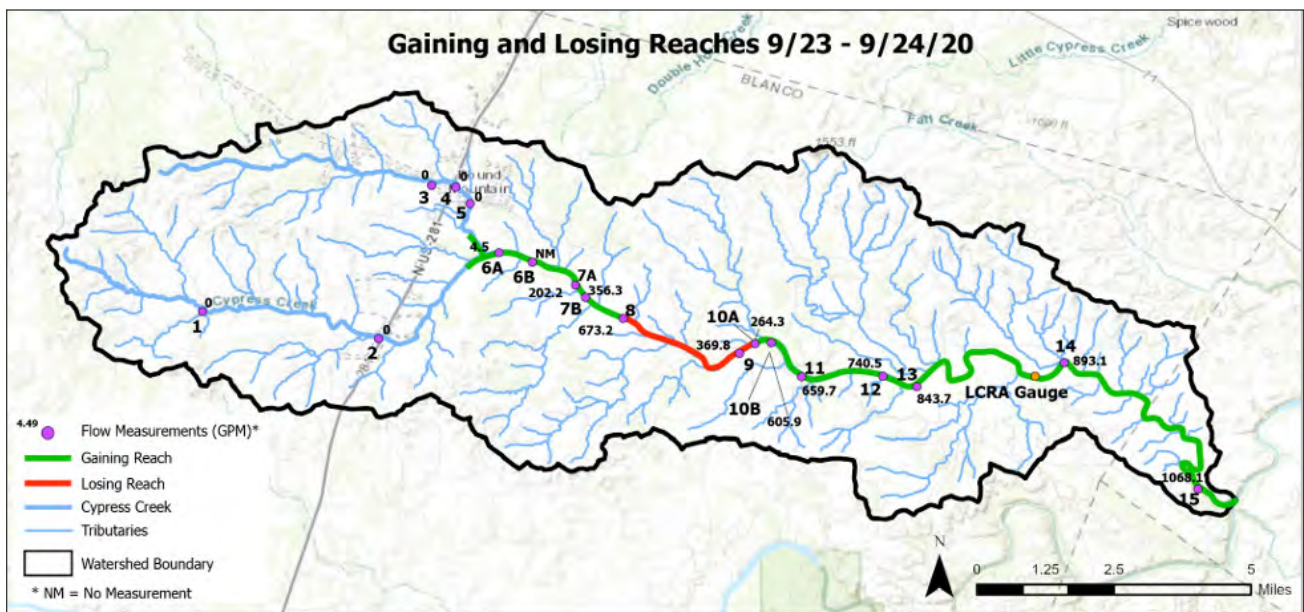
**Figure 24.** Surface Water Flow Measurements 9/23-24/2010

During the July event (Figure 24), no flow was observed at Sites 1-5 in the western part of the watershed, though minimal flow had been observed at Sites 2 and 5 several months earlier. The minimal flow observed at Site 5 originates from direct recharge from precipitation into the alluvial deposits in that area. The creek is a gaining stream between Sites 6A and 8, with springs originating in the Ellenburger Group near Sites 7A and 7B significantly contributing to the flow. There are likely other similar springs in this reach on properties not accessible during this study.

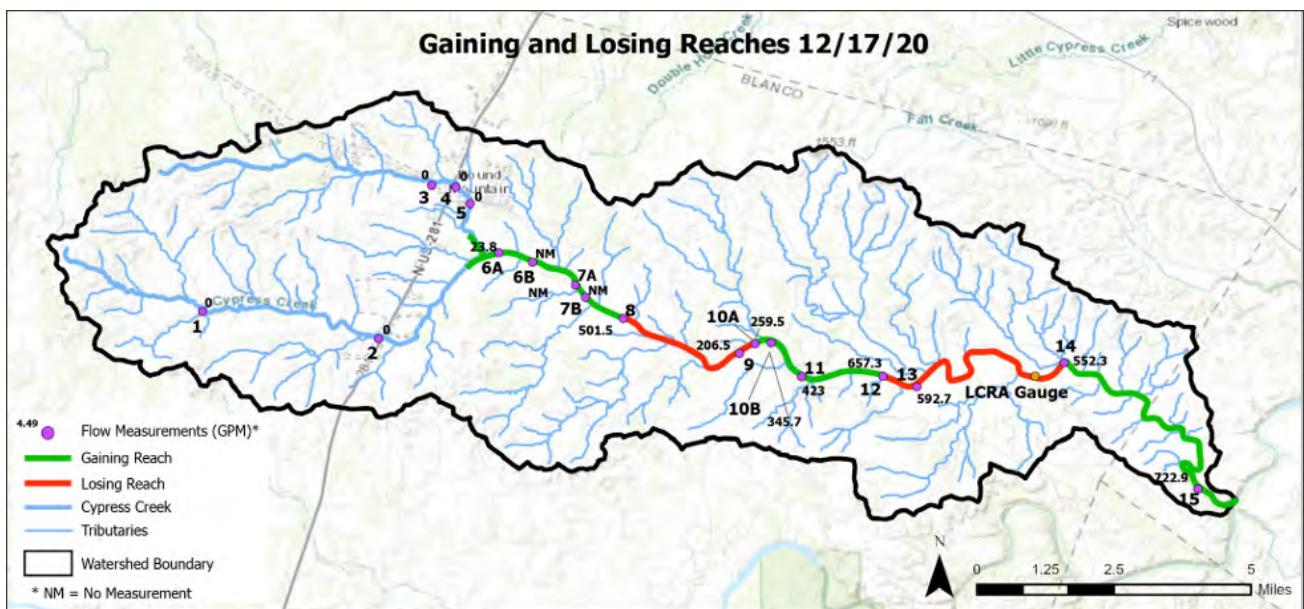
**Figure 25.** Surface Water Flow Measurements 12/17/2020

The same general gain/loss pattern was observed during the December (Figure 25) synoptic event except a small loss of less than ten percent was noted between Sites 12 and 14. The loss between Sites 8 and 9 was approximately sixty percent of flow.

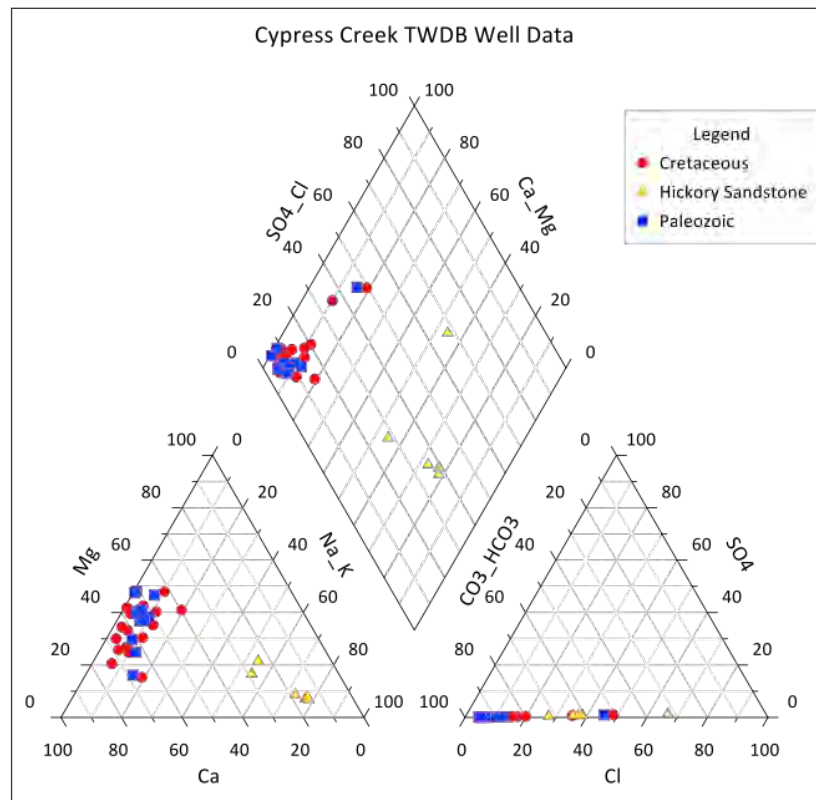
**Figure 34.** Piper Plot of TWDB Water Quality Data

A summary of historical water quality data from the TWDB groundwater database is shown on the piper plot, Figure 34. The water quality results are summarized on the Piper Plot, Figure 35. Piper plots (also known as trilinear diagrams) are used to visualize the abundance of common, natural ions in water. The plot comprises a ternary diagram showing cations (lower left), a ternary diagram representing anions (lower right) and a rhombic plot in middle.

The data are plotted by aquifer group. The Cretaceous Trinity group and Paleozoic Ellenburger group plot in a similar fashion. Both aquifers are primarily carbonate rocks with high calcium carbonate. The Hickory Sandstone wells are lower in calcium carbonate and higher in sodium and magnesium. All the aquifers have low sulfate. These samples would be considered calcium carbonate water. The Hickory samples would be characterized as calcium chloride or sodium bicarbonate waters.

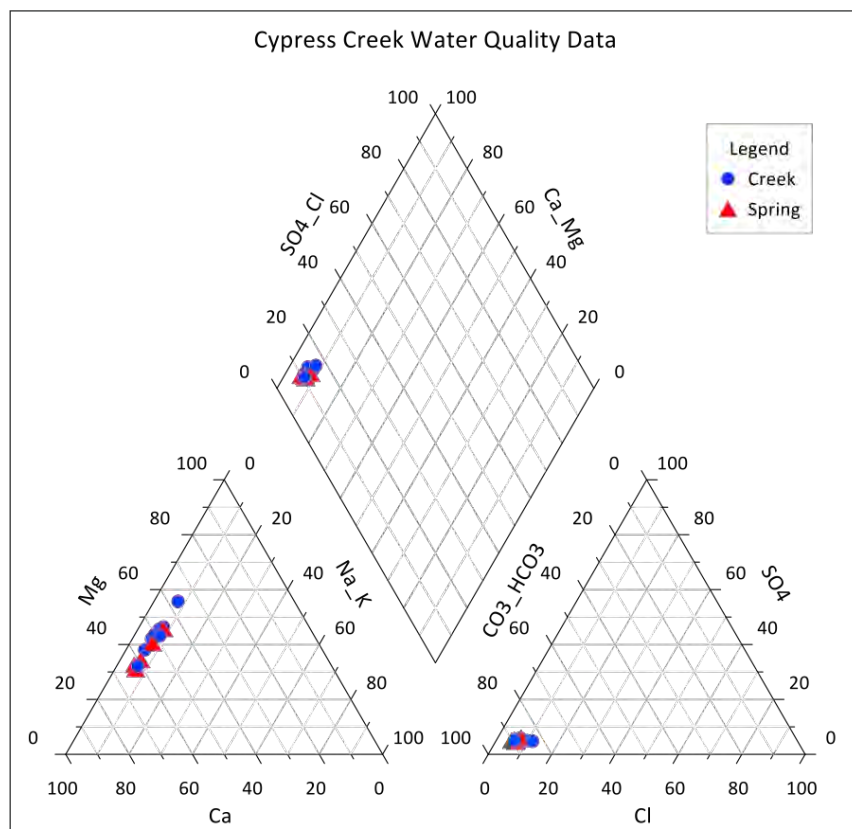
**Figure 35.** Piper Plot of Meadows Center Water Quality Data.
