Background

In 2019, a senior design team fabricated a penny press machine. Over time, the machine failed due to design errors and was decommissioned until our team undertook its restoration.

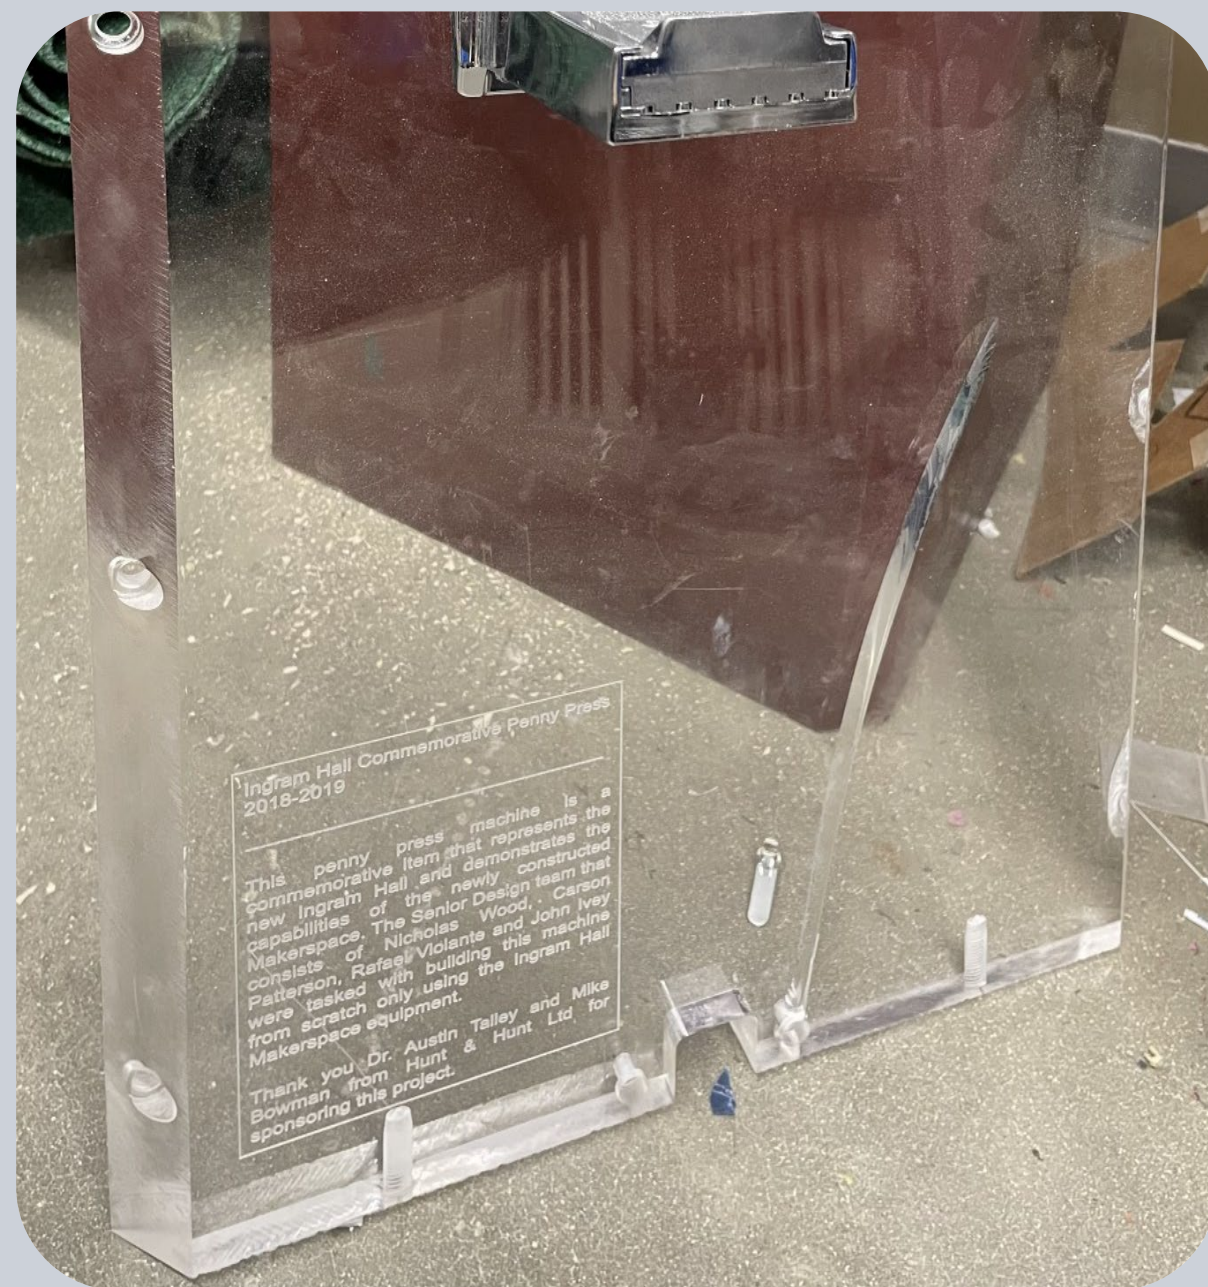
Structural Failure

Due to incredible forces on the acrylic frame, cracks formed.

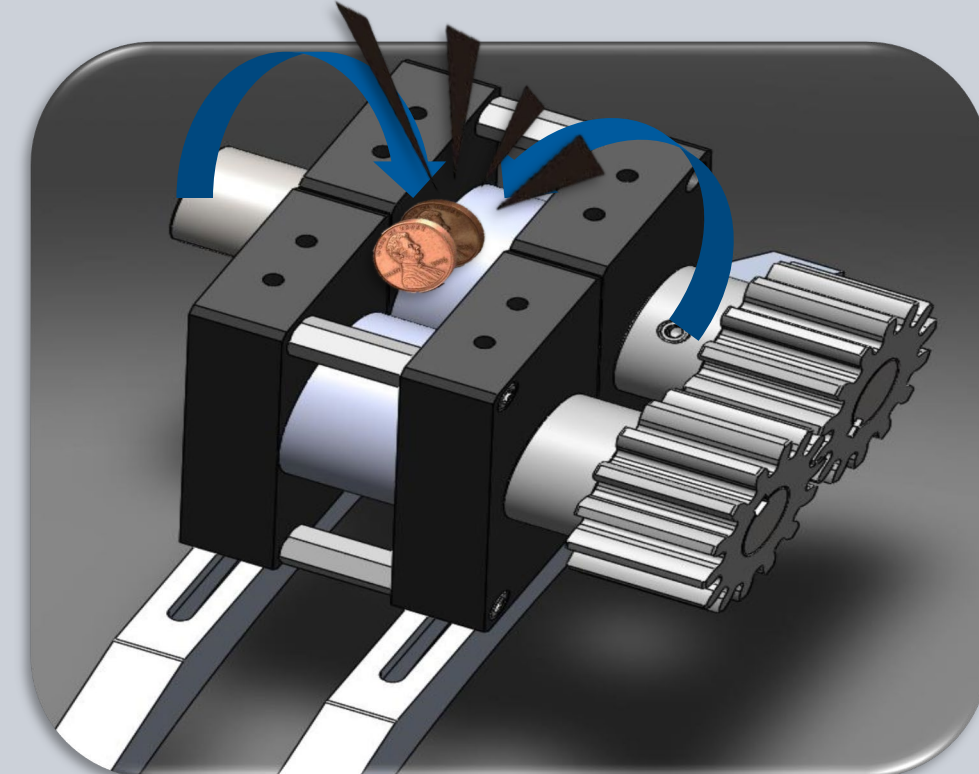
Coin drop failure

Multiple pennies fell through die simultaneously resulting in an overload of force

Added coin drop mechanism to allow one coin to enter die at a time

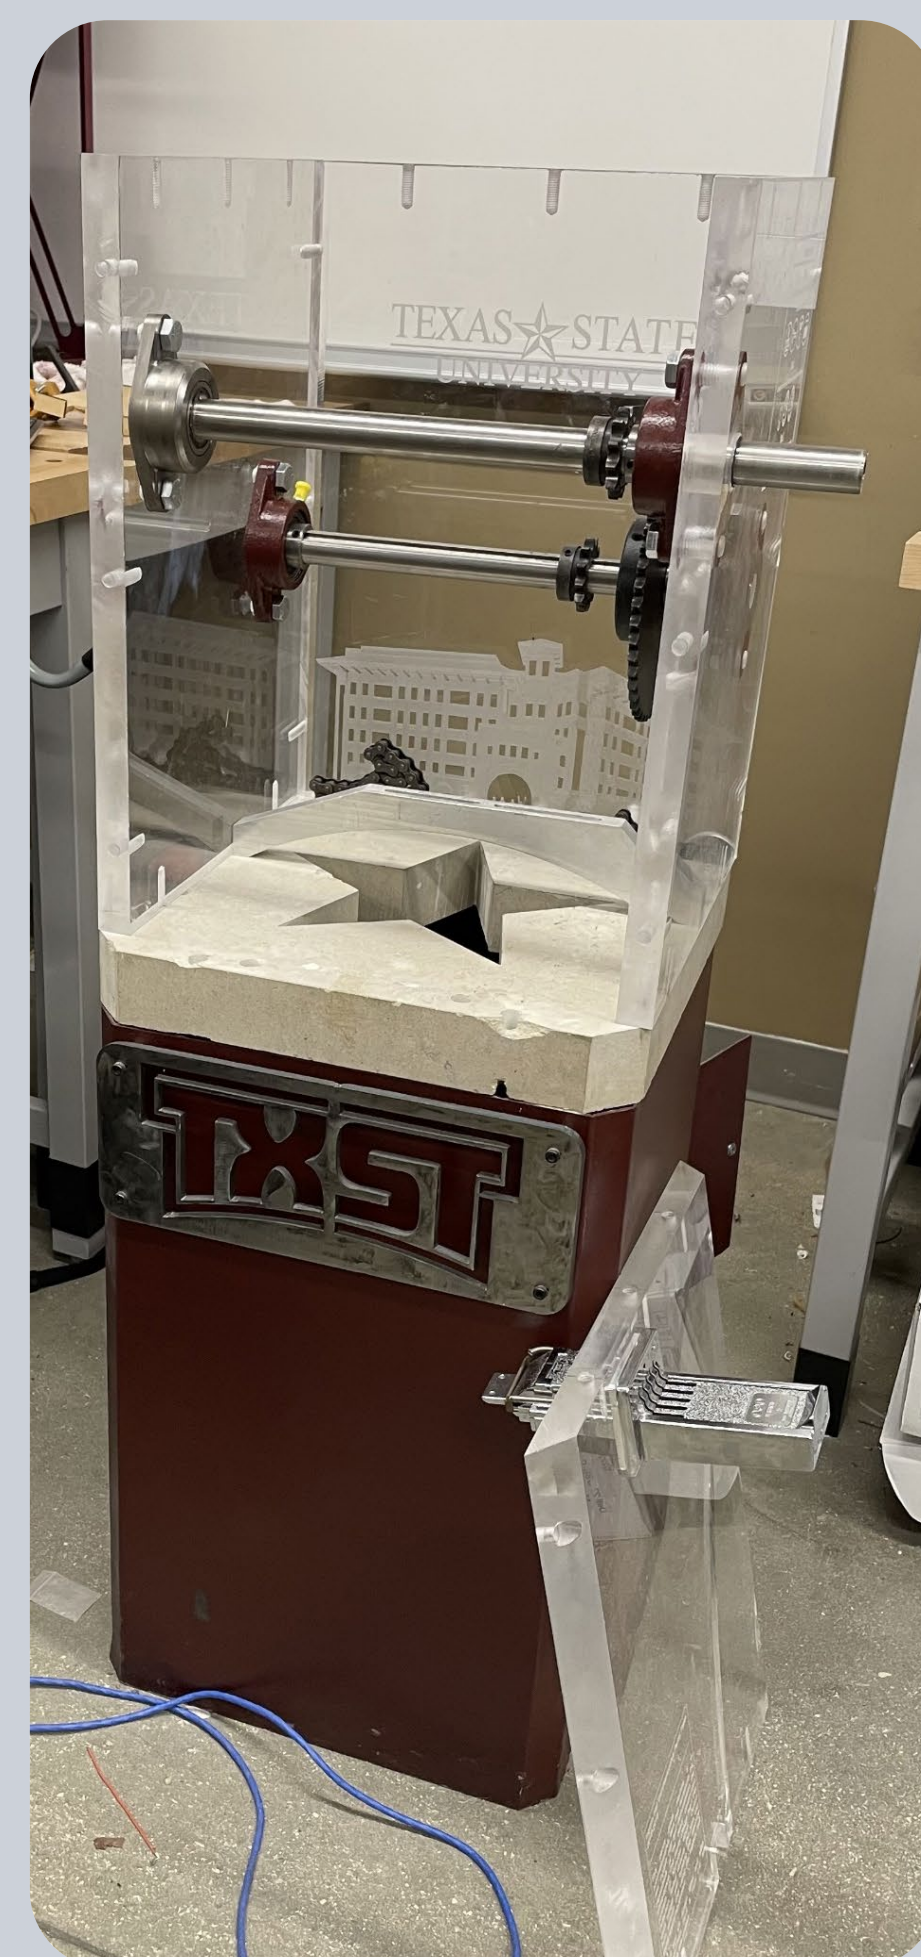
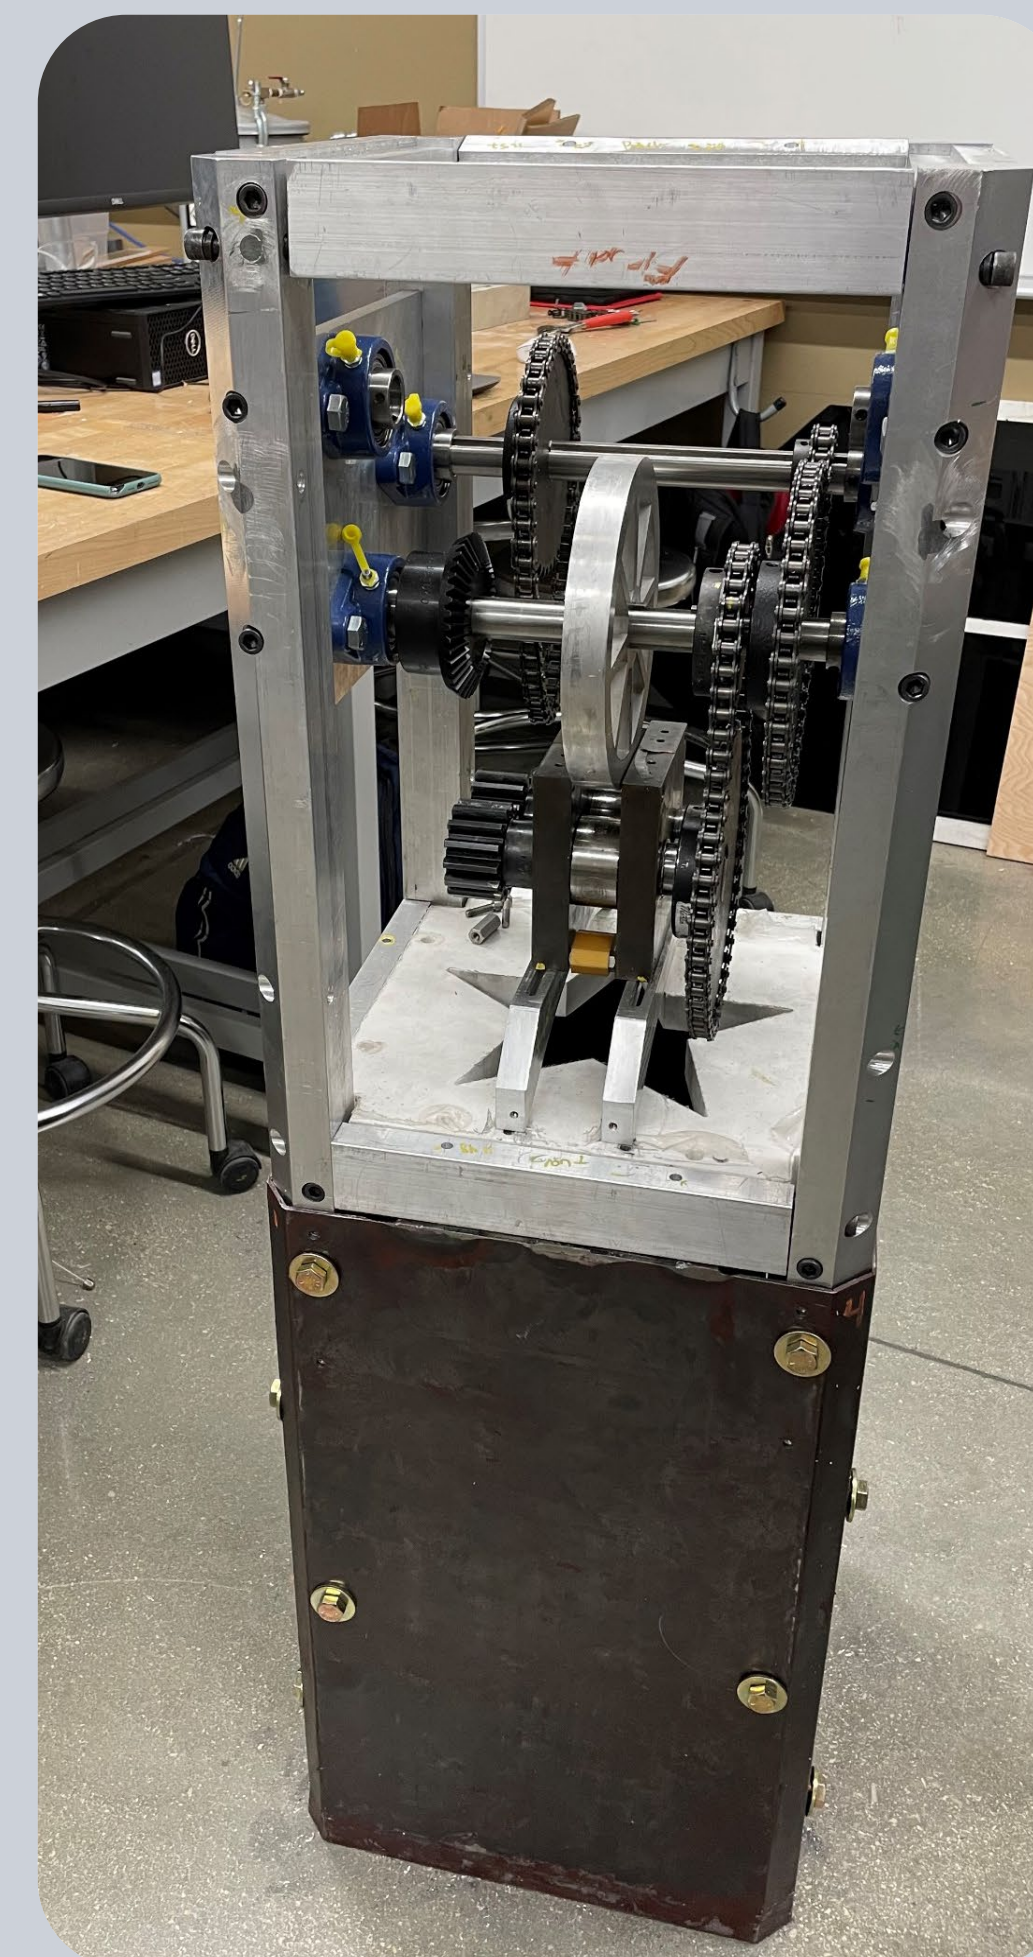
More Robust Structure

Old

New
