# FALL CREEK BRAZOS RIVER WATERSHED SUMMARY REPORT

June 2026

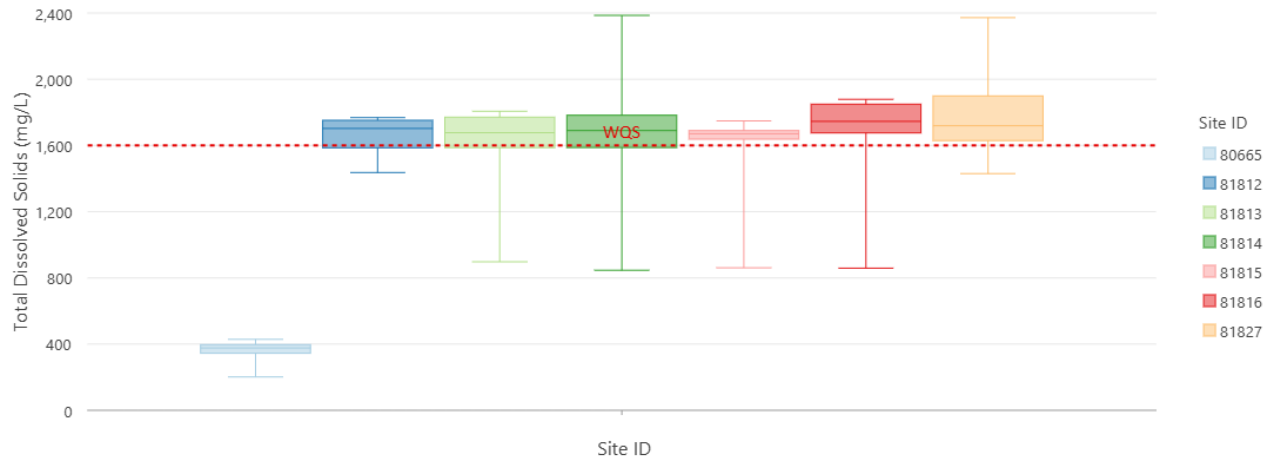
Average total dissolved solids concentrations across all sites ranged from 367.14 mg/L to 1,752.40 mg/L (Table 7), where majority of the sites exceeded the water quality standard of 1,600 mg/L. The lowest mean concentration (367.14 mg/L) was observed at Fall Creek at Langdon Ranch (site 80665), whereas the highest mean concentration (1,752.40 mg/L) was observed at Brazos River @ Pecan Plantation Clubhouse (site 81827). Discrete measurements showed variability across sites, including several elevated values identified as potential outliers during quality control screening.

Figure 9. Total Dissolved Solids for sites in the watershed (April 2011 – May 2026). WQS = Water Quality Standard.
