BLANCO RIVER WATERSHED DATA REPORT

March 2021

THE MEADOWS CENTER
FOR WATER AND THE ENVIRONMENT
TEXAS STATE UNIVERSITY

TEXAS STREAM TEAM

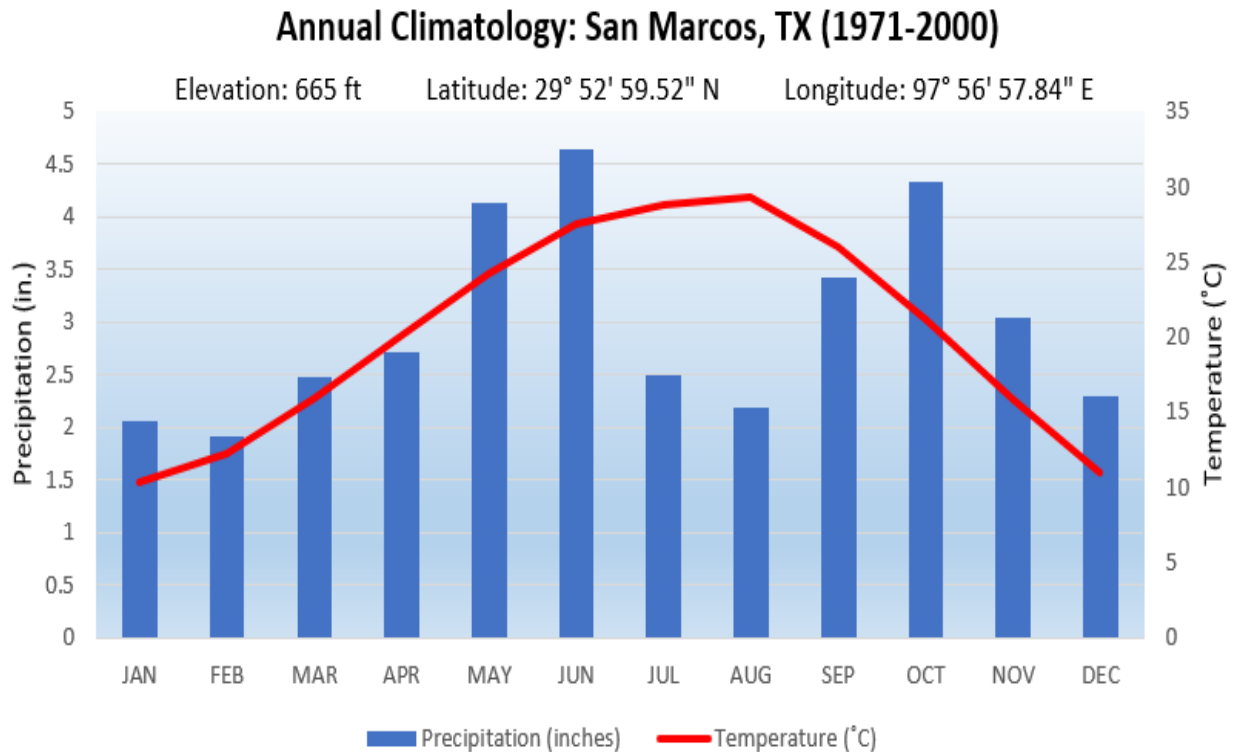
Figure 2. Long-term (1971-2000) monthly average precipitation (in) and air temperature (°C) from San Marcos, Texas (NOAA Climate Data, 2020).

National Oceanic and Atmospheric Administration (NOAA) climate data from San Marcos, Texas was acquired from the National Data Center (NOAA, 2020). Precipitation averaged 35.7 inches annually and occurs year-round (Figure 2). Monthly precipitation has a bimodal distribution with peaks occurring in June and October. Average rainfall in June and October was 4.6 and 4.3 inches, respectively. The least amount of rainfall occurred in August, which coincides with the warmest time of the year (29.7 °C).

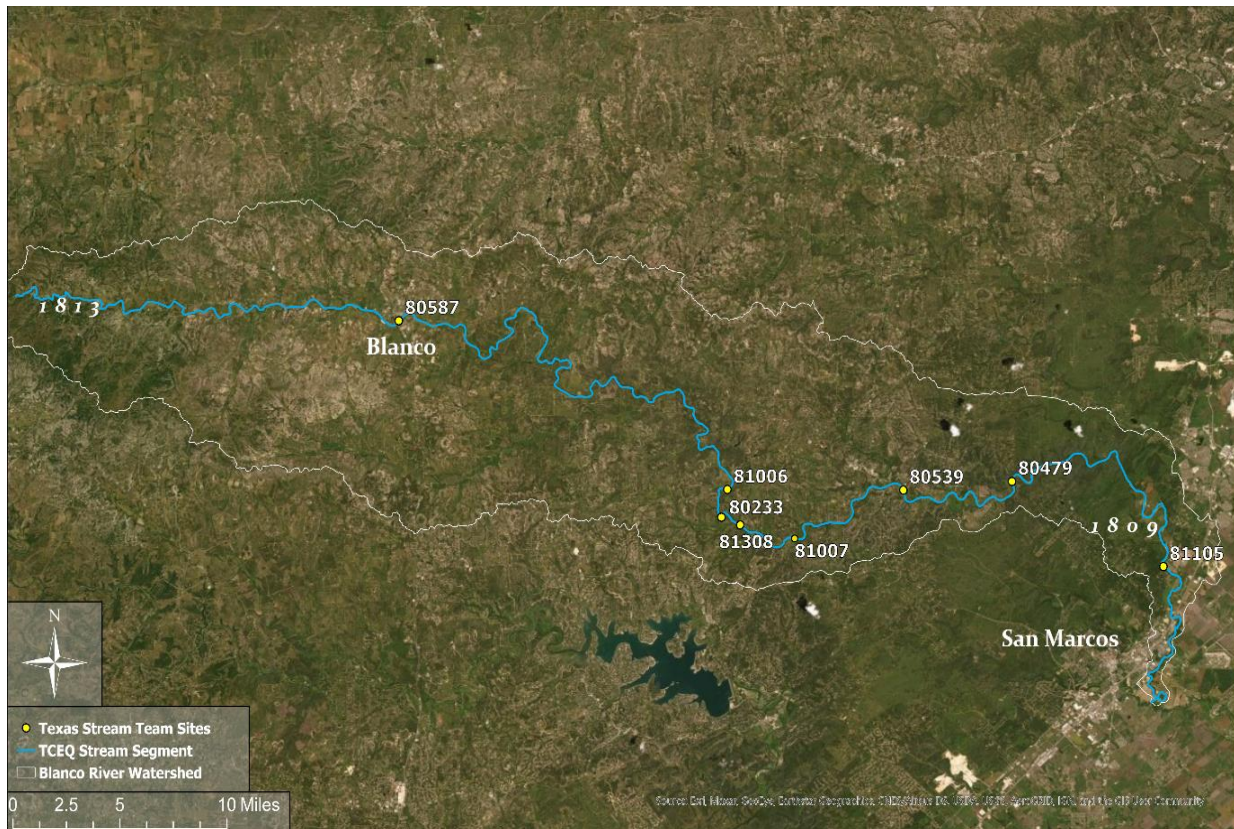
Figure 4. Blanco River watershed active Texas Stream Team citizen scientist monitoring sites.

Water quality data from eight Texas Stream Team monitoring sites on the Blanco River were acquired for this report (Figure 4). One site (81105) is located on the Lower Blanco River, while the remaining seven sites (80587, 81106, 80233, 81308, 81008, 80539 and 80479) are on the Upper Blanco River. Between 15 and 113 sampling events occurred at each site, for a total of 319 sampling events (Table 4). The period of record for the sampling events ranged from May 2011 to January 2021, with some sites experiencing temporal intermittent sampling.

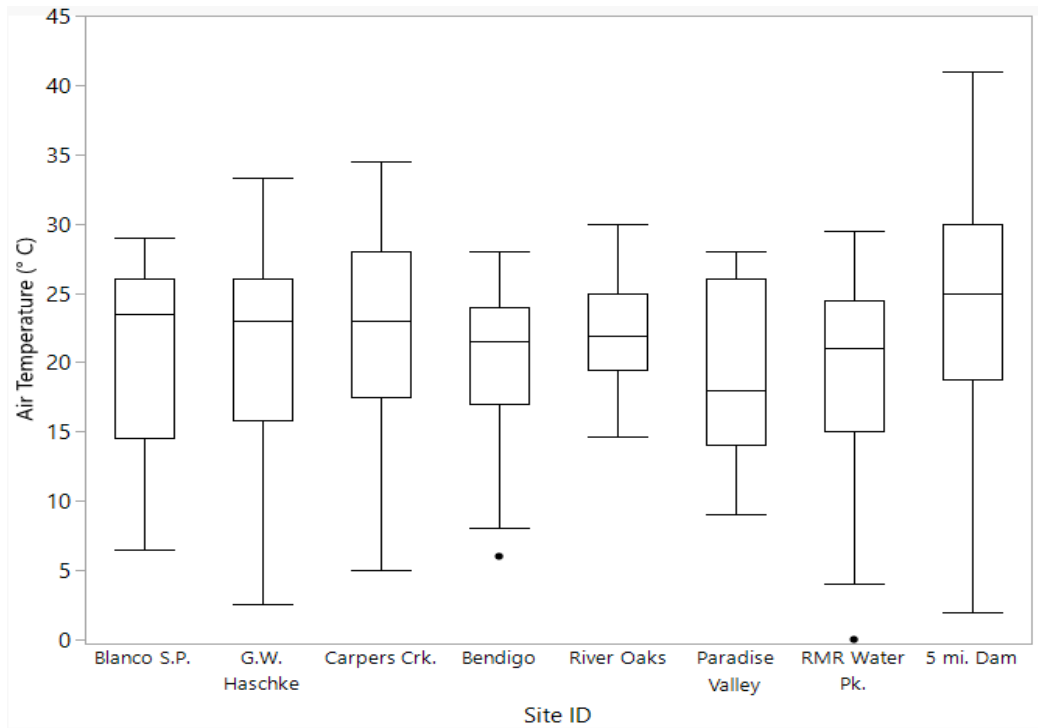
Figure 5. Air temperature (°C) for sites in the Blanco River watershed (May 2011-January 2021).

Average air temperature for all sites ranged from 19.2 to 24.4 °C (Table 5). The lower overall mean air temperature (19.2 °C) was observed at the RMR Water Park (80479) in the lower reach of the Upper Blanco River. The higher mean air temperature (24.4 °C) was observed at the 5 mi. Dam site (81105) on the Lower Blanco River. The distribution of air temperatures for each site are displayed in Figure 5 from upstream to downstream with the highest median temperature reported at 5-mile Dam (81105) and the lowest median temperature reported at Paradise valley (80539).

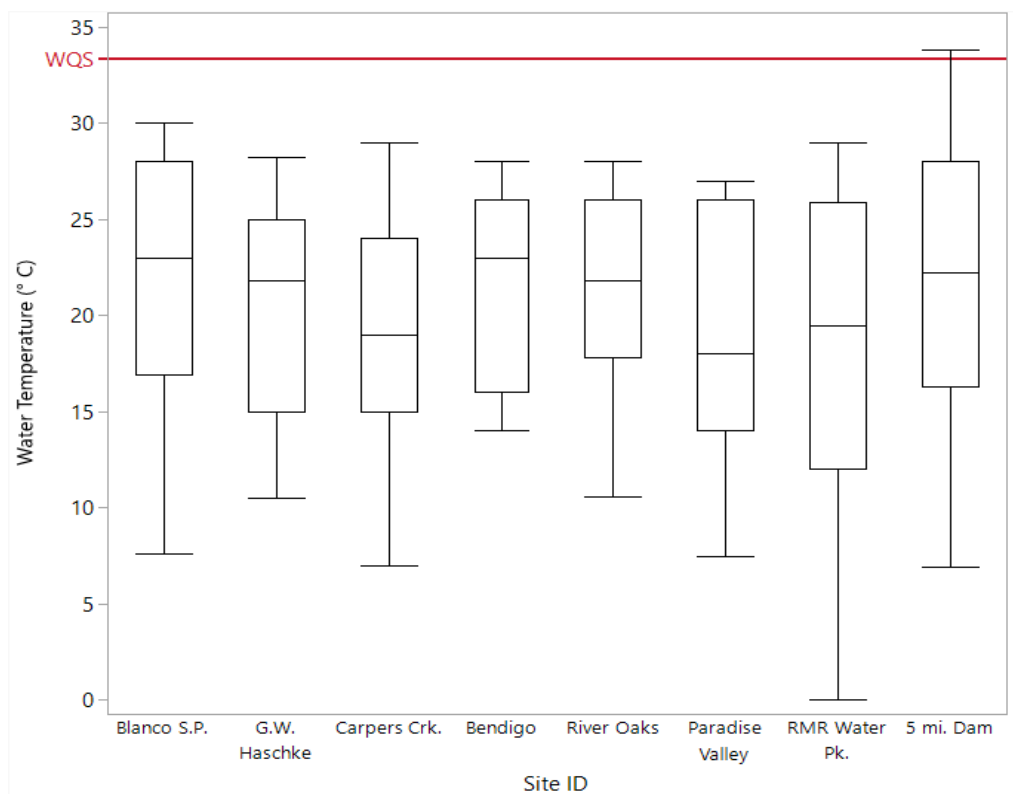
Figure 6. Water temperature (°C) for sites in the Blanco River watershed (May 2011-January 2021).

Water temperatures at all sites were well below the water quality standard (WQS) of 33.3°C. Average water temperature for all eight sites ranged from 18.6°C at the RMR Water Park (80479) in the lower reach of the Upper Blanco River to 22.4°C at the Bendigo (81308) site (Table 5). The distribution of water temperatures for each site are displayed in Figure 6 from upstream to downstream with the highest median temperature reported at 5-mile Dam (81105) and the lowest median temperature reported at Paradise valley (80539).

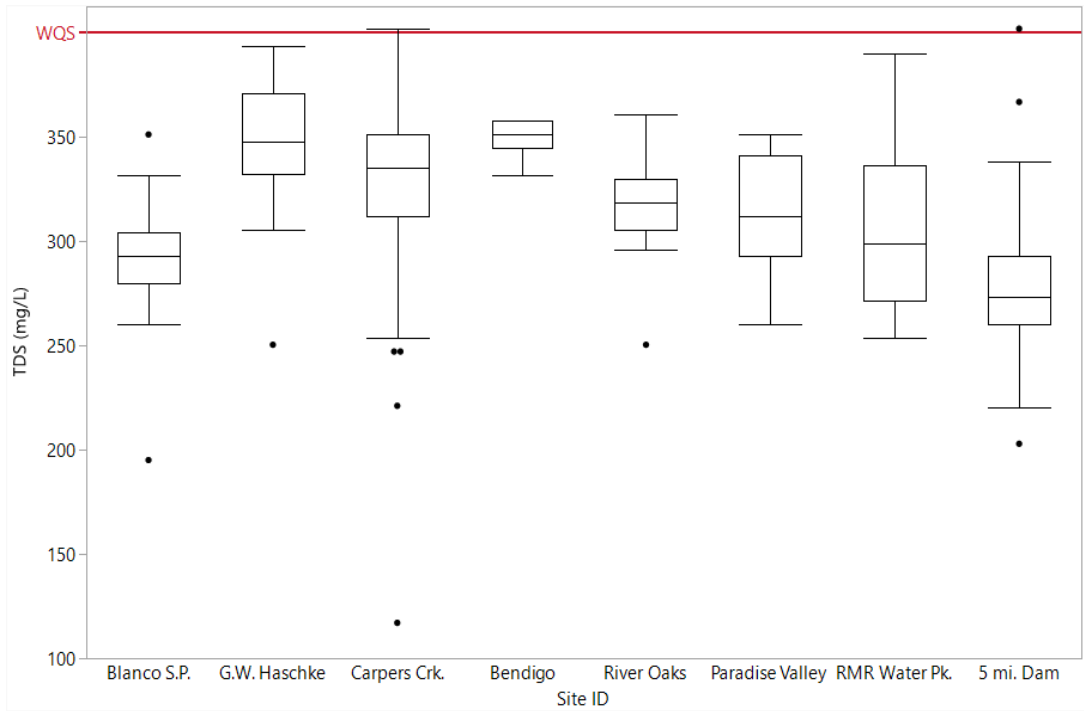
Figure 7. Total dissolved solids for sites in the Blanco River watershed (May 2011-January 2021).

Conductivity measurements were converted to total dissolved solids for all sites (Table 5). Average TDS values at all sites were below the water quality standard (WQS) of 400 mg/L. Average TDS values for all eight sites ranged from 280 to 389 mg/L (Table 5). The distribution of TDS measurements for each site from upstream to downstream are displayed in Figure 7 with the highest median TDS reported at Bendigo (81308) in the Upper Blanco River and the lowest median TDS reported at 5-mile Dam (81105) in the Lower Blanco River.

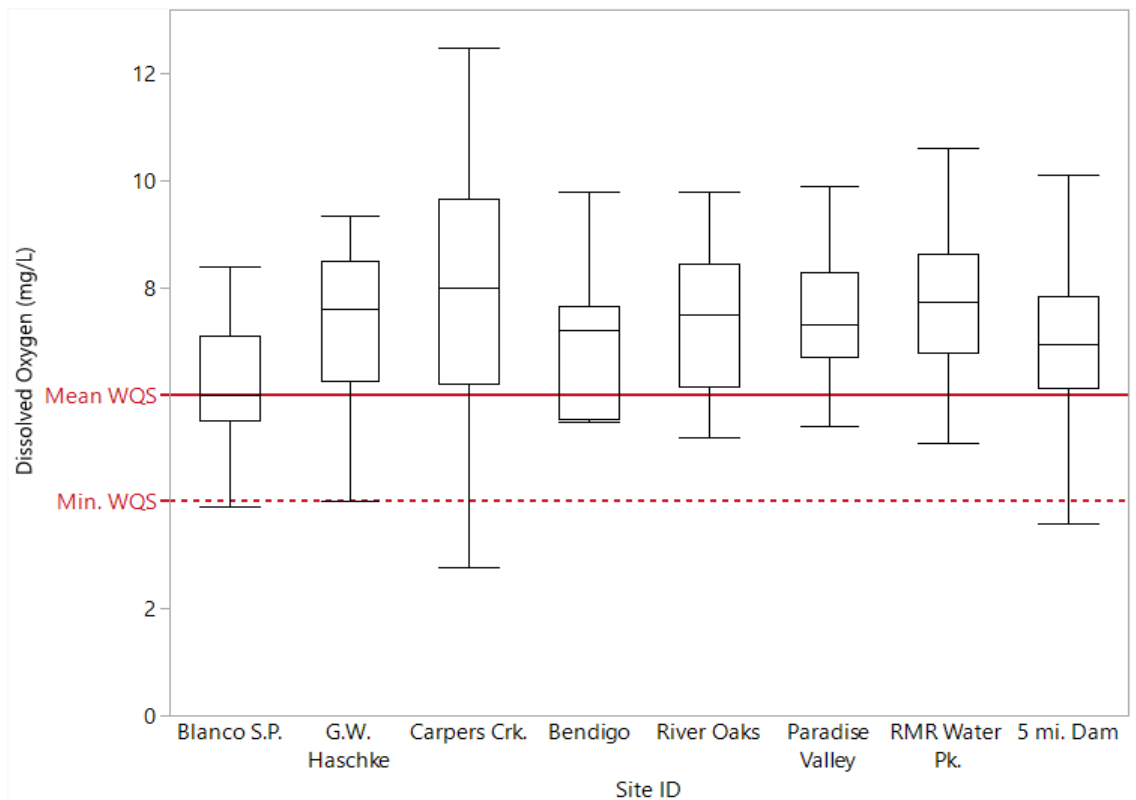
Figure 8. Dissolved oxygen (mg/L) for sites in the Blanco River watershed (May 2011-January 2021).

Average dissolved oxygen values at all sites were above the TSWQS of 6.0 mg/L in the Upper Blanco River and 5.0 mg/L in the Lower Blanco River (Table 5). The range of average DO values for all sites spanned from 6.2 to 7.9 mg/L. The distribution of DO measurements for each site from upstream to downstream are displayed in Figure 8. The highest median DO was reported at Carpers Creek (80233) and the lowest at Blanco State Park (80587) in the Upper Blanco River.

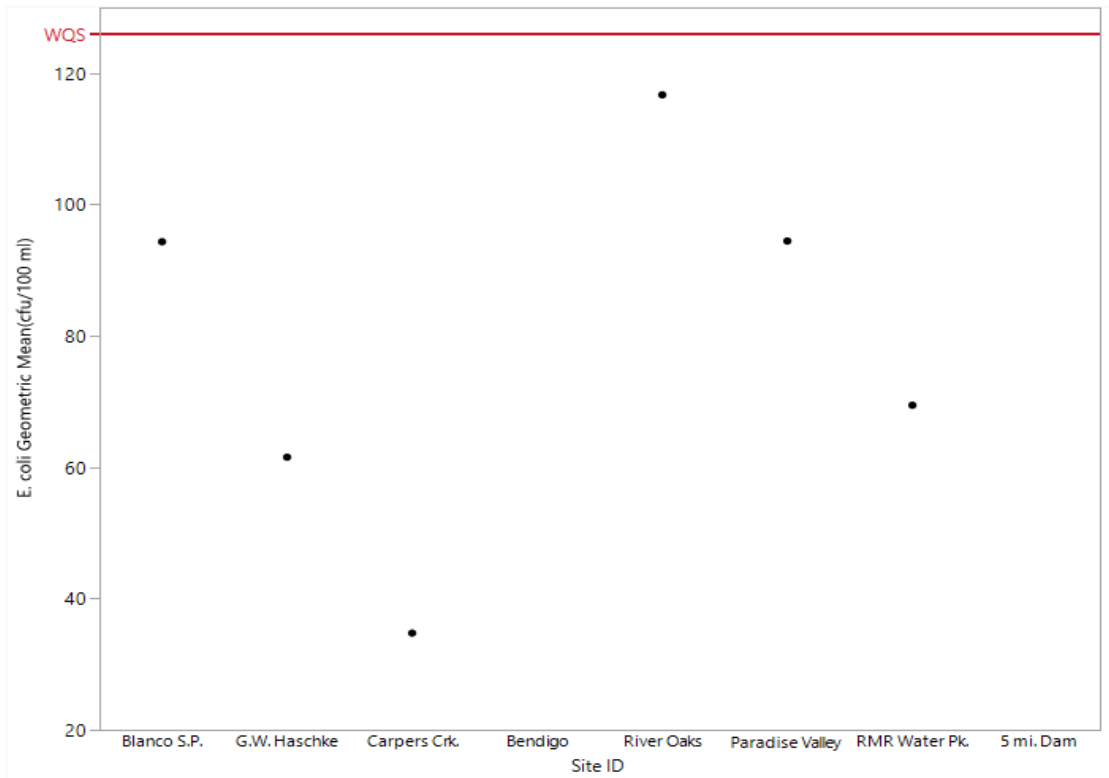
Figure 11. *E. coli* bacteria geometric means for sites in the Blanco River watershed (May 2011-January 2021).

E. coli bacteria was measured and reported at six of the eight sites on the Blanco River (Table 5). No bacteria data was available from the site in the Lower Blanco River, but bacteria data was available at six of the seven sites in the Upper Blanco River. The *e. coli* geometric means met the TSWQS (126 cfu/100 ml) at all sites where measurements were collected (Figure 11).
