Group C2.02 - ScourGuard

Project Overview

Location: San Antonio Texas, Highway FM 78 crossing Salitrillo Creek
Problem: Scouring damage near foundation and channel lining

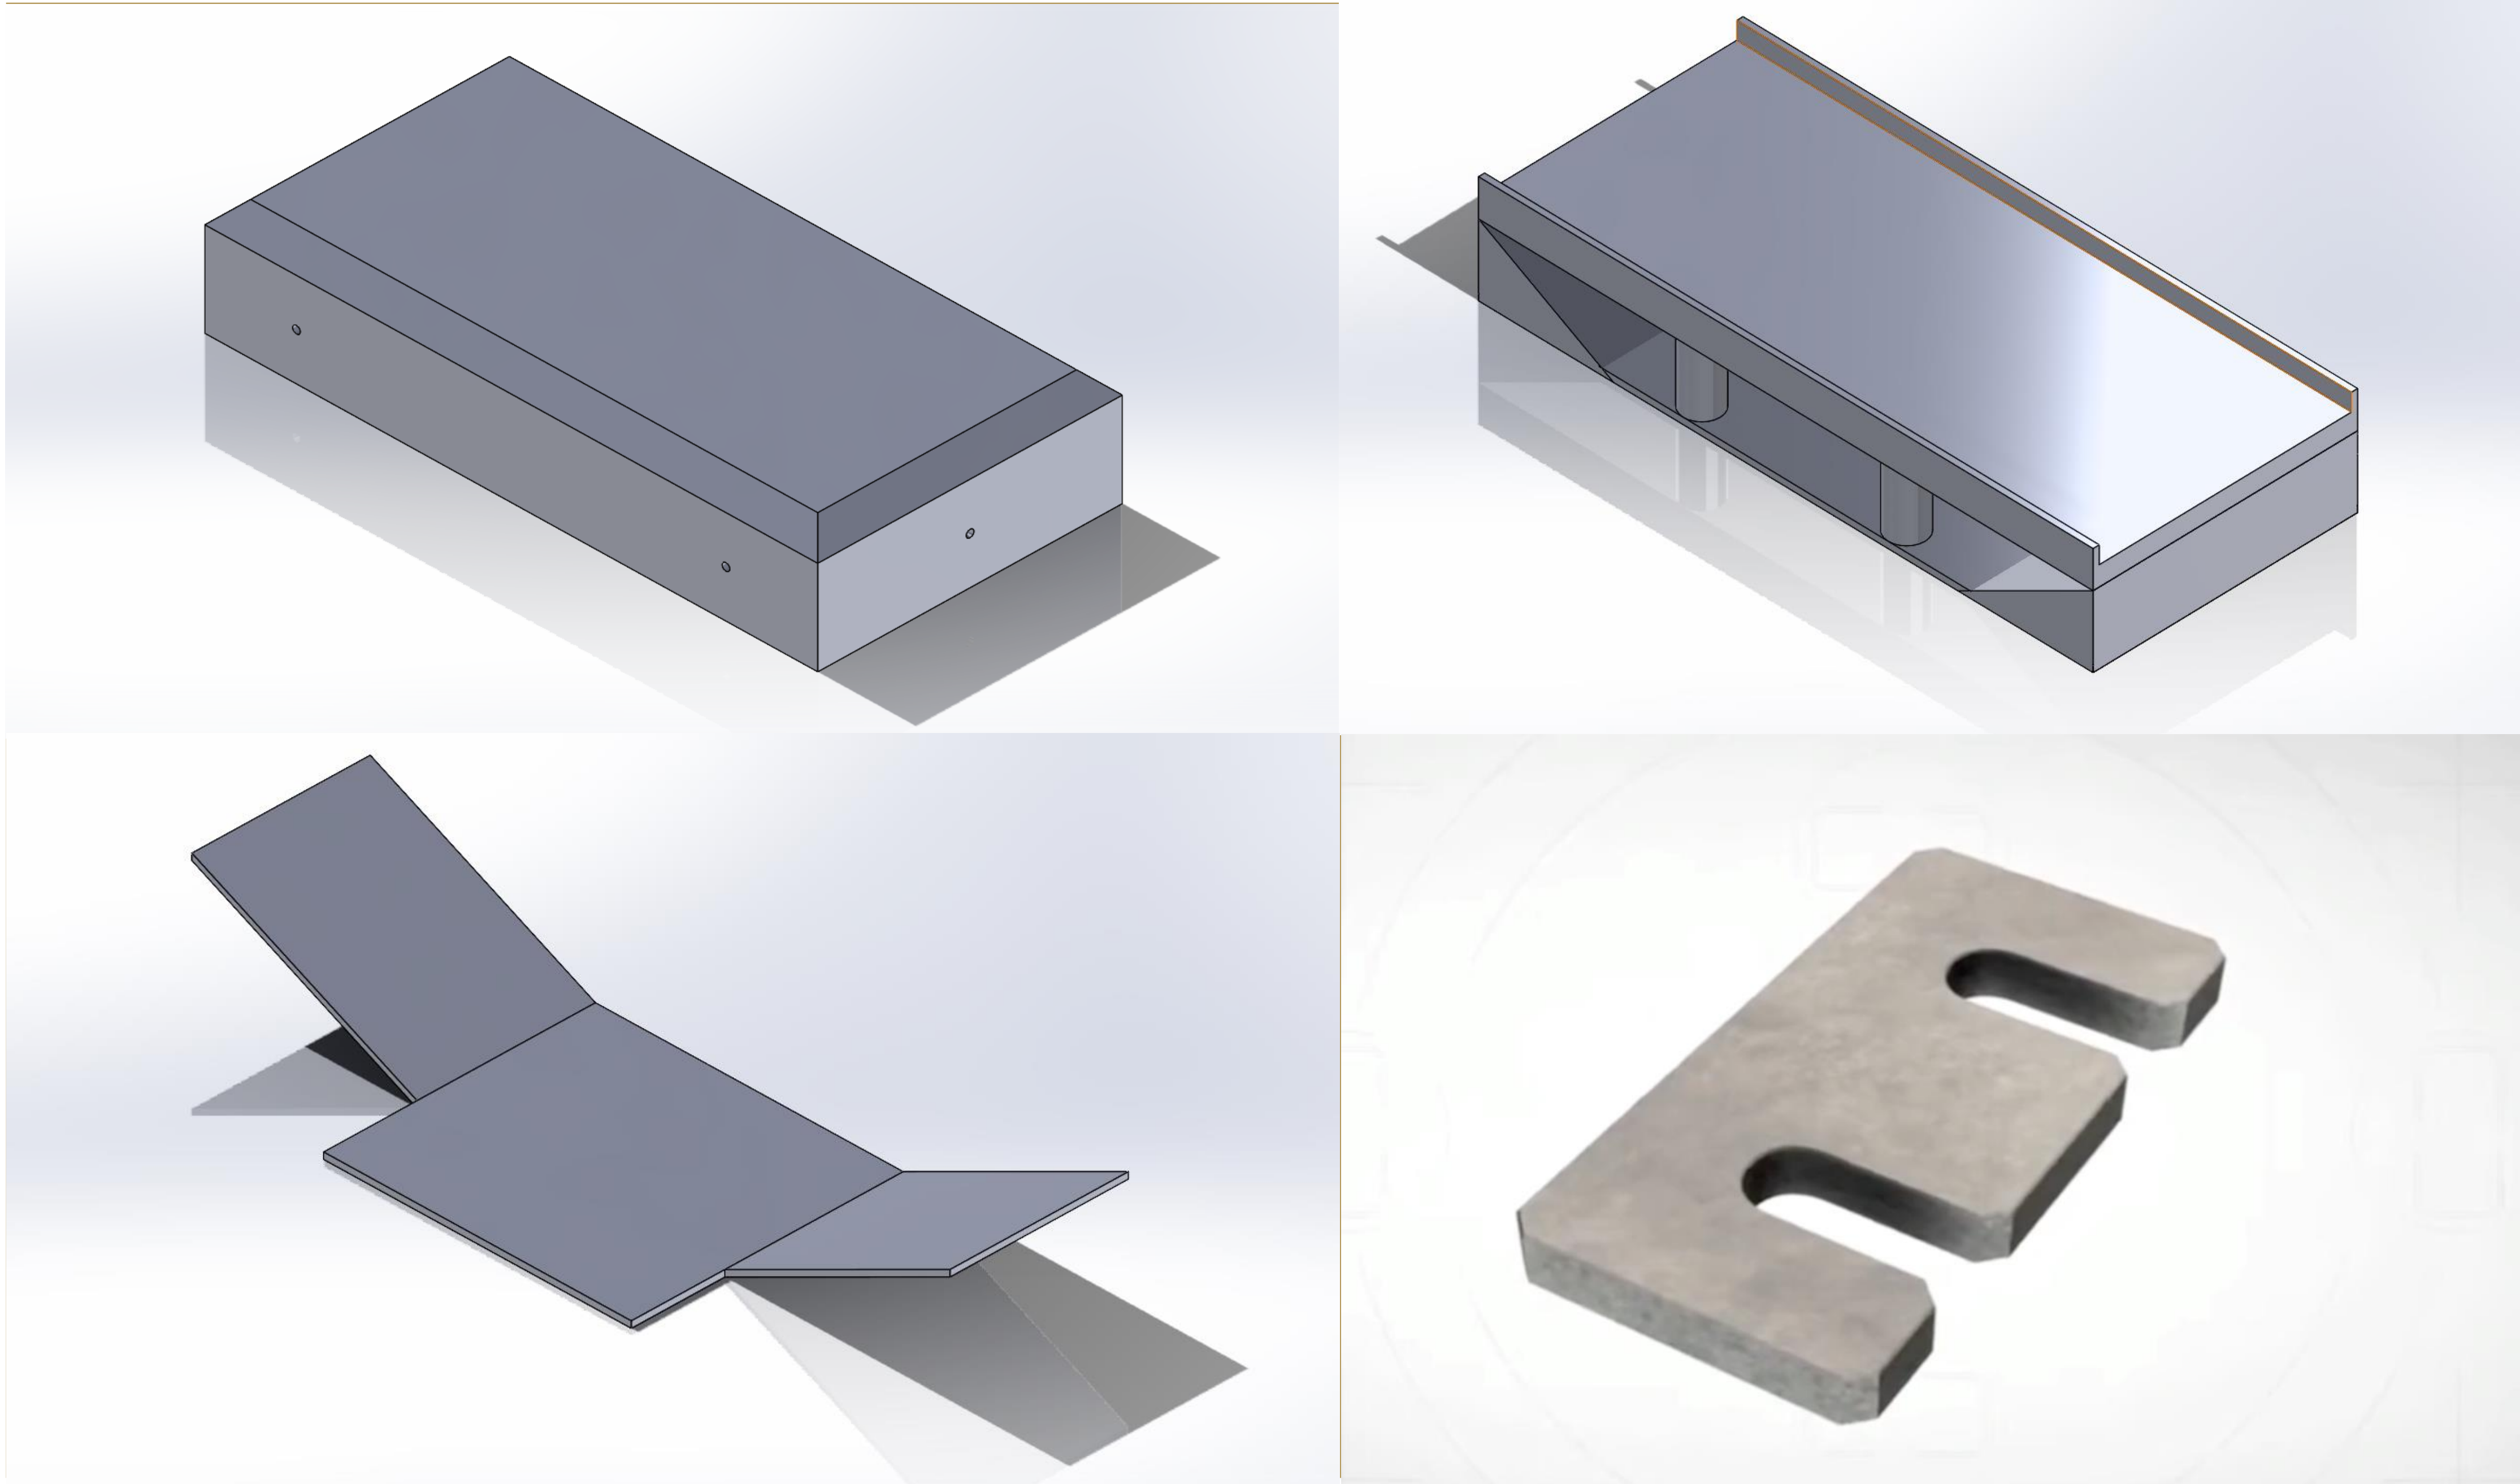
Solution Specifications

Concrete	Area (ft²)	Volume (ft³)	Volume (CY)	Weight (lb)
Left Slope	407.6	273.1	10.1	40,965
Center Flat	798.6	535.1	19.8	80,265
Right Slope	407.6	273.1	10.1	40,965
Total	1,613.8	1,081.3	40.1	162,195

- A concrete slab has been designed to match the bridge foundation elevation that's 8 inches thick
- Elevation drop: ~1 ft from bridge foundation to river channel toe
- Slab ensures revetment mat sits flush with bridge skirt
- Soil backfill required to regrade existing channel to a 2:1 slope
- Filter fabric placed between compacted soil and concrete for drainage and stability

Mat	Blocks (L x W)	Block Count	Area (ft²)	Volume (cy)	Weight (lb)	
Left Slope	14 x 21	294	407.6	5.04	20,417	
Center Flat	18 x 32	576	798.6	9.88	40,000	
Right Slope	14 x 21	294	407.6	5.04	20,417	
Total	—	1,164	1,613.8	19.96	80,834

- Precast concrete blocks: 4" x 10" x 20"
- Three mats will be pre-cast then assembled on sight
- Layout avoids half blocks and ensures durability.
- Slight uncovered edges will be sealed with non-shrink grout or mortar

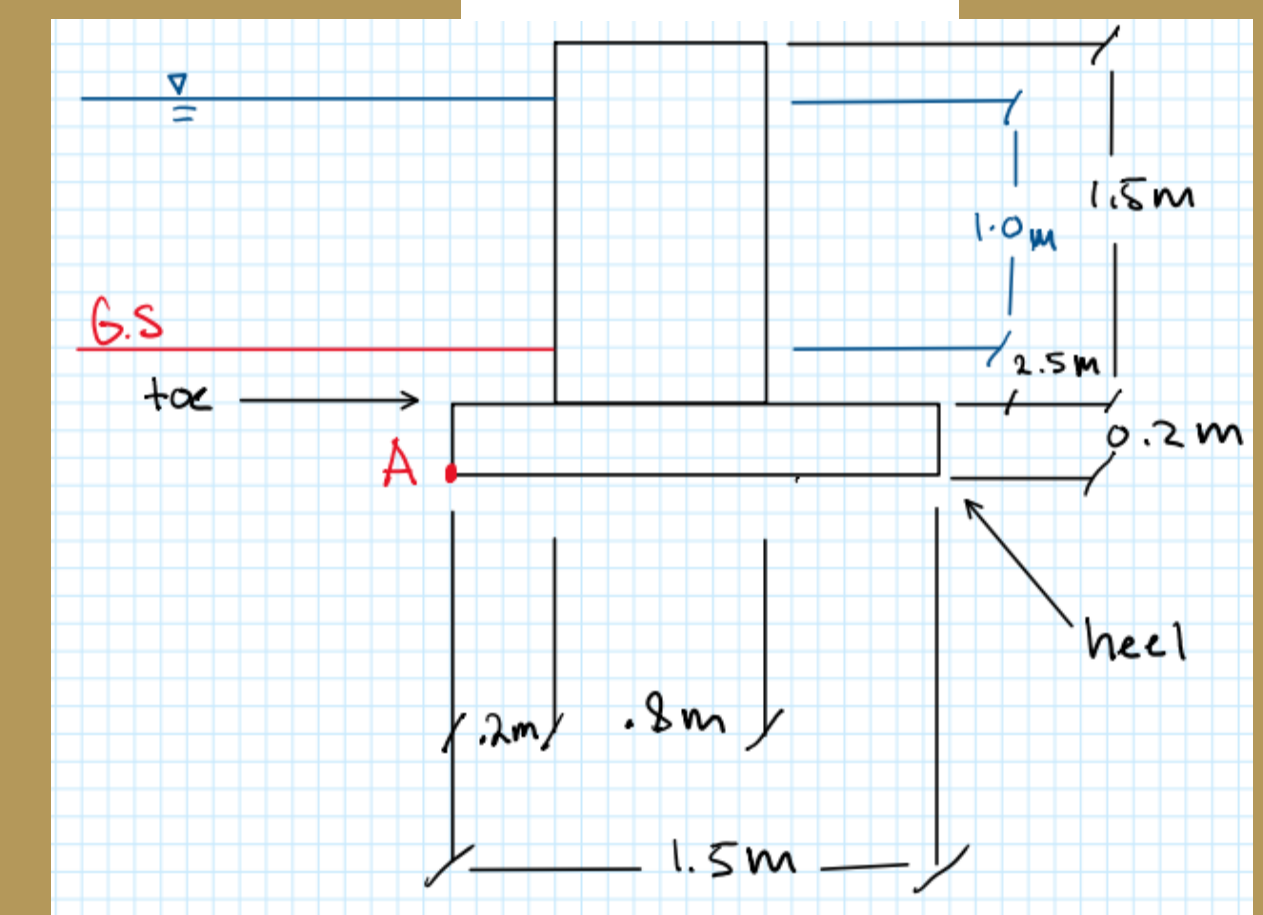
Stability Checks

There are many factors that contribute to the design of a retaining wall. For a wall to remain stable, and to not fail under loads and stresses, the wall must pass a series of stability checks:

- **Overturning** – The ability to resist lateral pressures acting on wall. Resistance to overturning prevents the wall from tipping in any direction.

- **Sliding** – Determines whether the resisting forces can overcome the active pressures acting on the wall. This check ensures the wall from sliding out of its position

- **Bearing capacity** – Evaluated whether the bearing pressure exerted by the wall exceeds the maximum allowable bearing capacity of the soil. In other words, it ensures that the soil does not fail under pressure due to the wall.
