Design, manufacture, and install six durable diver-below-buoys to support 3 to 4 divers, provide stable flotation, storage, and durability for long-term reliability and cost efficiency.

ME2.02 – Logan Mallow, Claudia Quilter, Andres Herrera, Ryan Beakley

Design and Fabrication of Diver Below Buoys

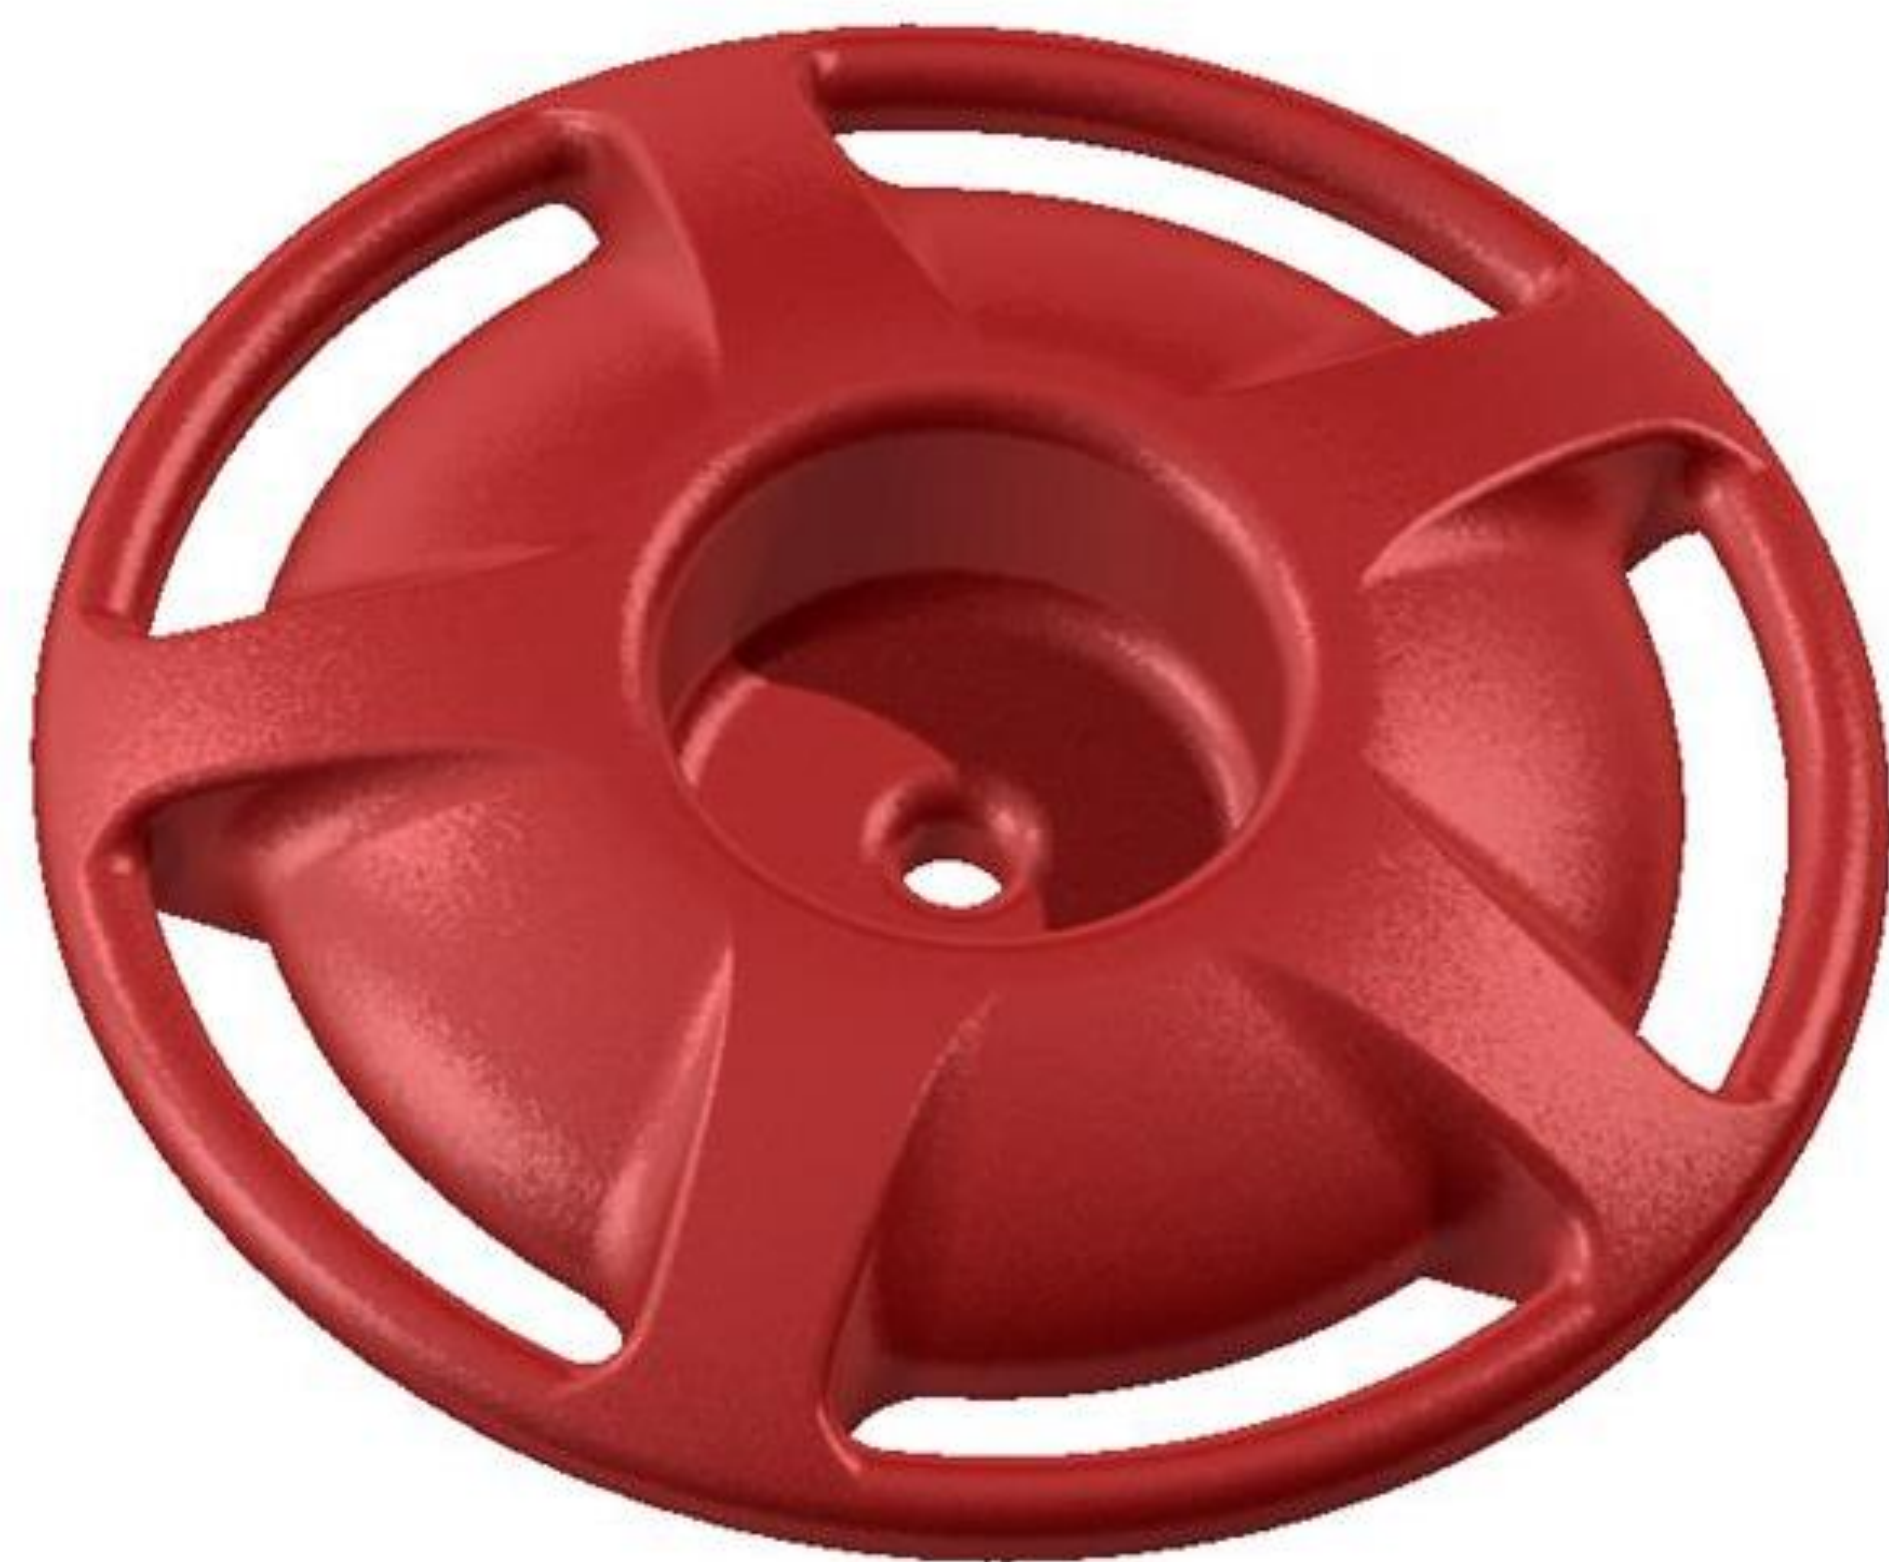
FINAL DESIGN

- Red marine grade, vacuum molded HDPE shell
- Marine grade closed cell foam core
- 3 feet in diameter
- Supports 4-5 divers
- Resistant to galvanic corrosion, UV degradation, rips, tears, and punctures
- Product life of 7-10 years

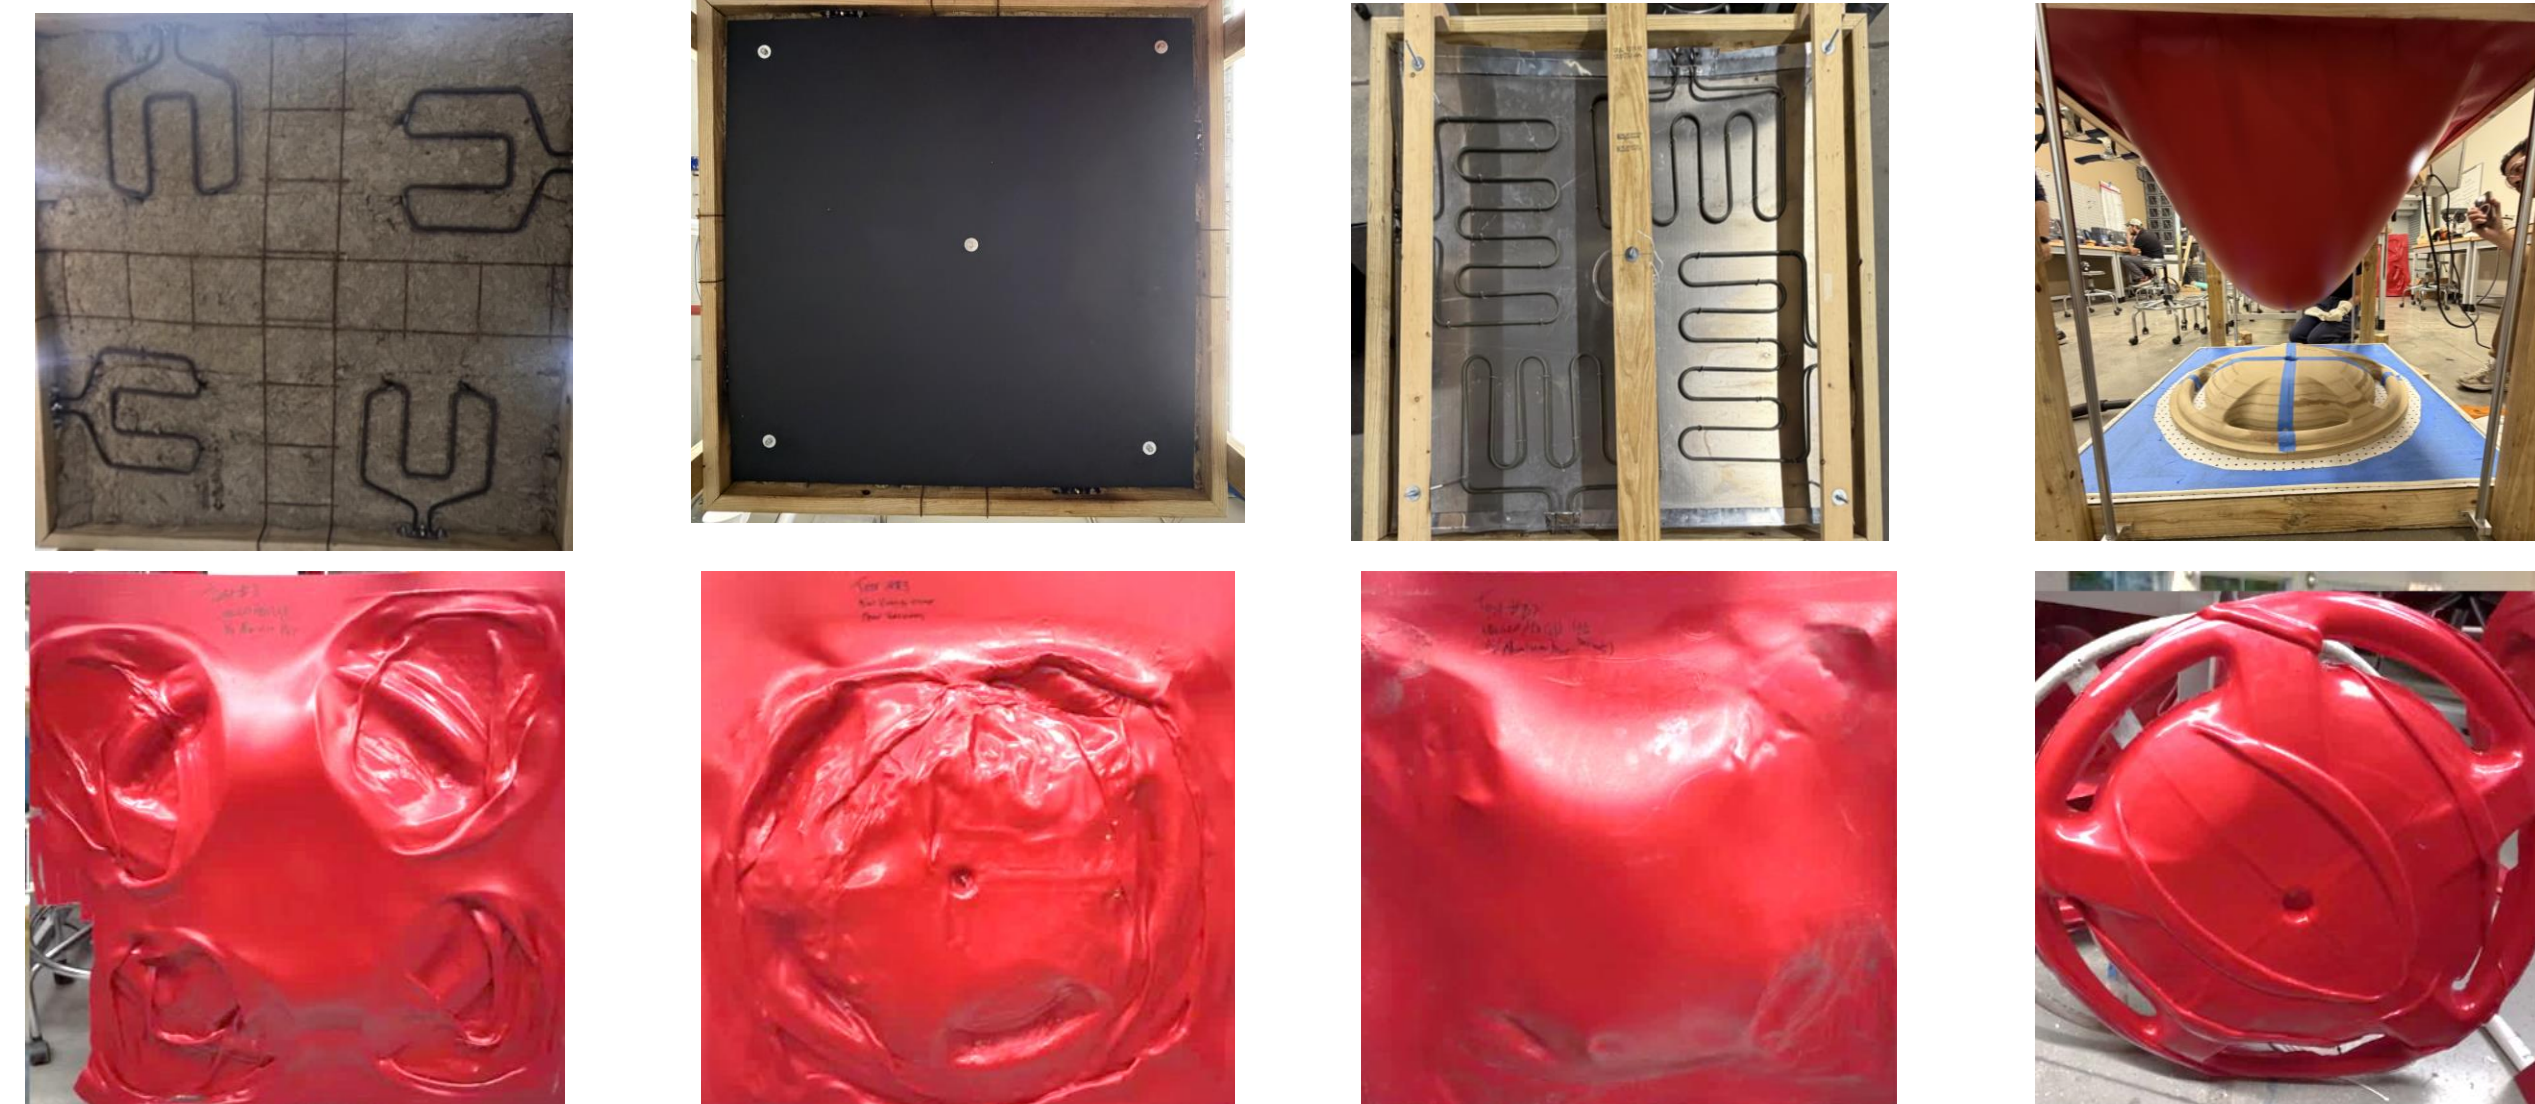
Heating Array Systems Test

TEST 1
Uneven heating of plastic sheet

TEST 2
Added aluminum hotplate to heating elements

Plastic still heated unevenly

TEST 3
New larger heating element array was wired and installed

Proper heating
Improper vacuum seal

TEST 4
Vacuum leaks isolated and sealed

Held under heat too long

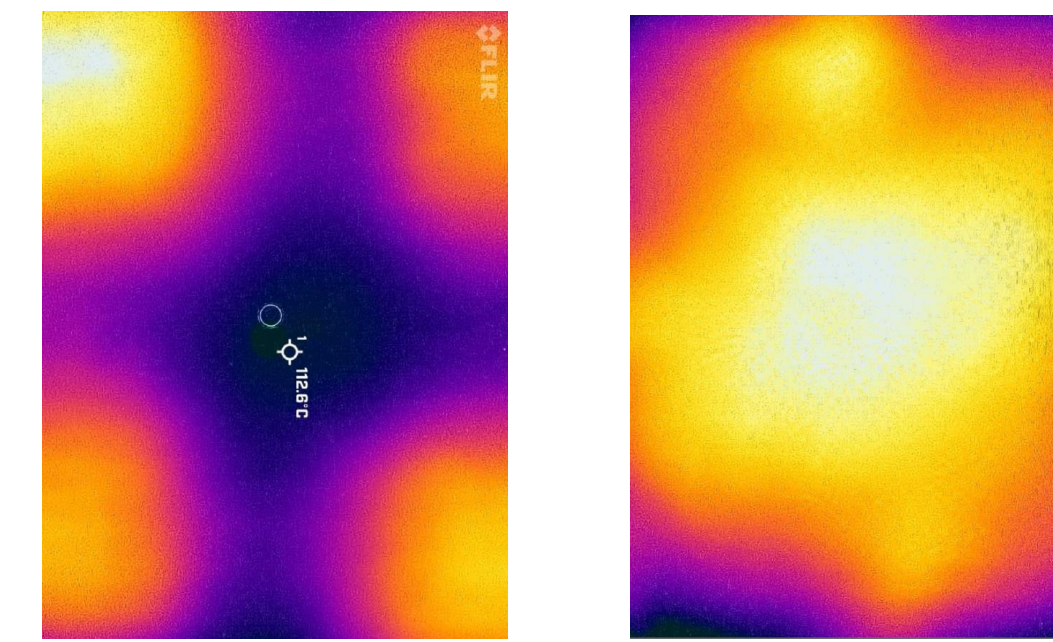
Thermal Imaging

Thermal gradient on the aluminum sheet before and after the heating system upgrades

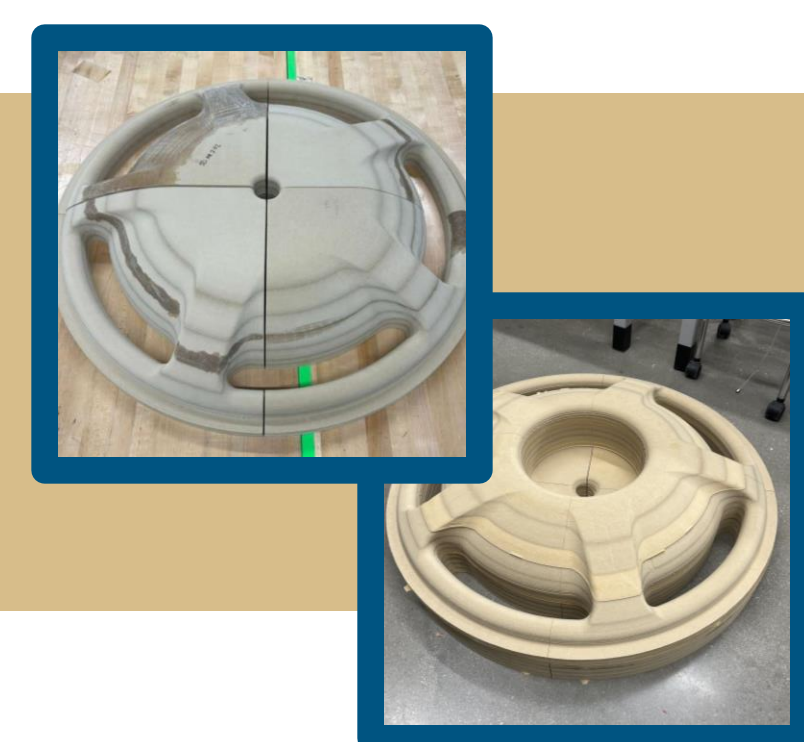
A top and bottom buck is machined out of MDF and is used to form all six buoys

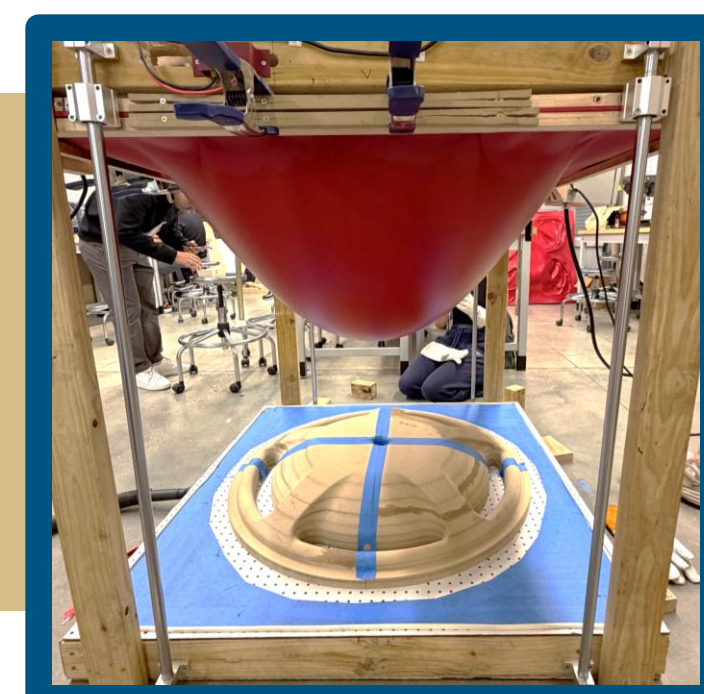
Marine grade HDPE is heated to its glass transition temperature (130°C-160°C)

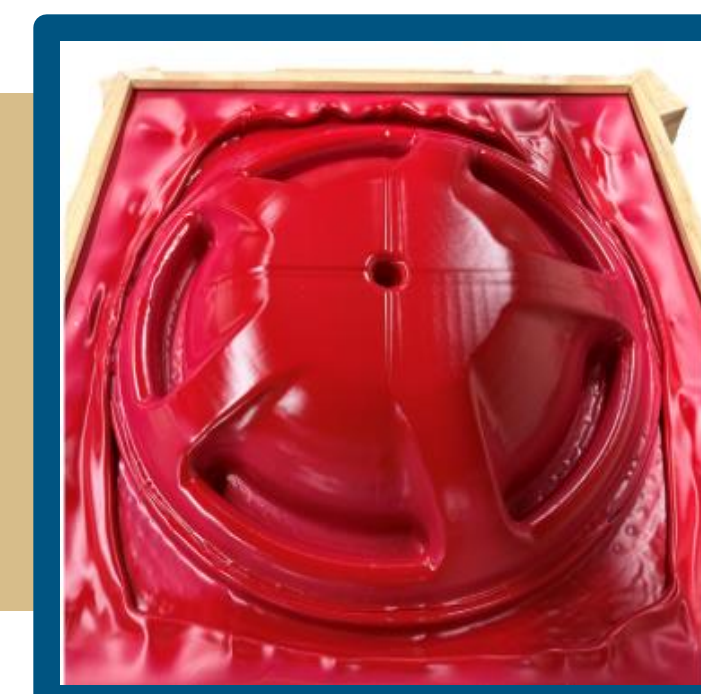
Heated plastic is lowered over the mold on a vacuum table

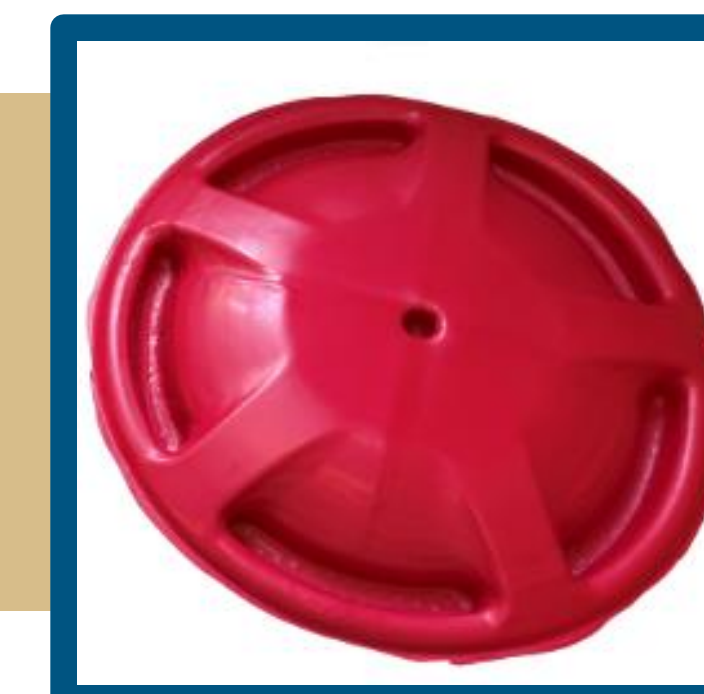
The HDPE is then cut and processed

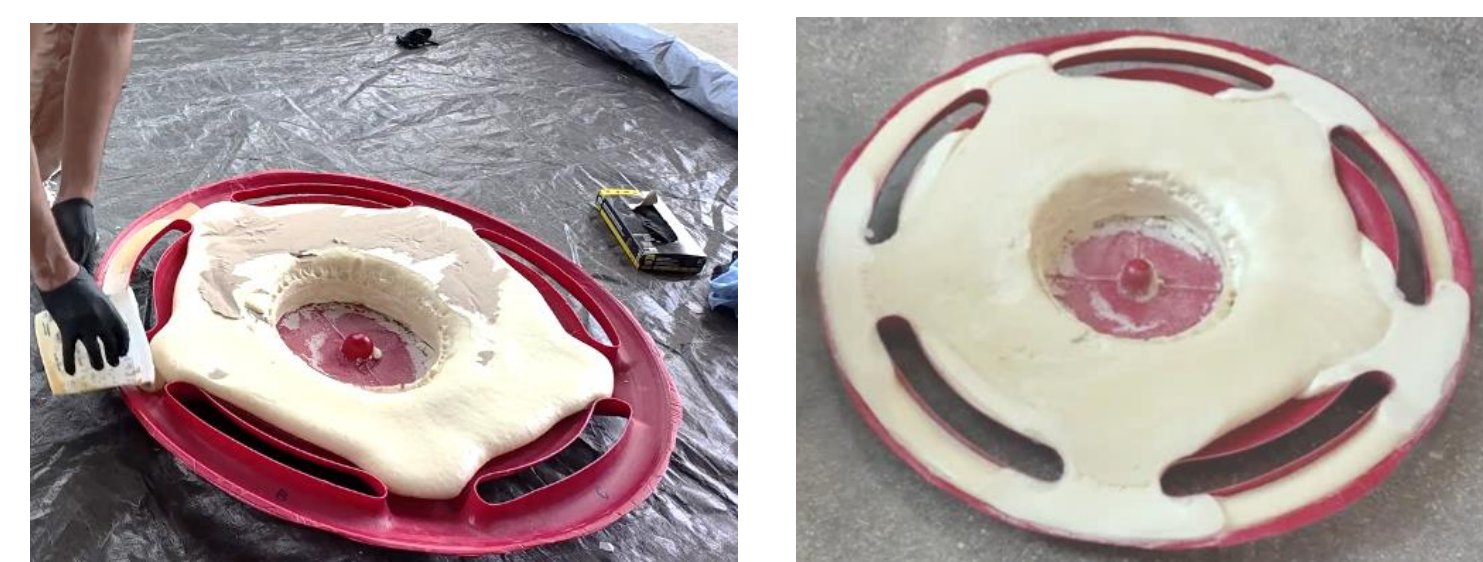
II. Foam Filling

Each half of the buoy is filled with a two-part expanding foam

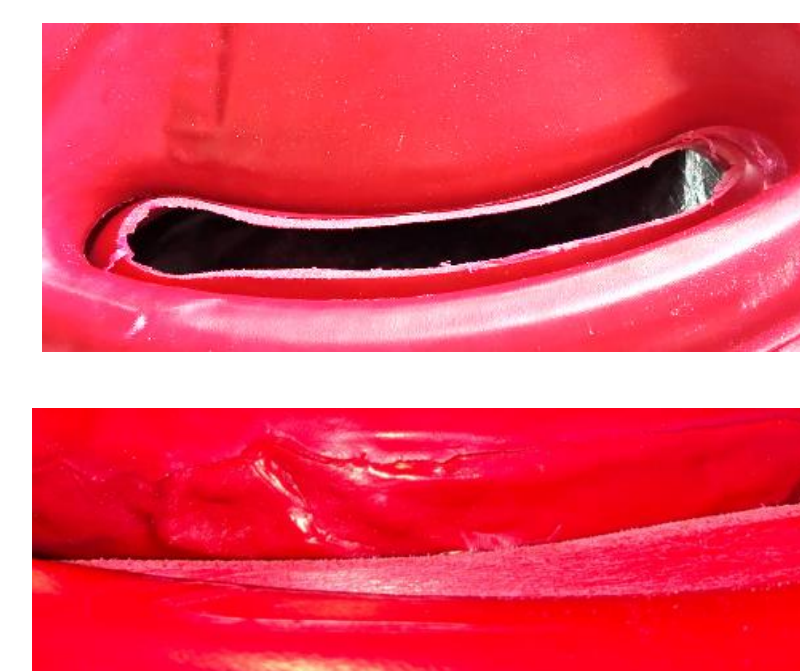
III. Plastic Welding

The two halves are then plastic welded together to create the final buoy
