Height Modernization Benchmark Survey

December 2007

0181-03-061

Project Number 0181-03-061

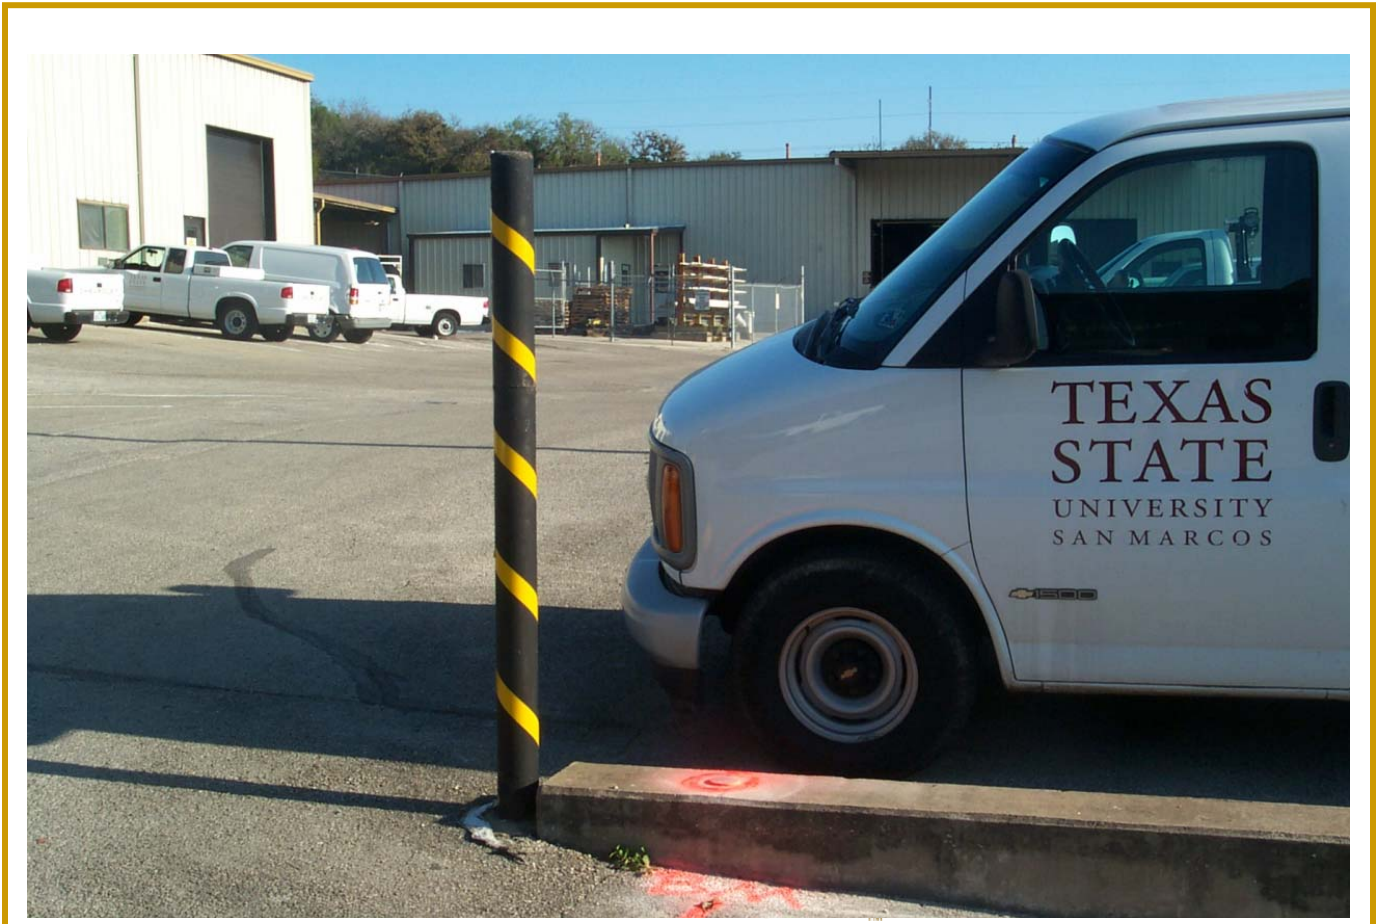
MONUMENT LOCATION PHOTO

DATE: December 2007
BENCHMARK ID: BM-1 GPS

NAVD 88 ELEVATION IN FEET: 629.17

DESCRIPTION: 3" Aluminum disk set in concrete retaining wall inside the maintenance facility yard on Sessom Drive.

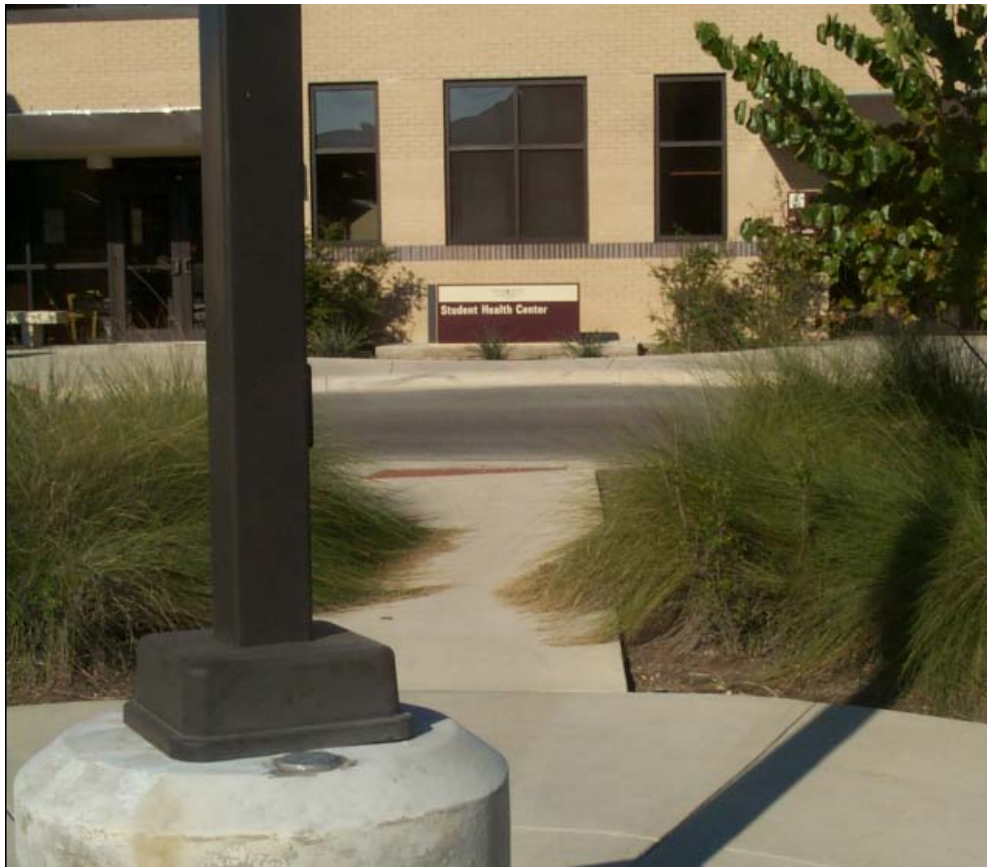
MONUMENT LOCATION PHOTO

DATE: December 2007
BENCHMARK ID: BM-2

NAVD 88 ELEVATION IN FEET: **735.47**
(Revised 7/14/08)

DESCRIPTION: 3” Aluminum disk set in concrete lamp post in center of circle drive in front of student health building.

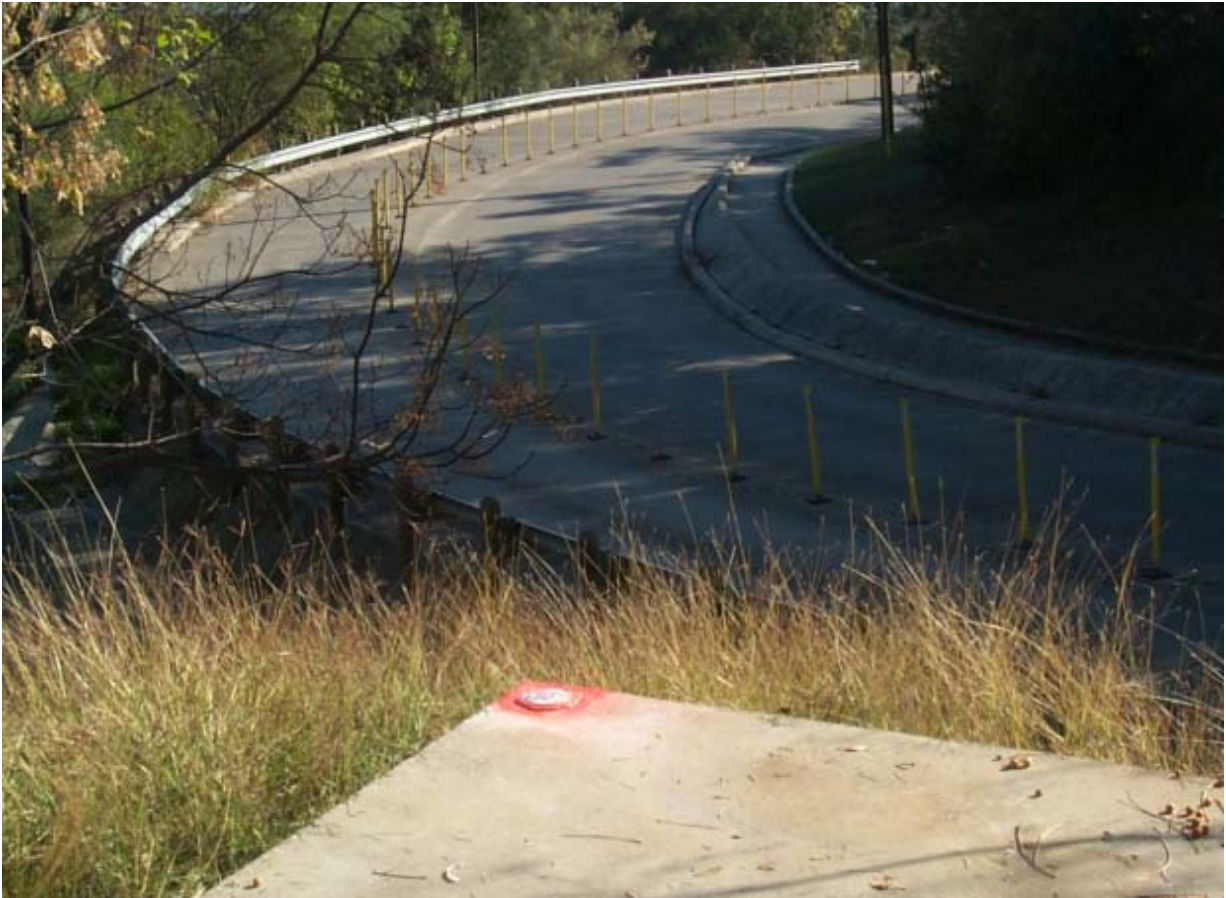
MONUMENT LOCATION PHOTO

DATE: December 2007
BENCHMARK ID: BM-3

NAVD 88 ELEVATION IN FEET: 687.45

DESCRIPTION: 3" Aluminum disk set in concrete on top of utility vault at corner of parking lot along Matthews Street .

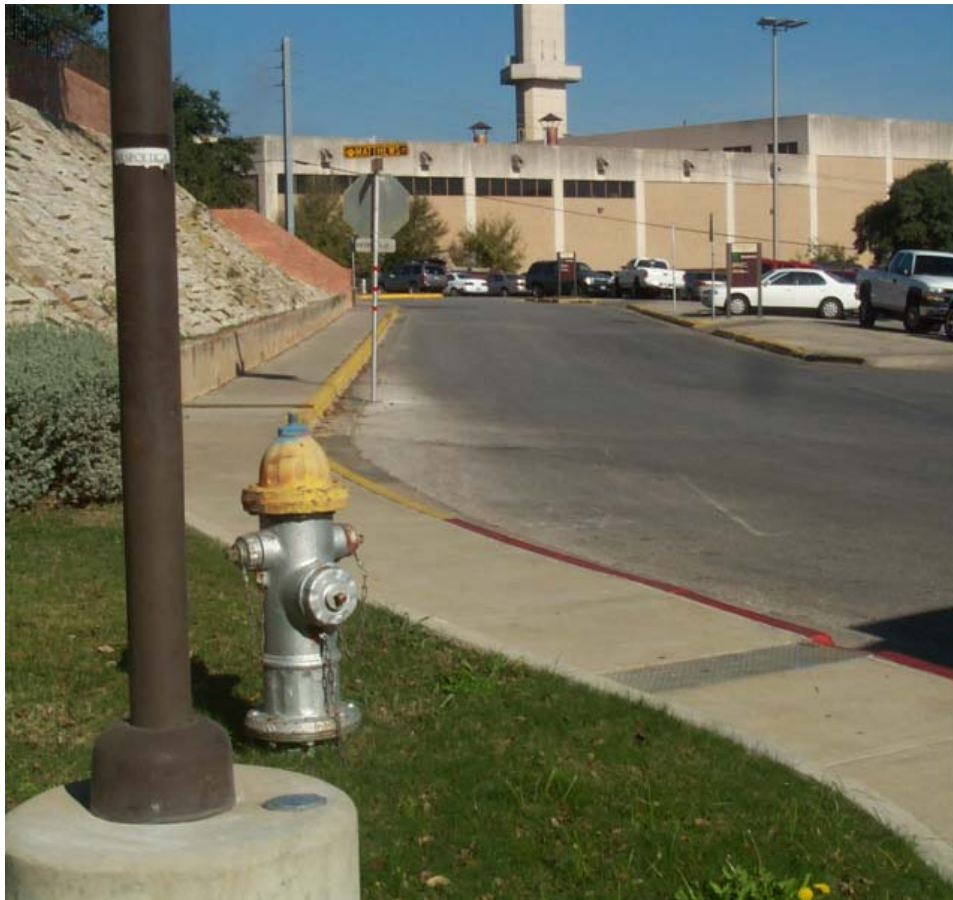
MONUMENT LOCATION PHOTO

DATE: December 2007
BENCHMARK ID: BM -4

NAVD 88 ELEVATION IN FEET: 730.31

DESCRIPTION: 3" Aluminum disk set in concrete lamp post south side of Student Center Drive at Matthews Street.

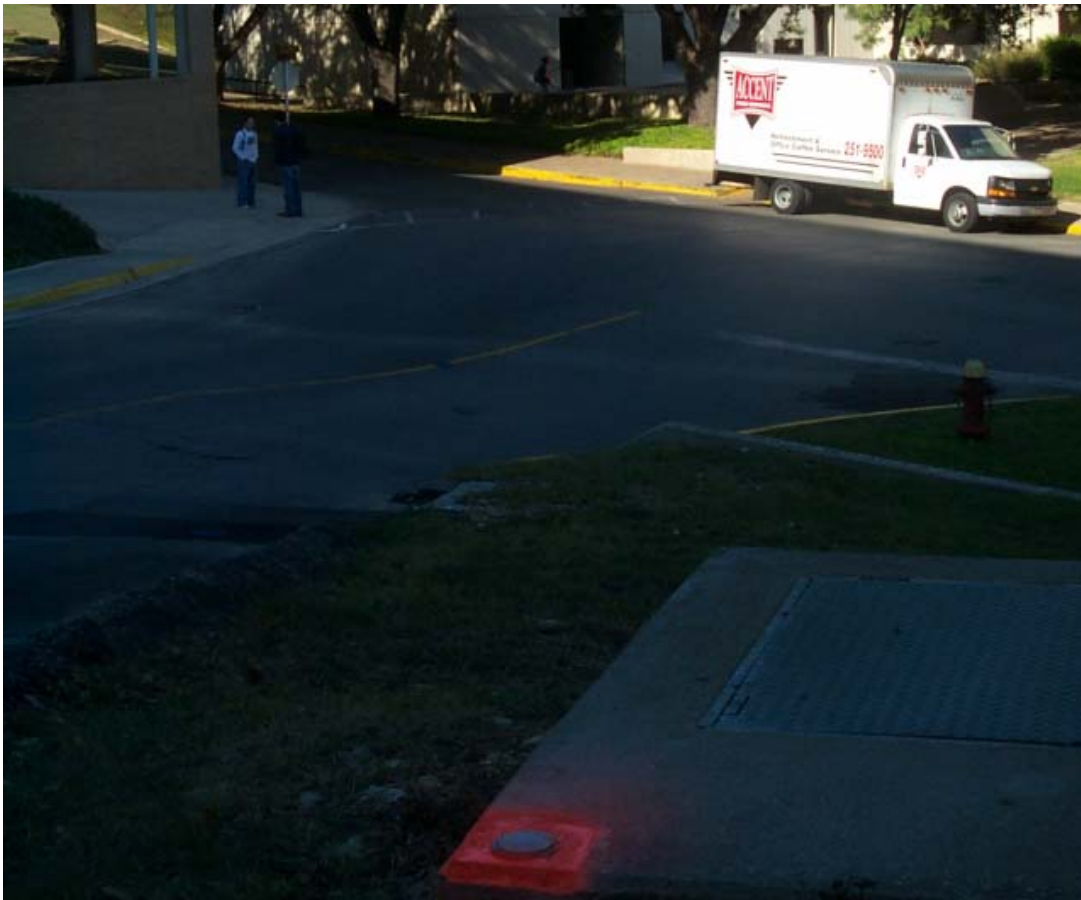
MONUMENT LOCATION PHOTO

DATE: December 2007
BENCHMARK ID: BM -5

NAVD 88 ELEVATION IN FEET: 648.04

DESCRIPTION: 3" Aluminum disk set in concrete utility vault northeast of the intersection of Pleasant Street and State Street.

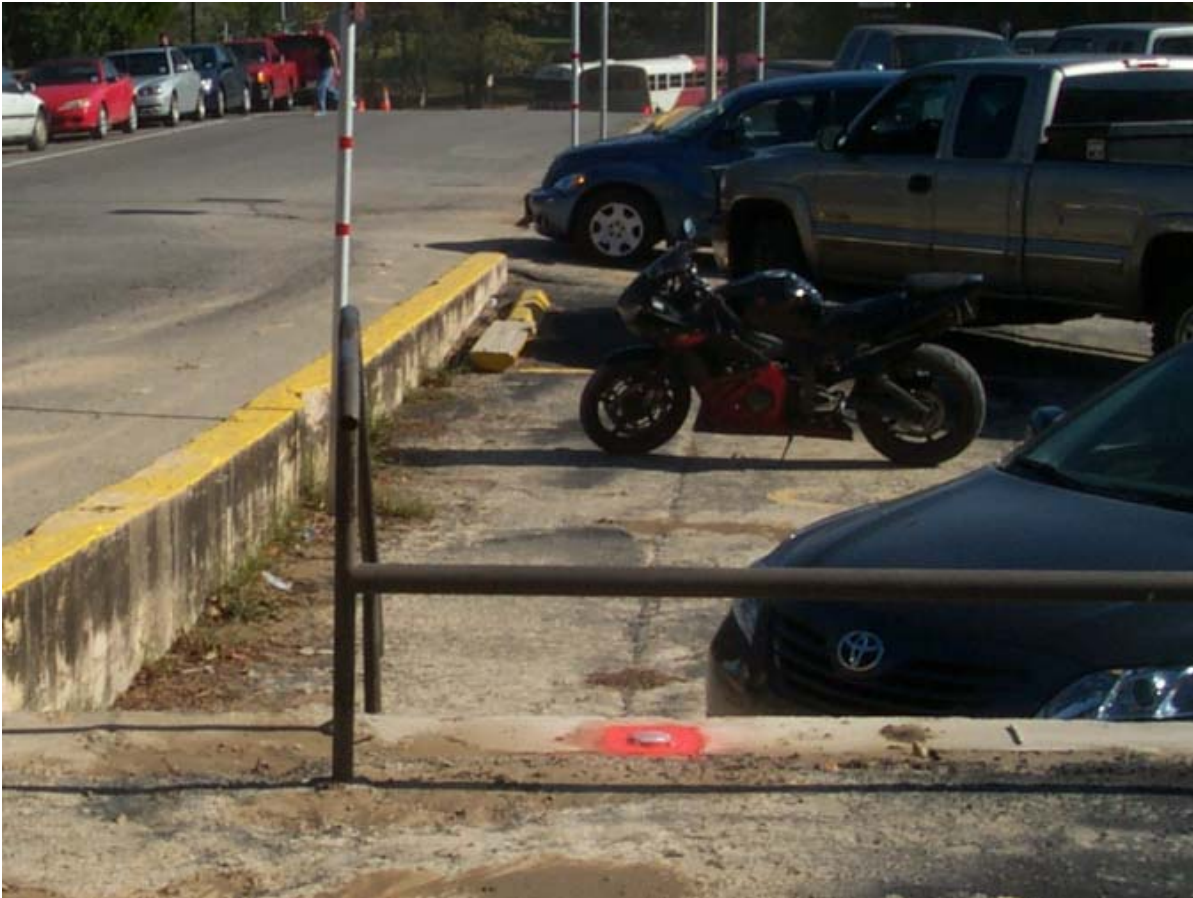
MONUMENT LOCATION PHOTO

DATE: December 2007
BENCHMARK ID: BM -6

NAVD 88 ELEVATION IN FEET: 614.10

DESCRIPTION: 3" Aluminum disk set in concrete retaining wall near stairs in Parking Lot 15, along State Street.

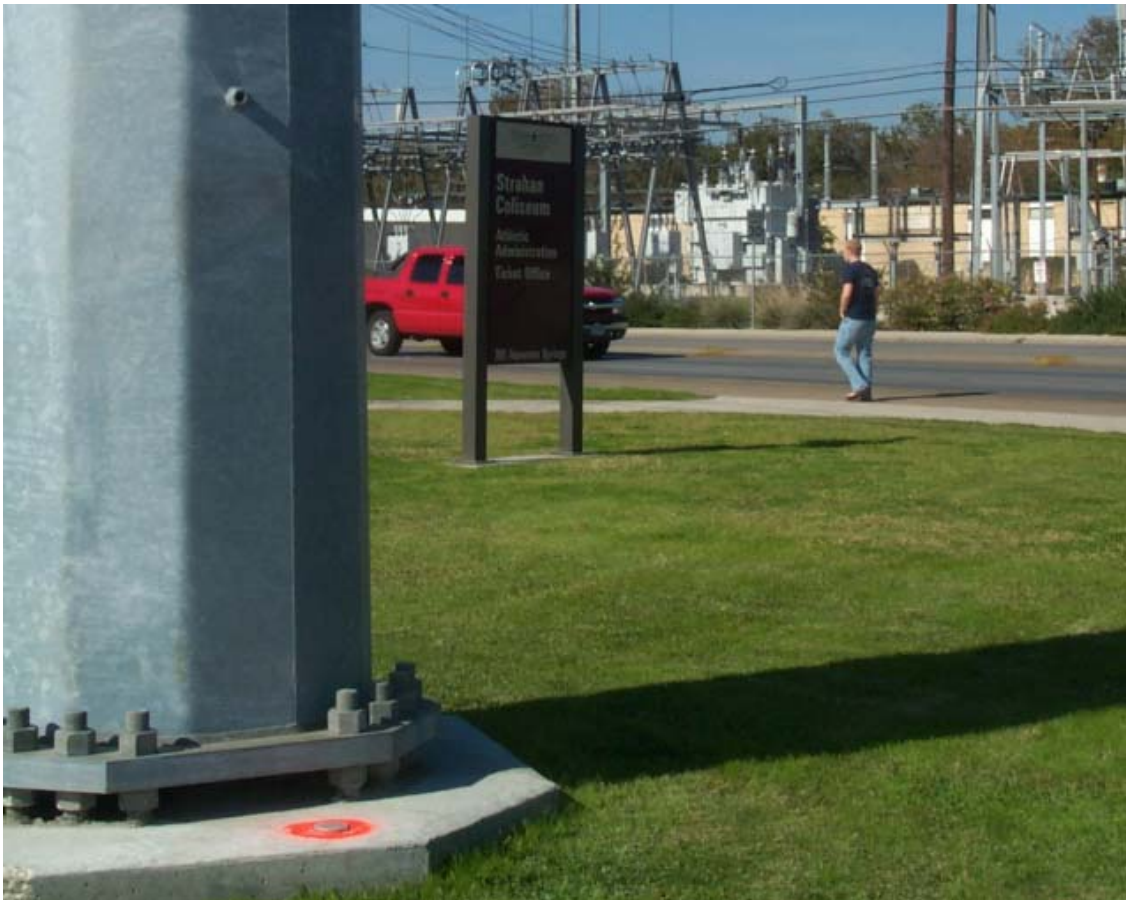
MONUMENT LOCATION PHOTO

DATE: December 2007
BENCHMARK ID: BM -7

NAVD 88 ELEVATION IN FEET: 582.17

DESCRIPTION: 3" Aluminum disk set in concrete base of LCRA power pole near Strahan Coliseum, at southeast corner of Aquarena Springs Drive and Charles Austin Drive.

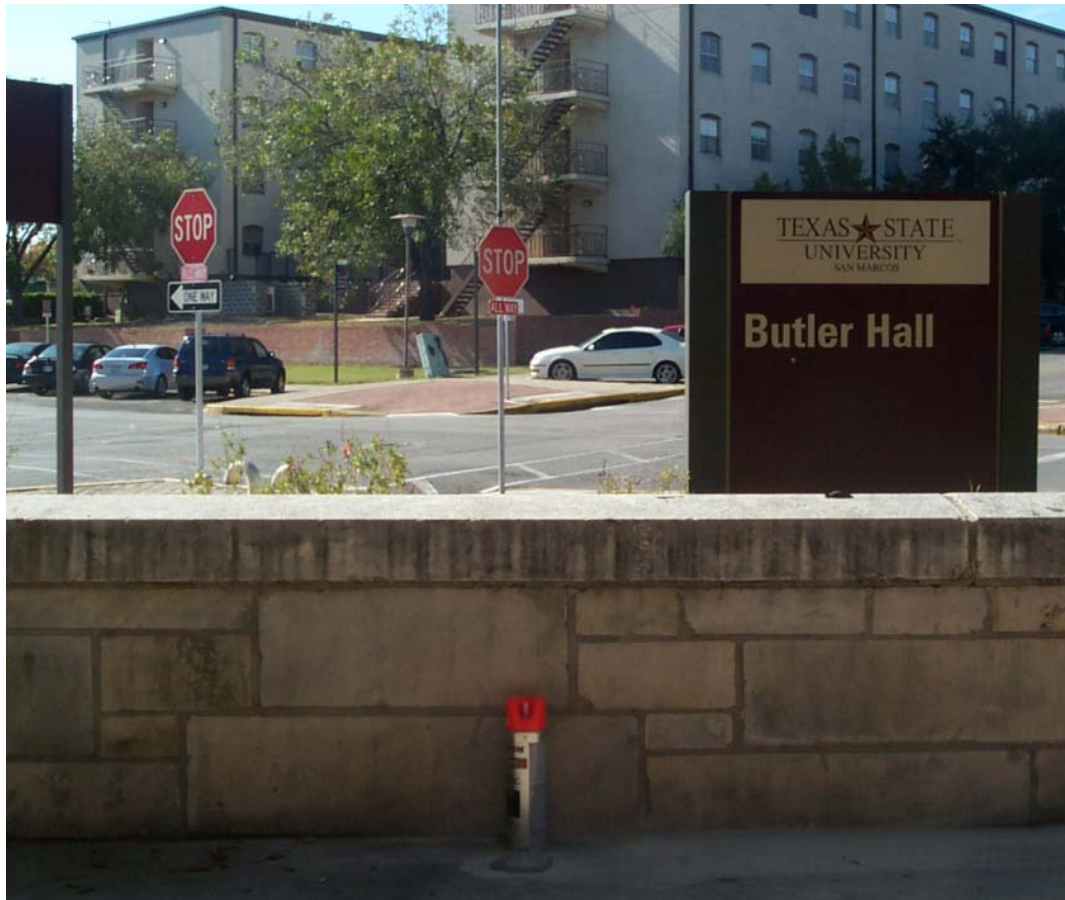
MONUMENT LOCATION PHOTO

DATE: December 2007
BENCHMARK ID: BM -8

NAVD 88 ELEVATION IN FEET: 598.15

DESCRIPTION: 3" Aluminum disk set in concrete landing of stairs at Butler Hall at northeast corner of Concho Street and N Edward Gray Street.

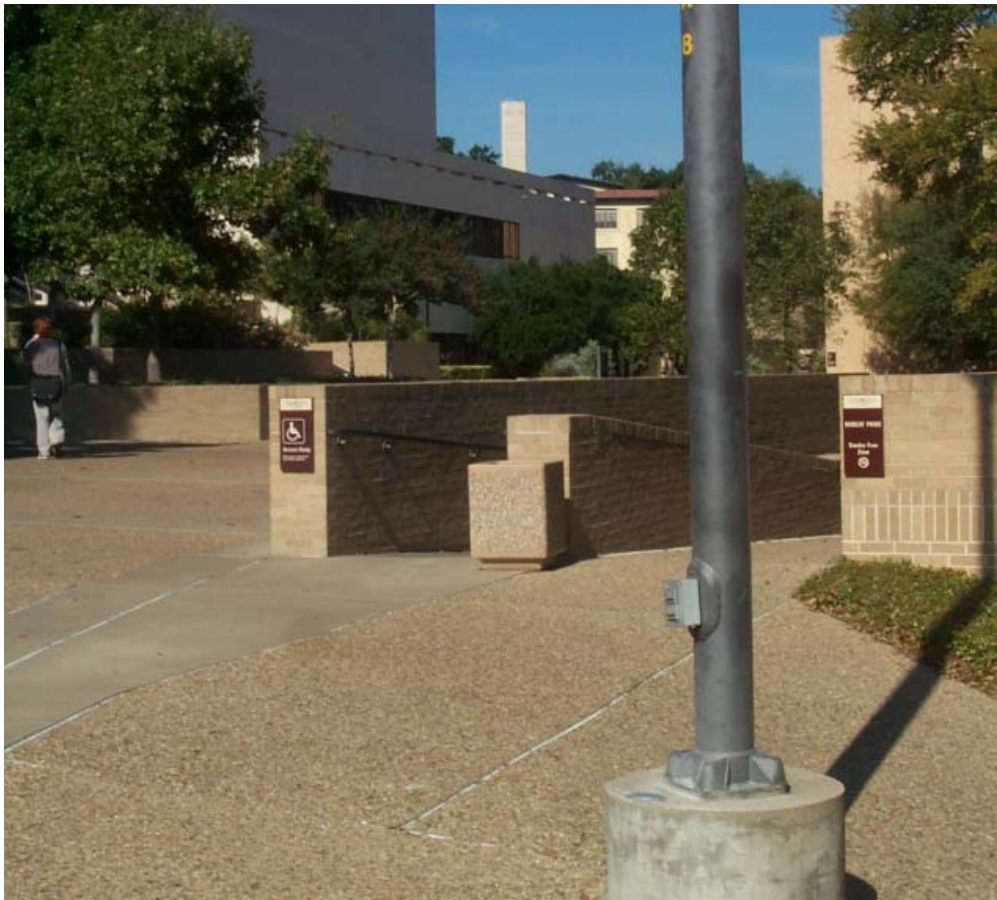
MONUMENT LOCATION PHOTO

DATE: December 2007
BENCHMARK ID: BM -9

NAVD 88 ELEVATION IN FEET: 690.73

DESCRIPTION: 3" Aluminum disk set in concrete lamp post in mall area north of northeast corner of the Alkek Library, and west of Campus Police Center.

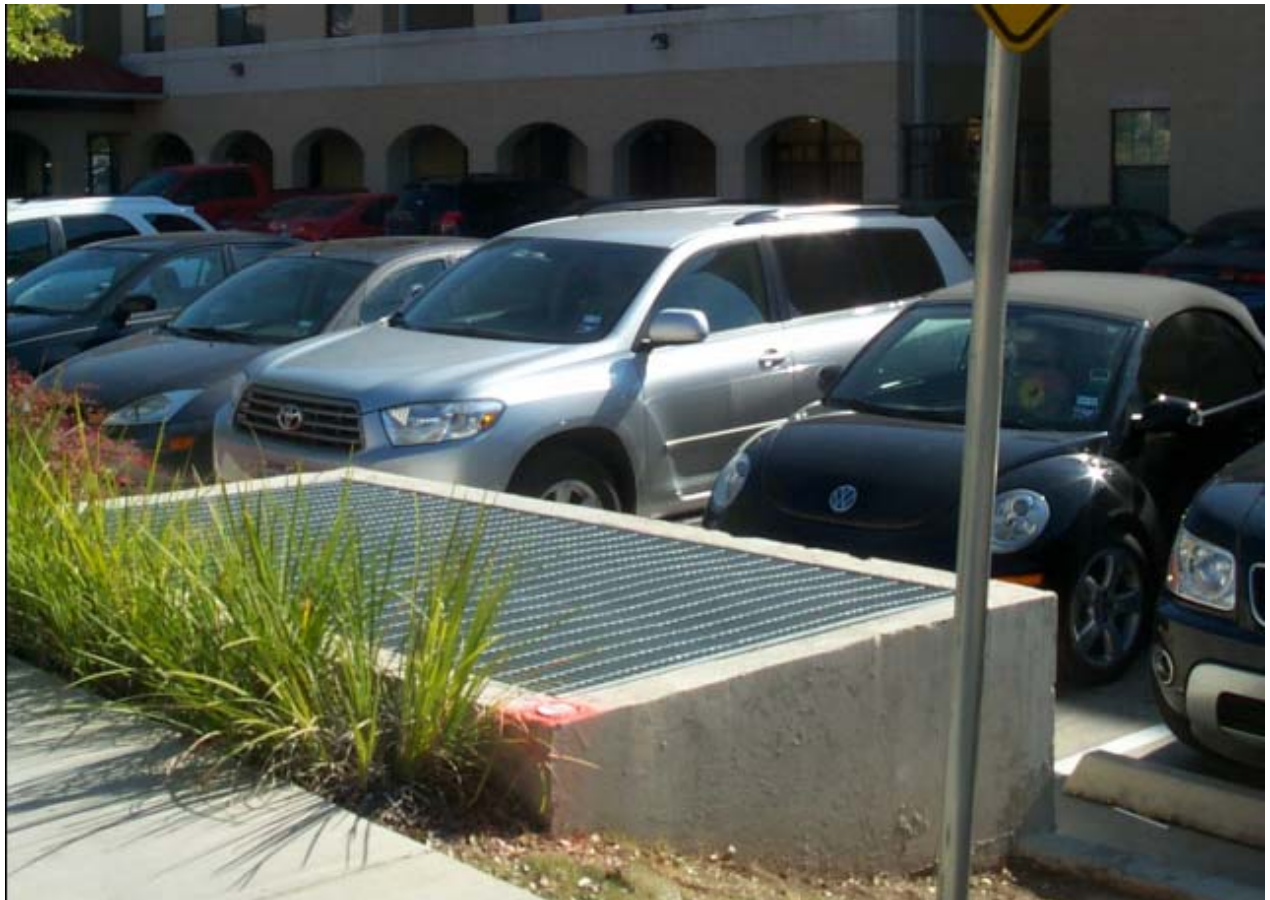
MONUMENT LOCATION PHOTO

DATE: December 2007
BENCHMARK ID: BM -10

NAVD 88 ELEVATION IN FEET: 697.98

DESCRIPTION: 3" Aluminum disk set in concrete at northwest corner of utility vault at southeast corner of the intersection of N. Comanche Street and W. Woods Street.

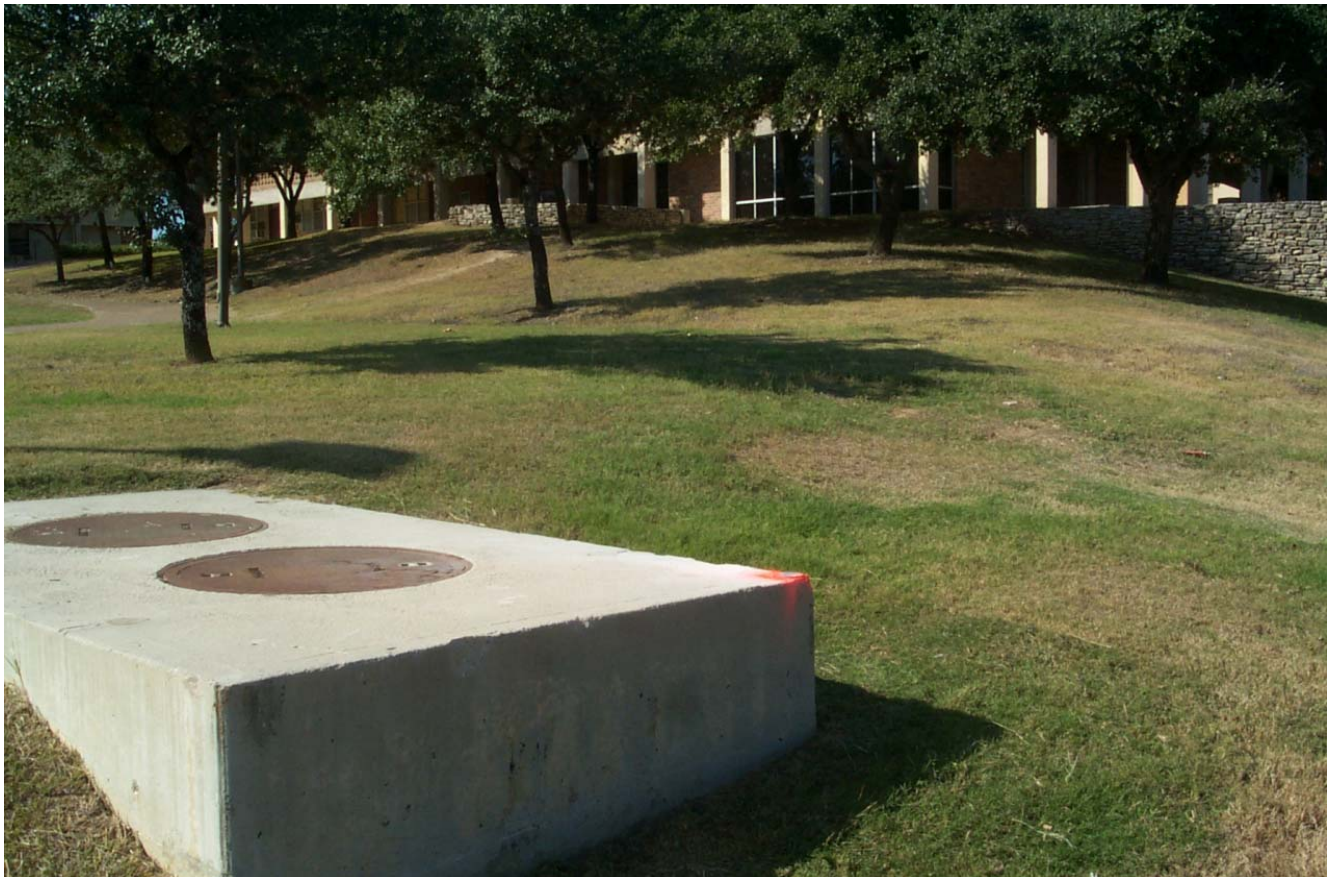
MONUMENT LOCATION PHOTO

DATE: December 2007
BENCHMARK ID: BM -11

NAVD 88 ELEVATION IN FEET: 762.93

DESCRIPTION: 3" Aluminum disk set in concrete utility vault on the south side of Moore Street at Read Street.

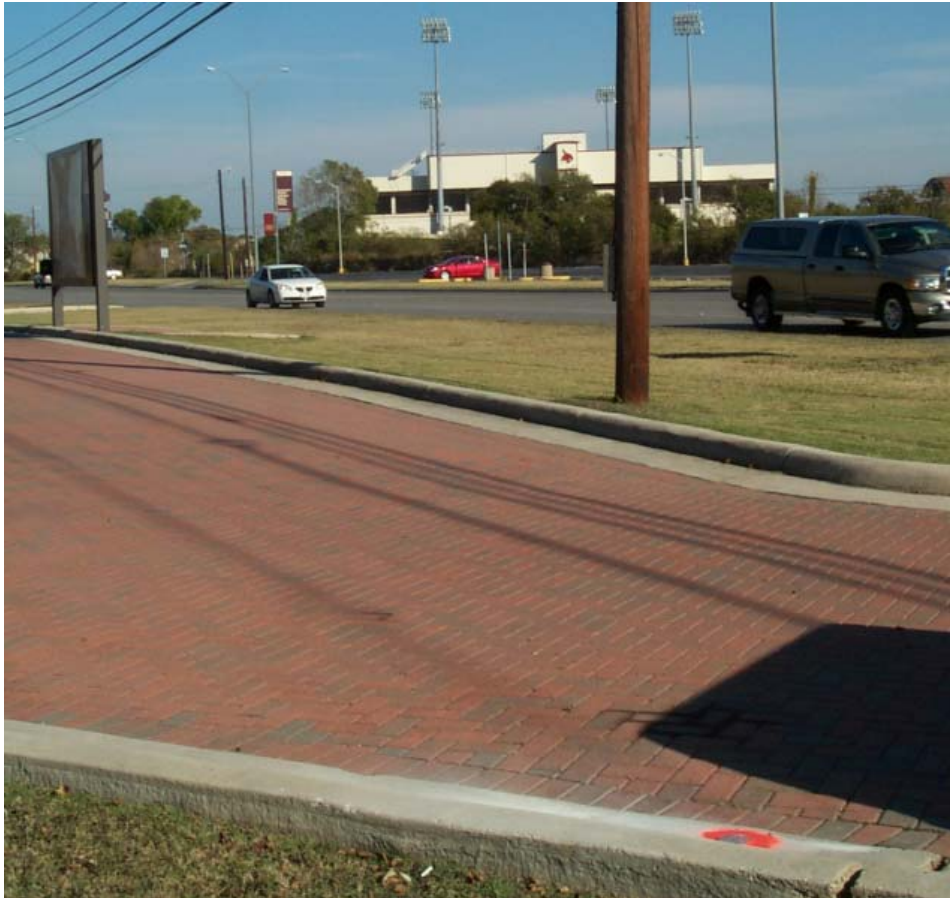
MONUMENT LOCATION PHOTO

DATE: December 2007
BENCHMARK ID: BM -12

NAVD 88 ELEVATION IN FEET: 581.84

DESCRIPTION: 3" Aluminum disk set in concrete curb of turnout for the Campus Directions Sign along Aquarena Springs Drive 650, feet northeast of Charles Austin Drive.

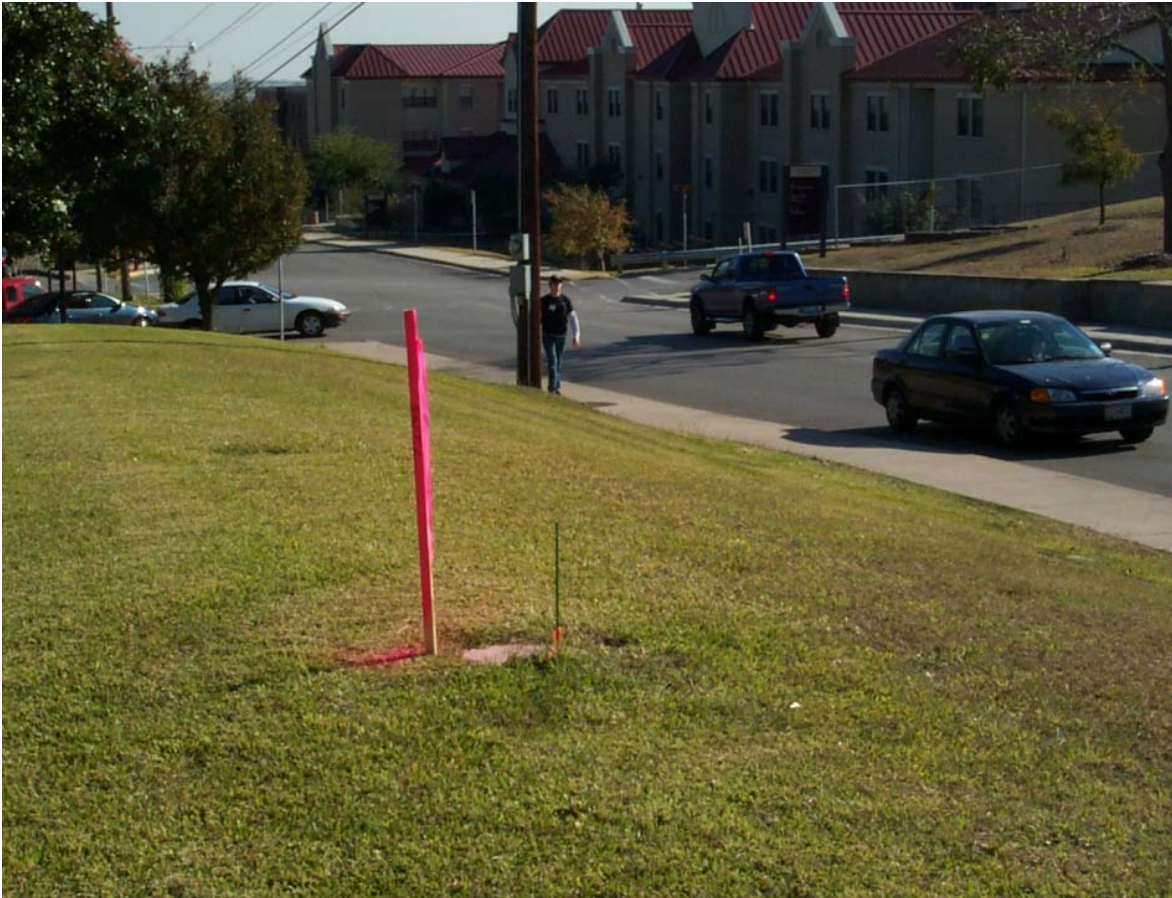
MONUMENT LOCATION PHOTO

DATE: December 2007
BENCHMARK ID: SWT1

NAVD 88 ELEVATION IN FEET: 767.83

DESCRIPTION: 3" Brass disk set in concrete on north side of Academy Street, 200 feet northwest of Llano Circle. Same as NGS Monument AJ6952

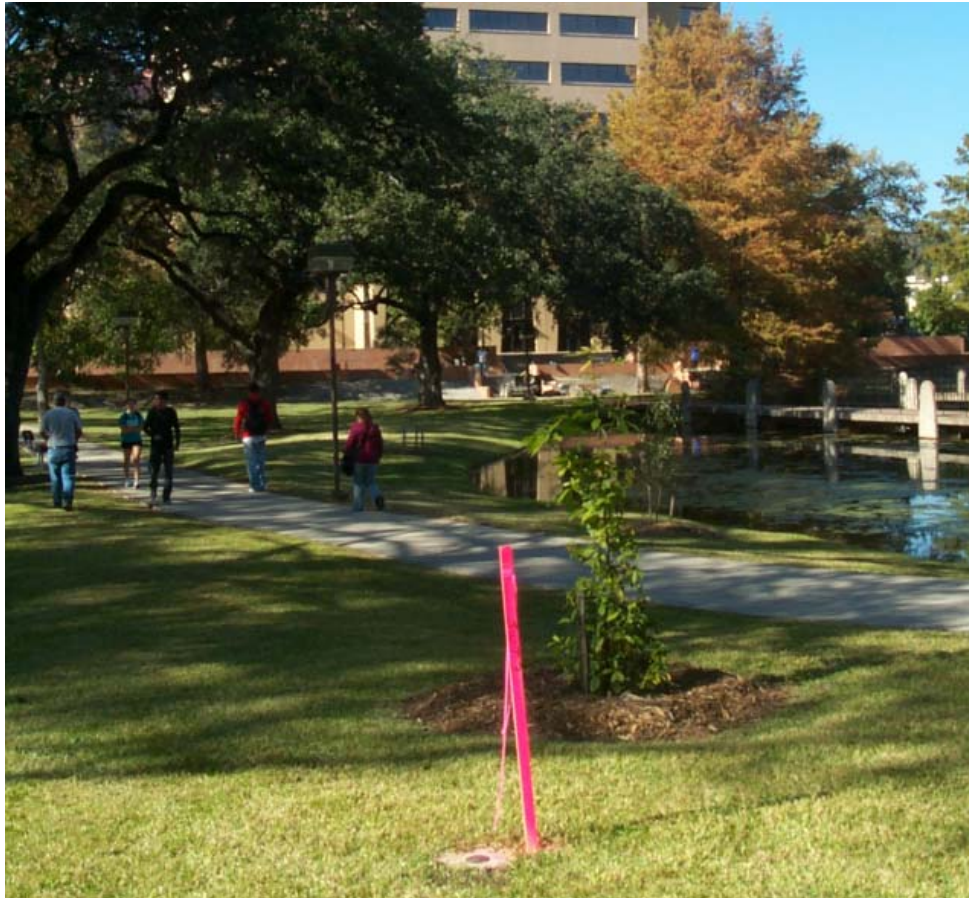
MONUMENT LOCATION PHOTO

DATE: December 2007
BENCHMARK ID: BM SWT3

NAVD 88 ELEVATION IN FEET: 581.73

DESCRIPTION: 3” Brass disk set in concrete 200 feet west of University Drive in grass area, 25 feet south of major sidewalk.

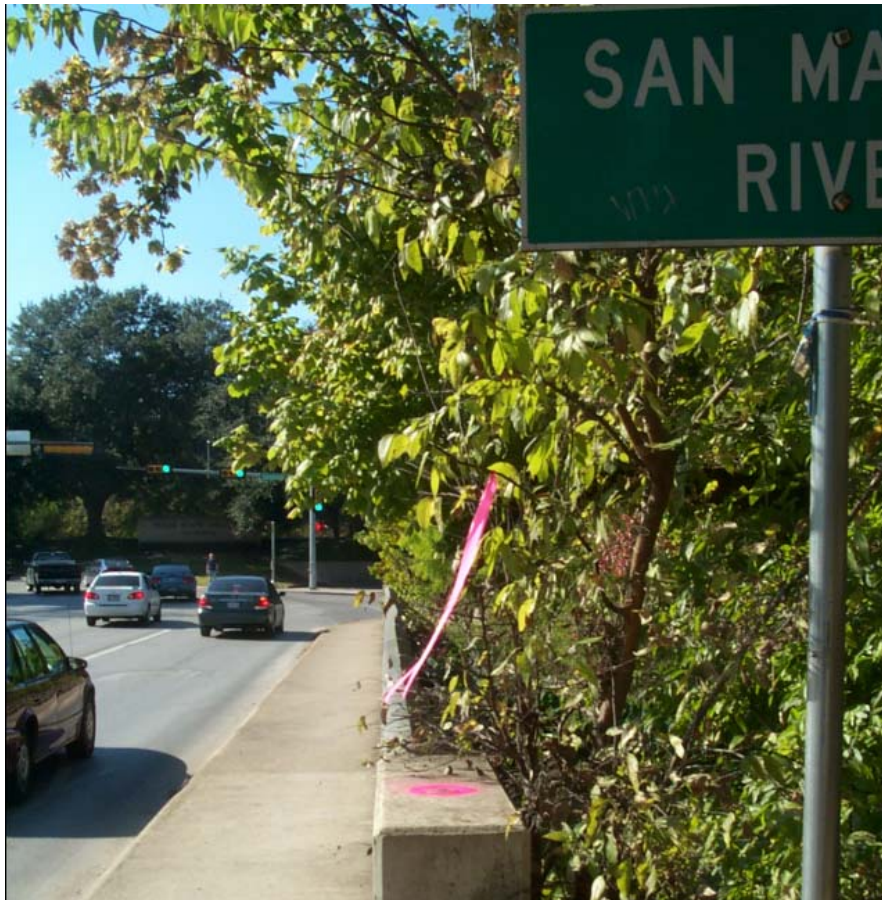
MONUMENT LOCATION PHOTO

DATE: December 2007
BENCHMARK ID: AX2445

NAVD 88 ELEVATION IN FEET: 572.44

DESCRIPTION: 3" Brass disk set in northeast concrete bridge abutment on Aquarena Springs Drive at the San Marcos River. This is NGS monument S1307

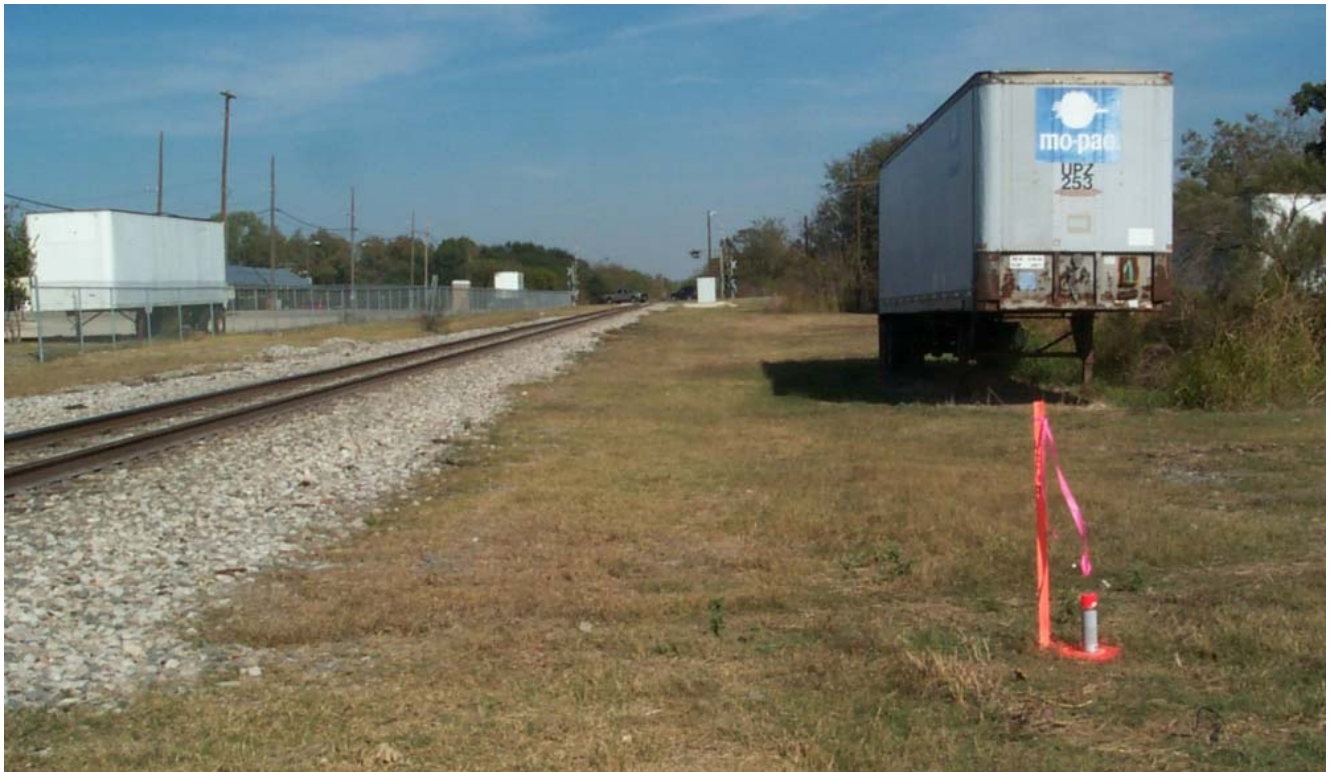
MONUMENT LOCATION PHOTO

DATE: December 2007
BENCHMARK ID: COSM GPS #6

NAVD 88 ELEVATION IN FEET: 581.58

DESCRIPTION: 3" Aluminum disk set in concrete on south side of railroad tracks and north side of Comal street, near covered train depot. This is a City of San Marcos GPS #6 monument and benchmark.

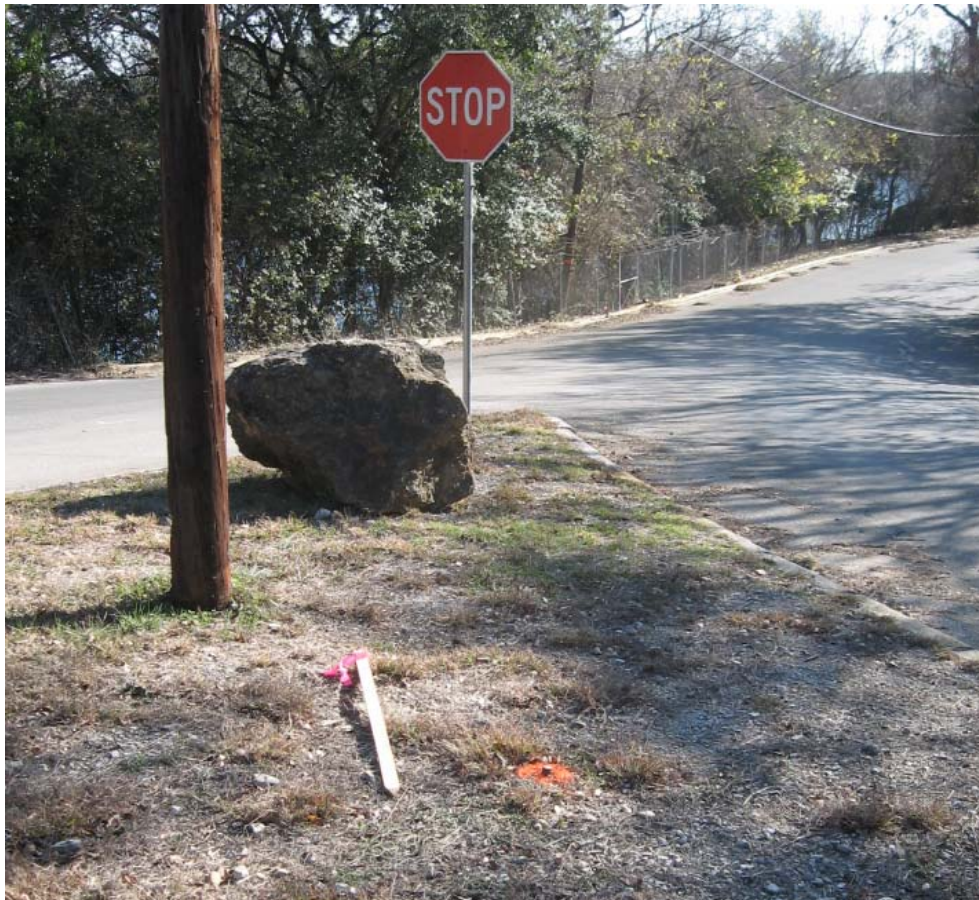
MONUMENT LOCATION PHOTO

DATE: December 2007
BENCHMARK ID: COSM 37

NAVD 88 ELEVATION IN FEET: 603.29

DESCRIPTION: 3" Aluminum disk set in traffic island at fork in Alta Vista Road and Ed JL Green Drive. This is a City of San Marcos benchmark.
