Brazos River Below Possum Kingdom Lake Data Report

November 2010

Prepared by:
Texas Stream Team
River Systems Institute
Texas State University – San Marcos

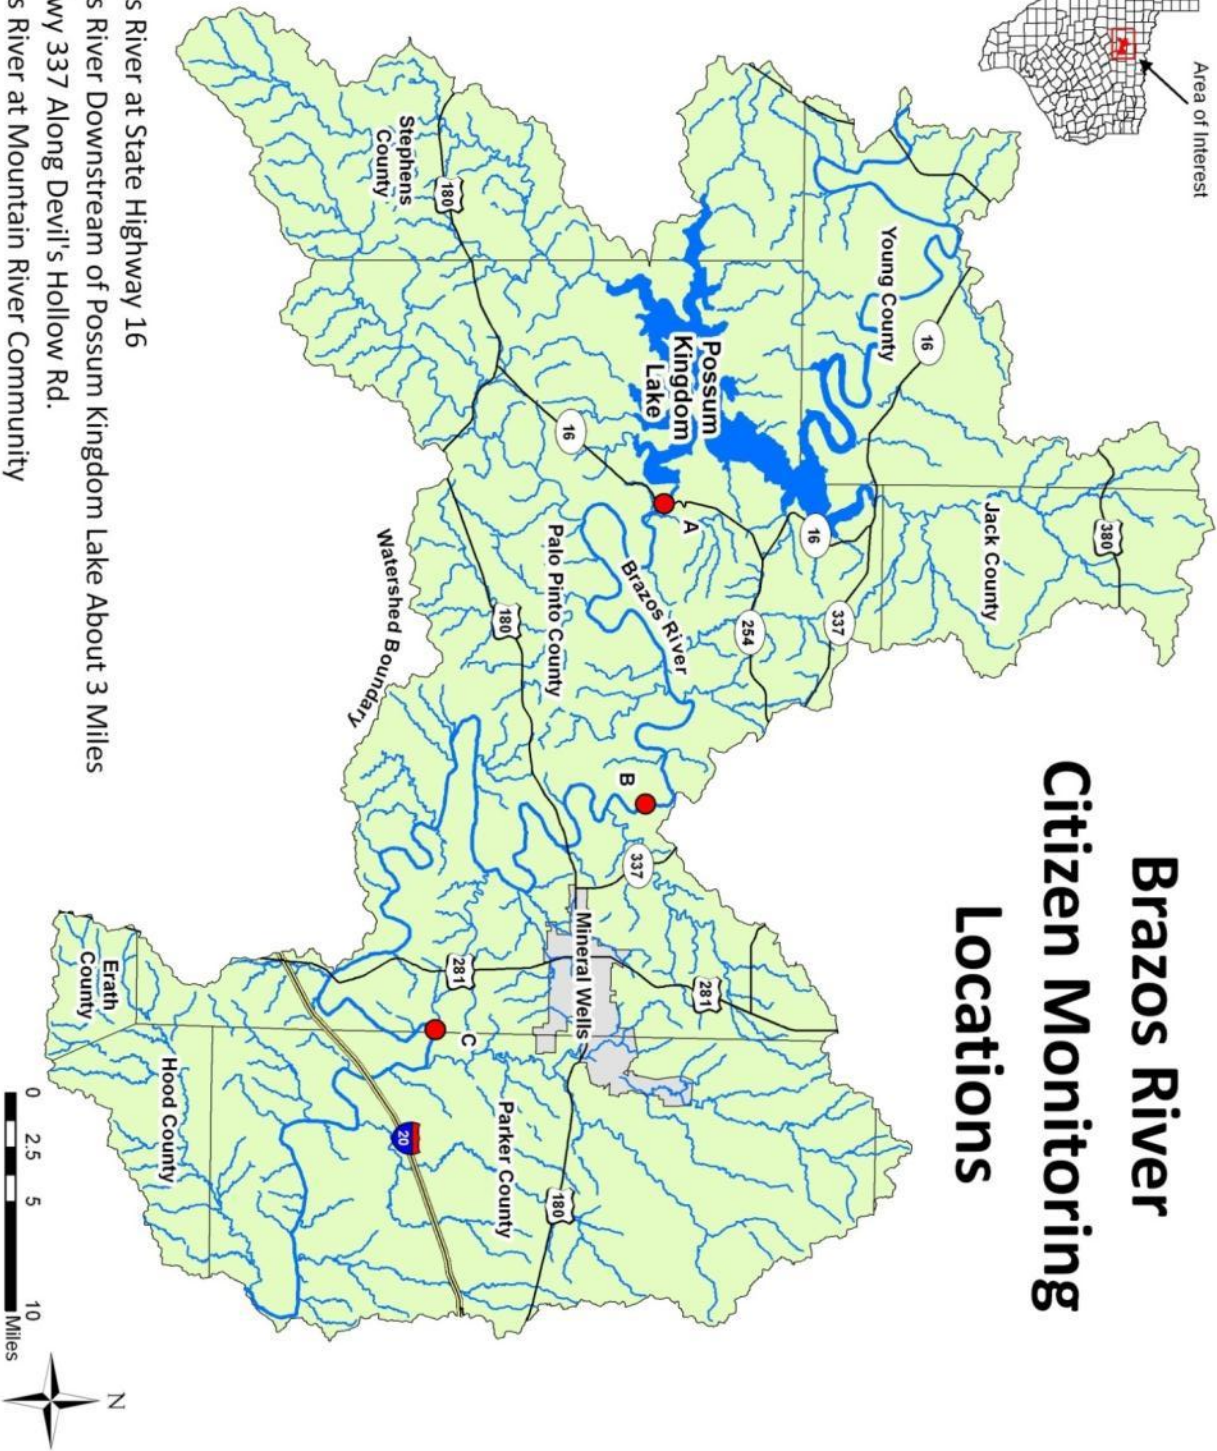
Brazos River Citizen Monitoring Locations

- A: Brazos River at State Highway 16
- B: Brazos River Downstream of Possum Kingdom Lake About 3 Miles Off Hwy 337 Along Devil's Hollow Rd.
- C: Brazos River at Mountain River Community

Note: This map shows 5 USGS 10-digit HUCs which encompass all three sites and Possum Kingdom Lake. This scale was more appropriate than an 8 digit HUC watershed.

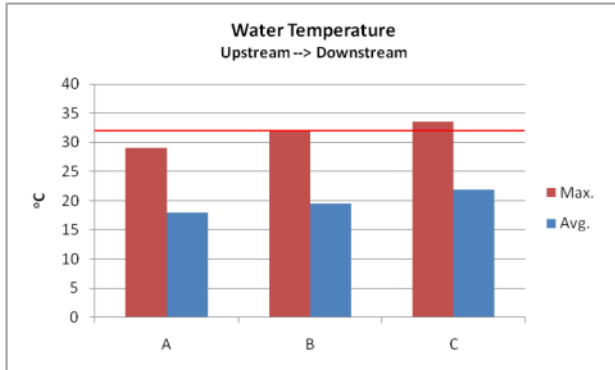
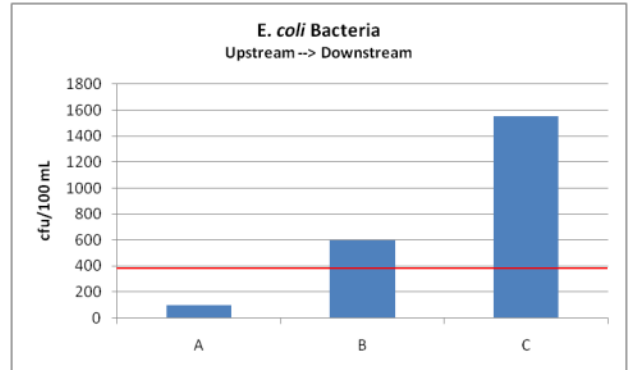
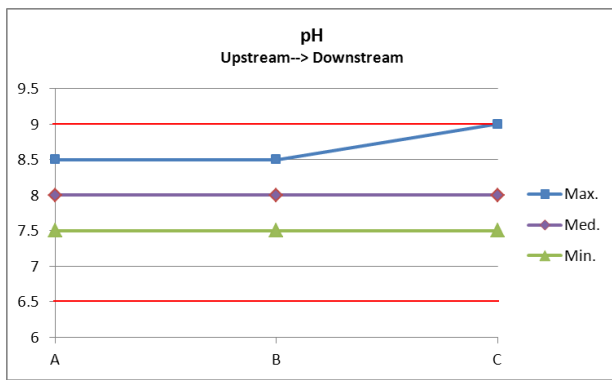
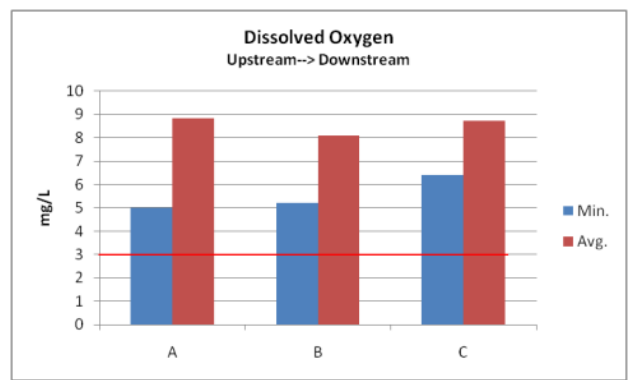
Upstream to Downstream Trends

Upstream to downstream trends are shown on the graphs below. The letters on the x-axis reference the map above. It can be seen that water temperature increases from upstream to downstream. Site A is near the Morris Sheppard Dam, which may be releasing colder water from the bottom of the lake. Dissolved oxygen and pH stay mostly steady, except pH spiked slightly at site C. Conductivity is highest at site A, but there is no significant difference observed between sites B and C.

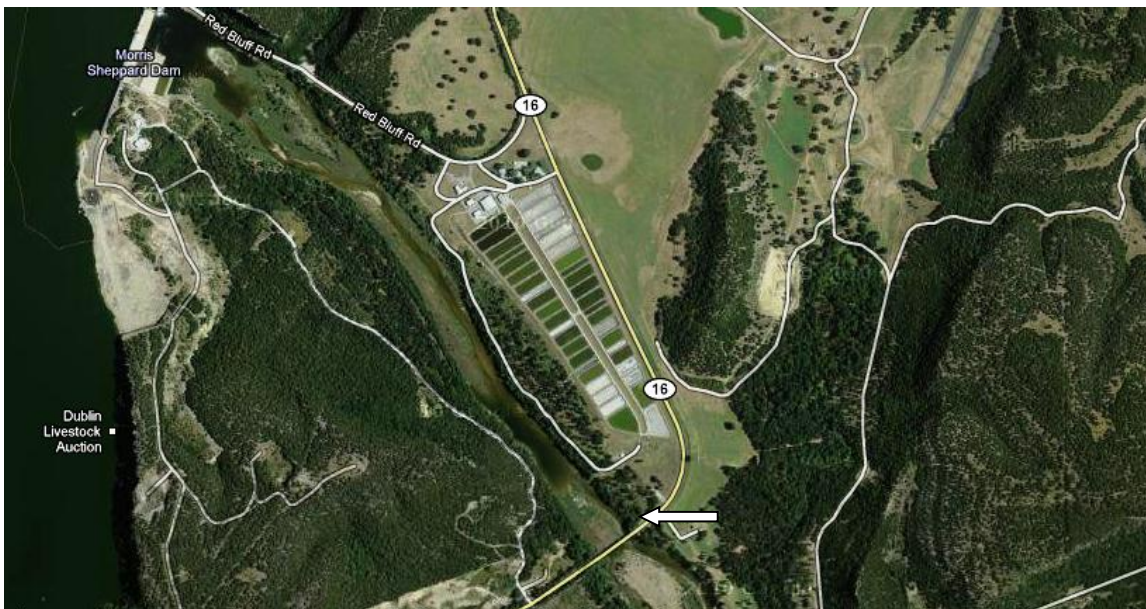
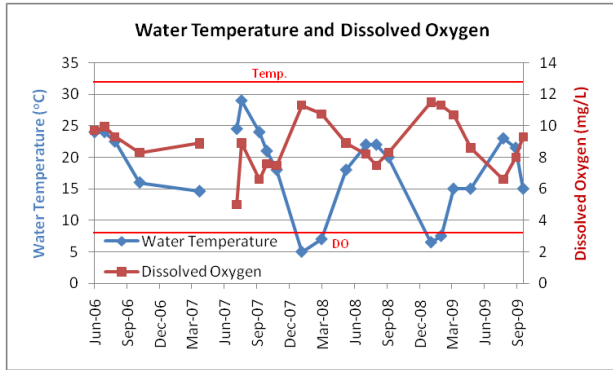
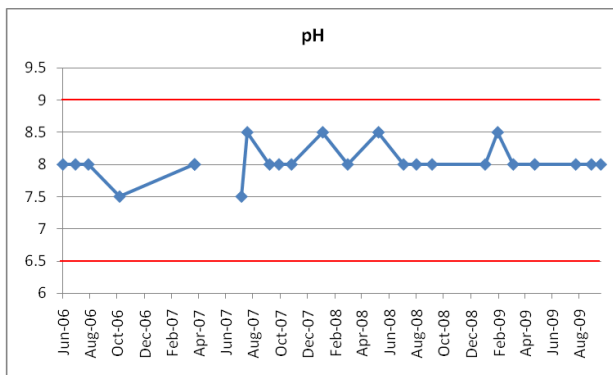
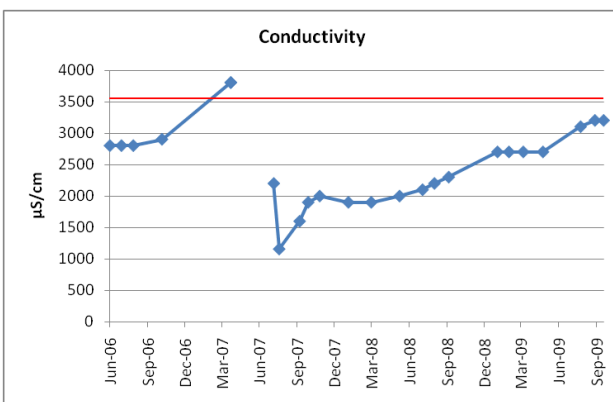
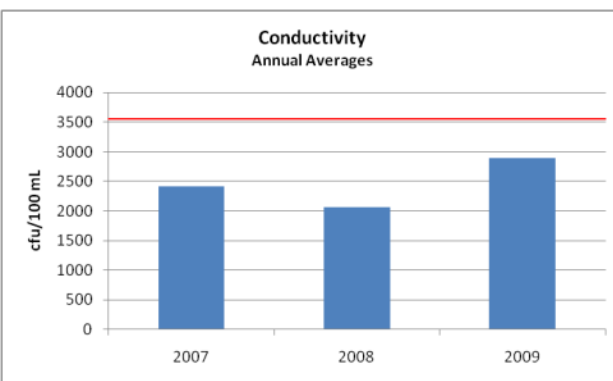
Site A: Brazos River at State Highway 16

Parameter	% Complete	#	Min.	Mean	Max.	Std. Dev.
Dissolved Oxygen	96	24	5	8.81	11.5	1.62
Water Temperature	96	24	5	17.9	29	6.46
Conductivity	96	24	1160	2519.17	3800	654.97
pH	96	24	7.5	8.04	8.5	0.25
E. coli Bacteria	4	1	100	100	100	N/A
Secchi Depth	64	16	0.2	1.17	3	0.68
Total Depth	92	23	0.2	1.2	3	0.60
Sample Time	96	24	11:43	13:57	16:14	0.06

Effluent from fish hatcheries can cause significant increases in temperature, pH, suspended solids, ammonia, nitrogen, and phosphorus. Dissolved oxygen can be decreased due to extensive respiration occurring in the hatchery.^y It is possible the observed gradual upward trend in conductivity has been caused by releases from the hatchery. However, the other parameters have shown relatively stable conditions within the standards set for this area.

It appears the flood in June 2007 washed away many of the dissolved solids. During that flood, the floodgates were opened, releasing water from the lake. The conductivity graph on pg. 10 shows a sharp decrease in dissolved solids following a break in the data in June of 2007, which was caused by the flood making the site inaccessible. Notice the big change in conductivity following this flood. The observed value in April '07 is 3,800 $\mu\text{S}/\text{cm}$, and the observed value in July '07 is 2,200 $\mu\text{S}/\text{cm}$. The following value was even lower and has since gradually increased. Although the data for sites B and C show peaks and troughs, values gradually increase as well. Stormwater runoff should cause peaks and troughs according to rainfall events. The fluctuations observed here do not correlate with wet and dry

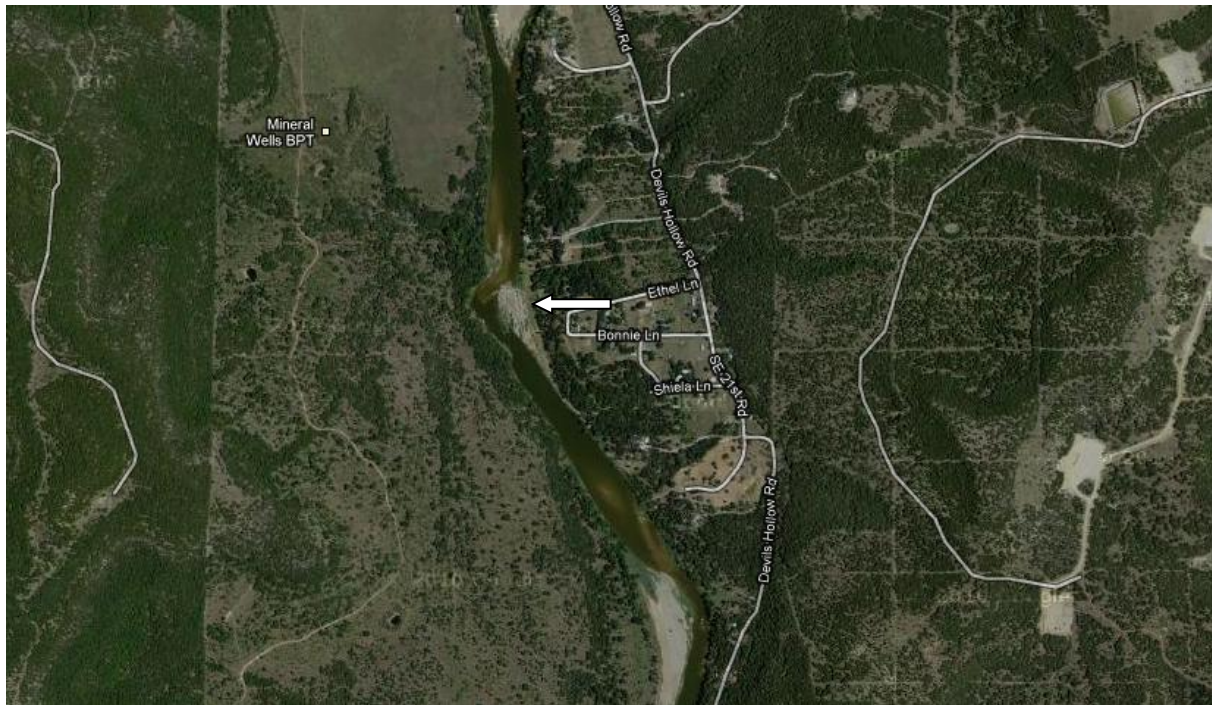
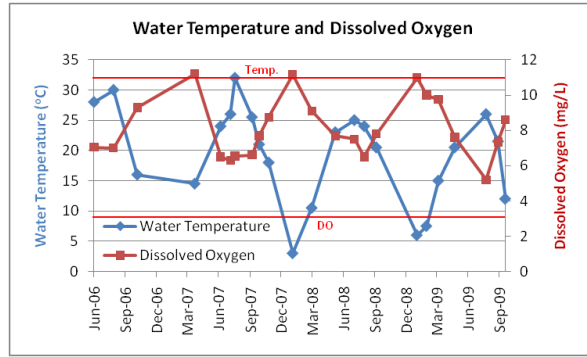
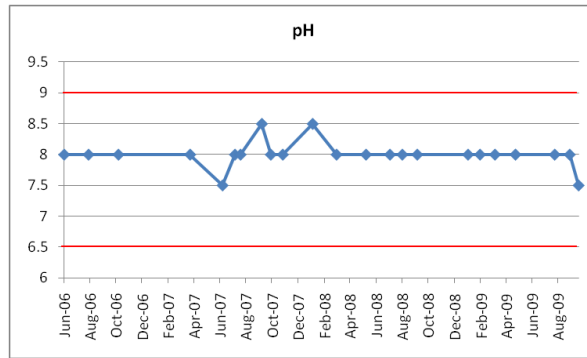
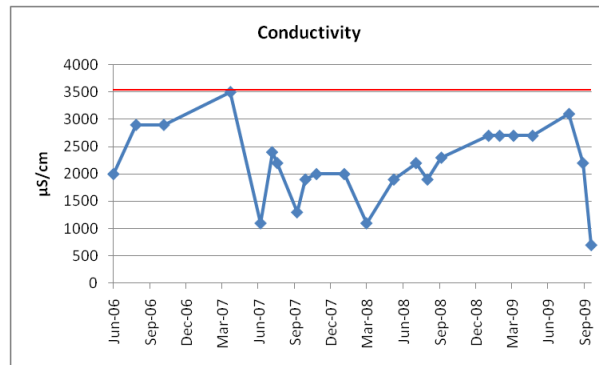
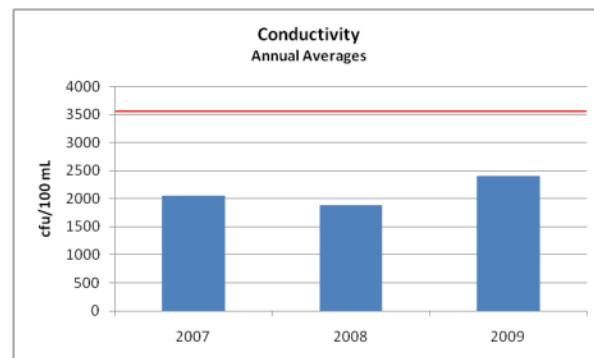
**Site B: Brazos River - Downstream Of Possum Kingdom Lake,
About 3 Miles Off Hwy 337 Along Devil's Hollow Rd**

Parameter	% Complete	#	Min.	Mean	Max.	Std. Dev.
Dissolved Oxygen	100	23	5.2	8.1	11.2	1.68
Water Temperature	100	23	3	19.54	32	7.82
Conductivity	100	23	700	2191.3	3500	687.49
pH	100	23	7.5	8	8.5	0.21
E. coli Bacteria	4	1	600	600	600	N/A
Secchi Depth	30	7	0.1	0.31	0.8	0.26
Total Depth	83	19	0.1	0.33	0.8	0.18
Sample Time	100	23	10:15	13:28	16:55	0.09

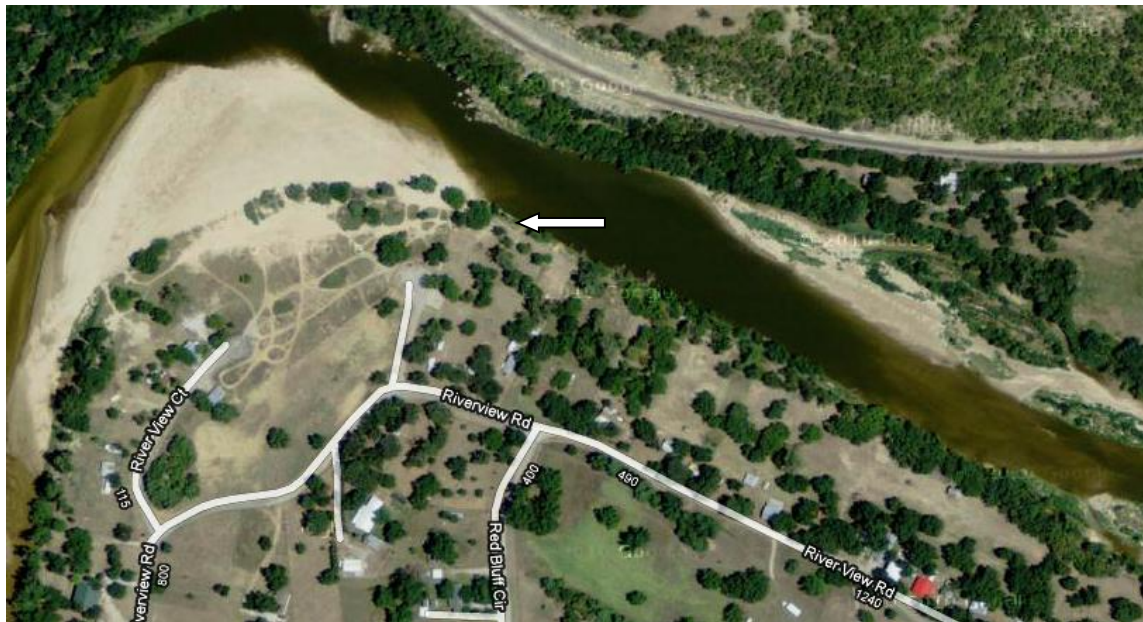
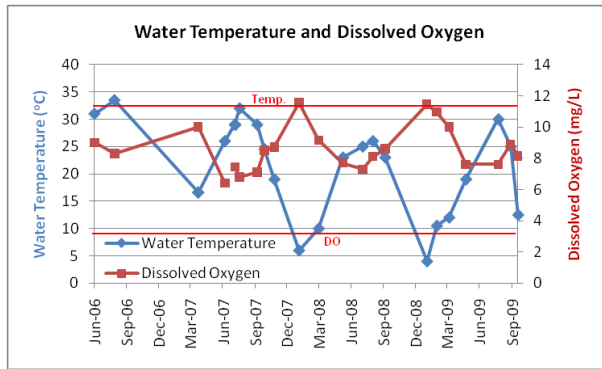
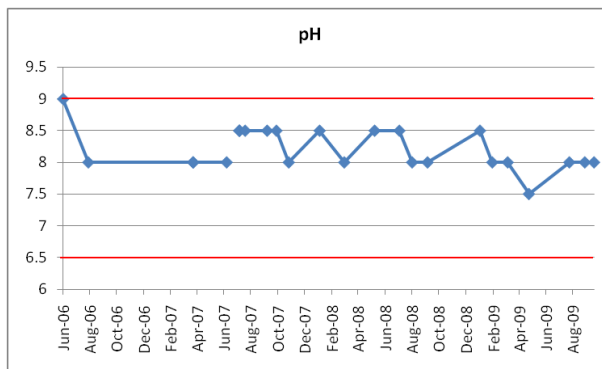
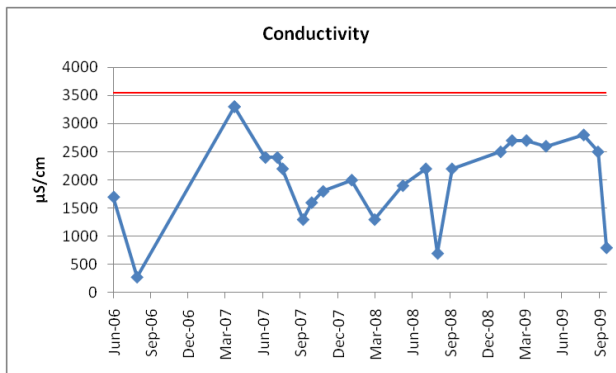
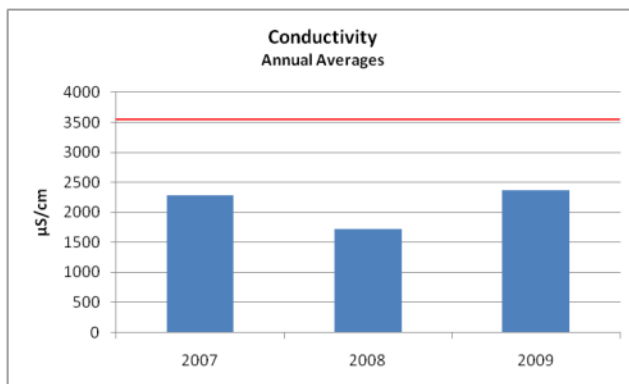
Site C: Brazos River at Mountain River Community Park

Parameter	% Complete	#	Min.	Mean	Max.	Std. Dev.
Dissolved Oxygen	96	22	6.4	8.72	11.55	1.45
Water Temperature	100	23	4	21.01	33.5	8.62
Conductivity	100	23	280	2051.3	3300	786.47
pH	96	22	7.5	8.18	9	0.33
E. coli Bacteria	4	1	1550	1550	1550	N/A
Secchi Depth	52	12	0.1	0.71	1.5	0.39
Total Depth	96	22	0.1	0.82	1.5	0.40
Sample Time	100	23	10:35	13:54	16:42	0.06
