# SALADO CREEK WATERSHED SUMMARY REPORT

March 2025

THE MEADOWS CENTER  
FOR WATER AND THE ENVIRONMENT  
TEXAS STATE UNIVERSITY

TEXAS STREAM TEAM

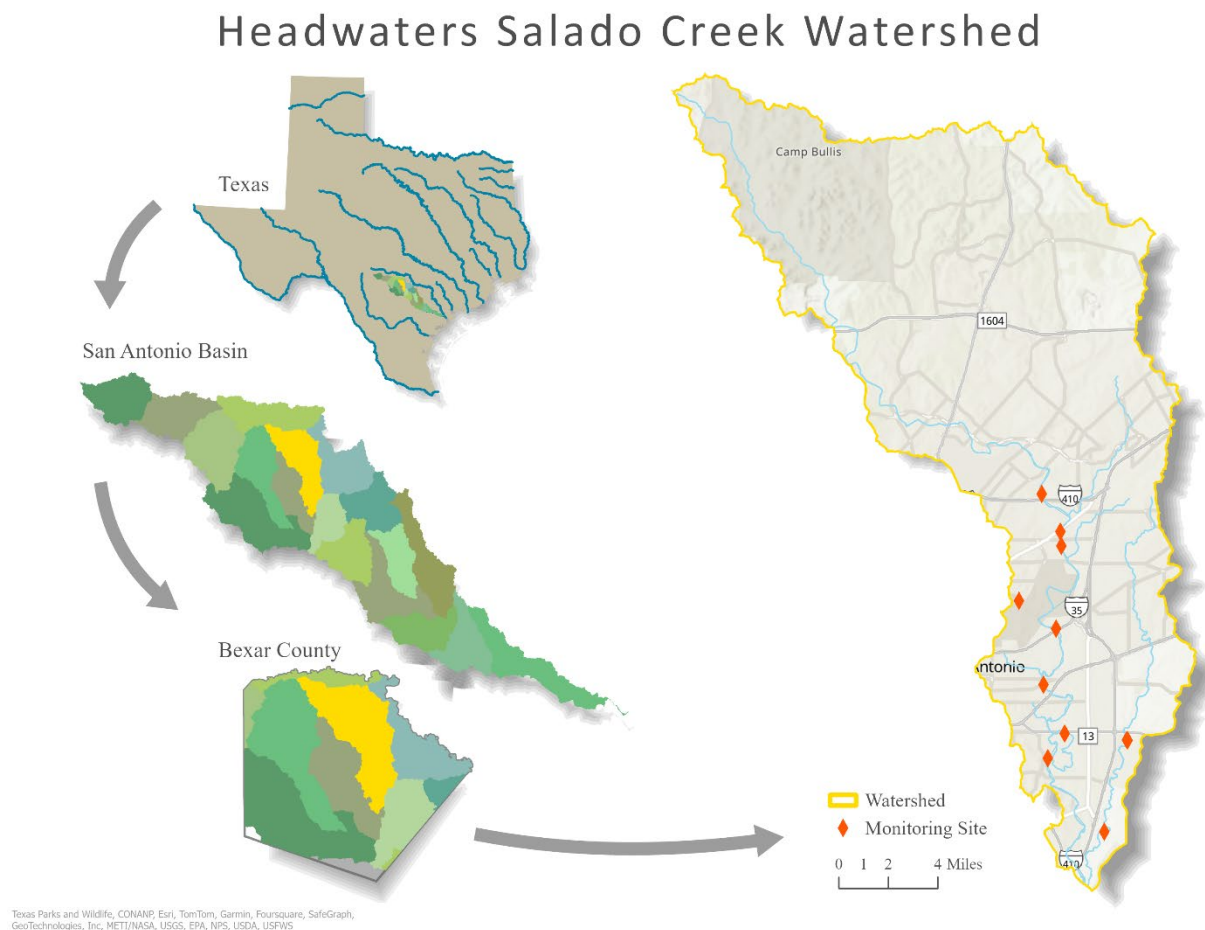
Figure 1. Salado Creek watershed in Bexar County, Texas

The watershed covers 219 square miles, encompassing Bexar County (Figure 1). Salado Creek arises in the upper part of the San Antonio River Basin, with its headwaters located in the northern region of Bexar County. Salado Creek flows for 38 miles until it converges with the San Antonio River (Texas Commission on Environmental Quality, n.d.).

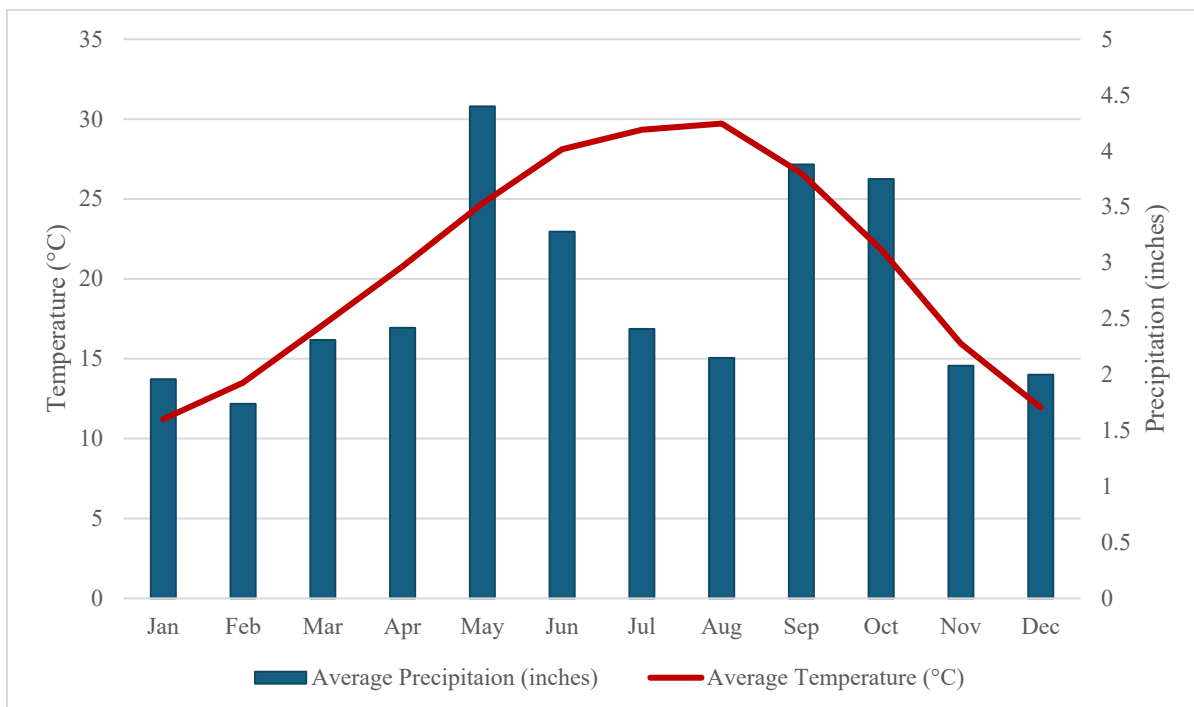
Figure 2. Long-term (1991-2020) monthly average precipitation (inches) and air temperature (°C) from San Antonio International Airport, Texas (National Oceanic and Atmospheric Administration, 2021).

The climate in this area is described as humid, subtropical climate with mild winters and hot summers (Köppen-Geiger climate classification). Climate data from the National Oceanic and Atmospheric Administration, was collected at a weather station at the San Antonio International Airport, Texas and acquired from the National Data Center (National Oceanic and Atmospheric Administration, 2021). The average annual precipitation is 32.38 inches and typically occurs year-round (Figure 2). Long-term monthly average precipitation shows a binomial distribution, with peaks occurring in May and September, averaging 4.14 inches of rainfall during these months. The least amount of rainfall (1.74 inches) occurs in February. The warmest and coldest months of the year are August (29.7°C) and January (11.2°C), respectively.

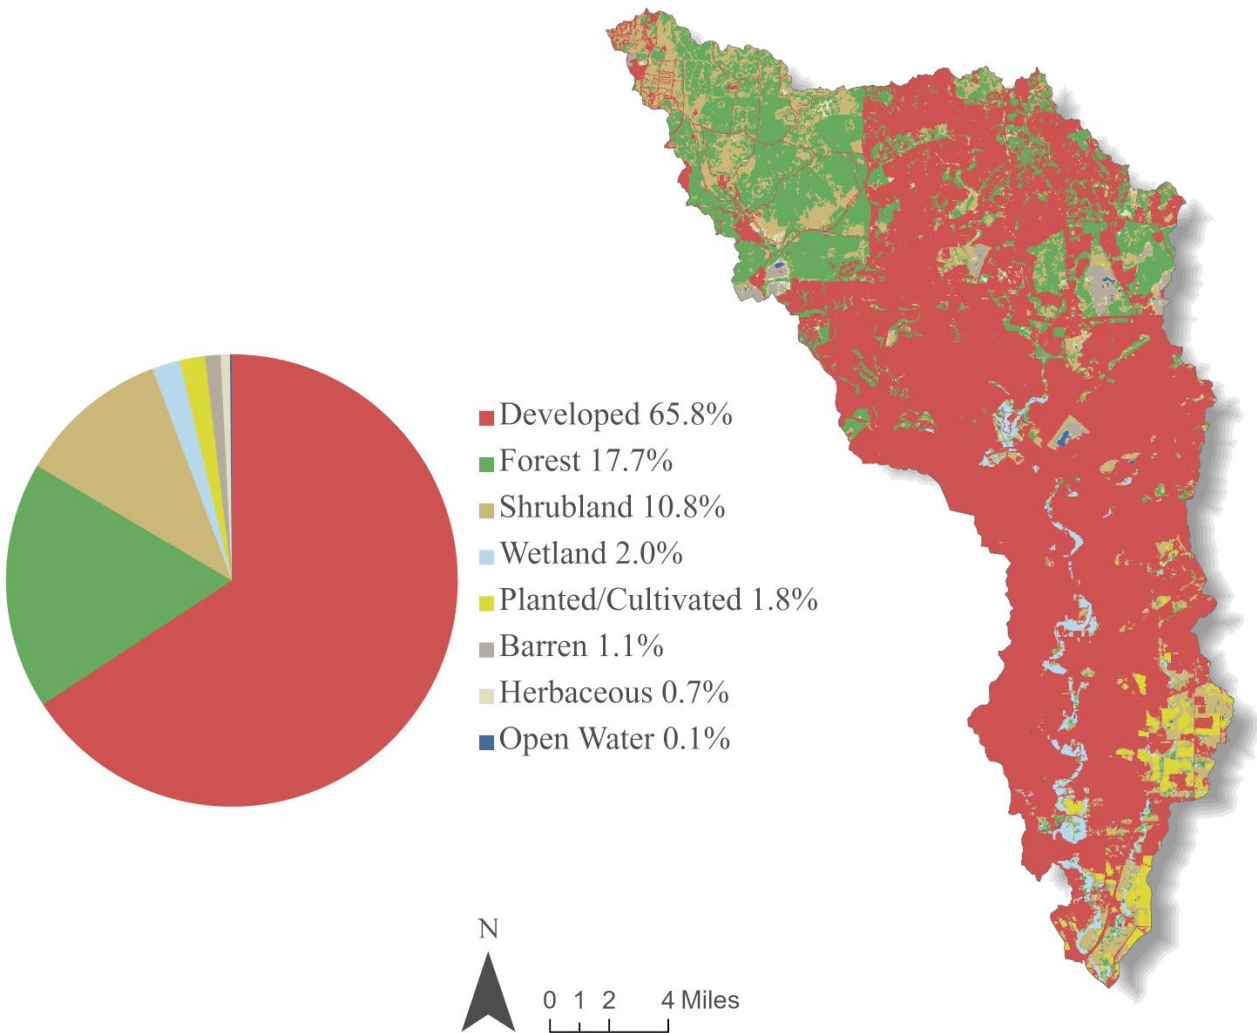
Figure 3. 2019 land use and land cover for the Salado Creek watershed in Bexar County, Texas (National Land Cover Data, 2019).

Land cover types were determined from spatial datasets from the National Land Cover Database and processed in Esri ArcGIS Pro for the watershed (Figures 3 and 4).

A majority of the watershed consists of developed land, at 65.8%. Forest and shrubland cover follow, at 17.7% and 10.8%, respectively. The remaining 5.7% of the watershed consists of wetland (2%), planted/cultivated (1.8%), barren (1.1%), herbaceous (0.7%), and open water (0.1%).

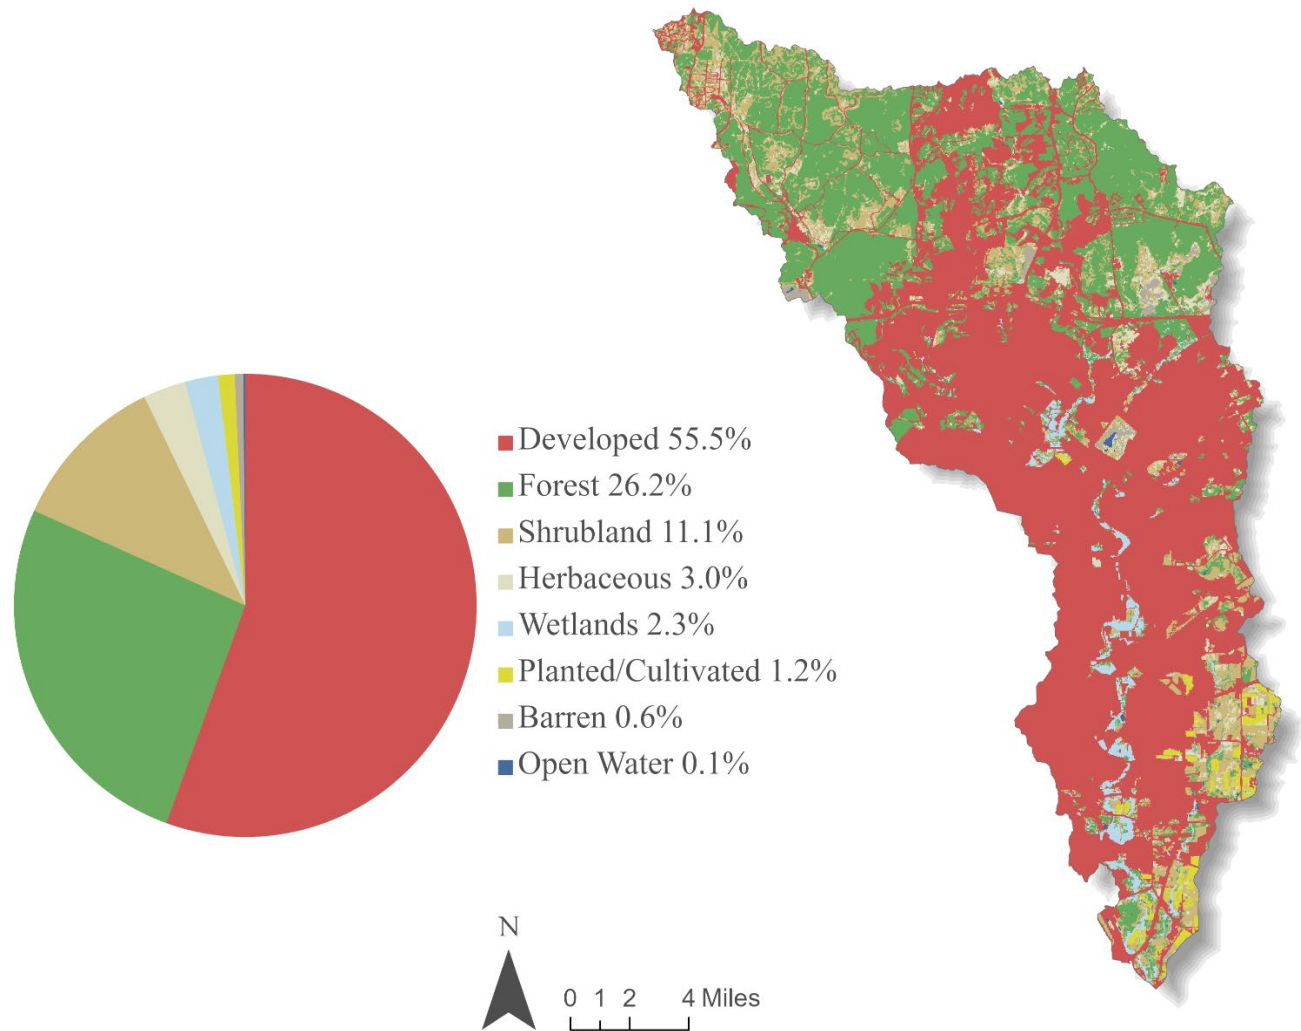
Figure 4. 2001 land use and land cover for the Salado Creek watershed in Bexar County, Texas (National Land Cover Data, 2001).

From 2001 to 2019, developed land cover in the watershed increased from 55.5% to 65.8%, accounting for the combined 10.22% decrease in all other land cover and land use categories. Forest land decreased by 8.5% from 2001 to 2019. Excepting open water, which stayed at 0.1% of the watershed, all other categories decreased by less than 1%.

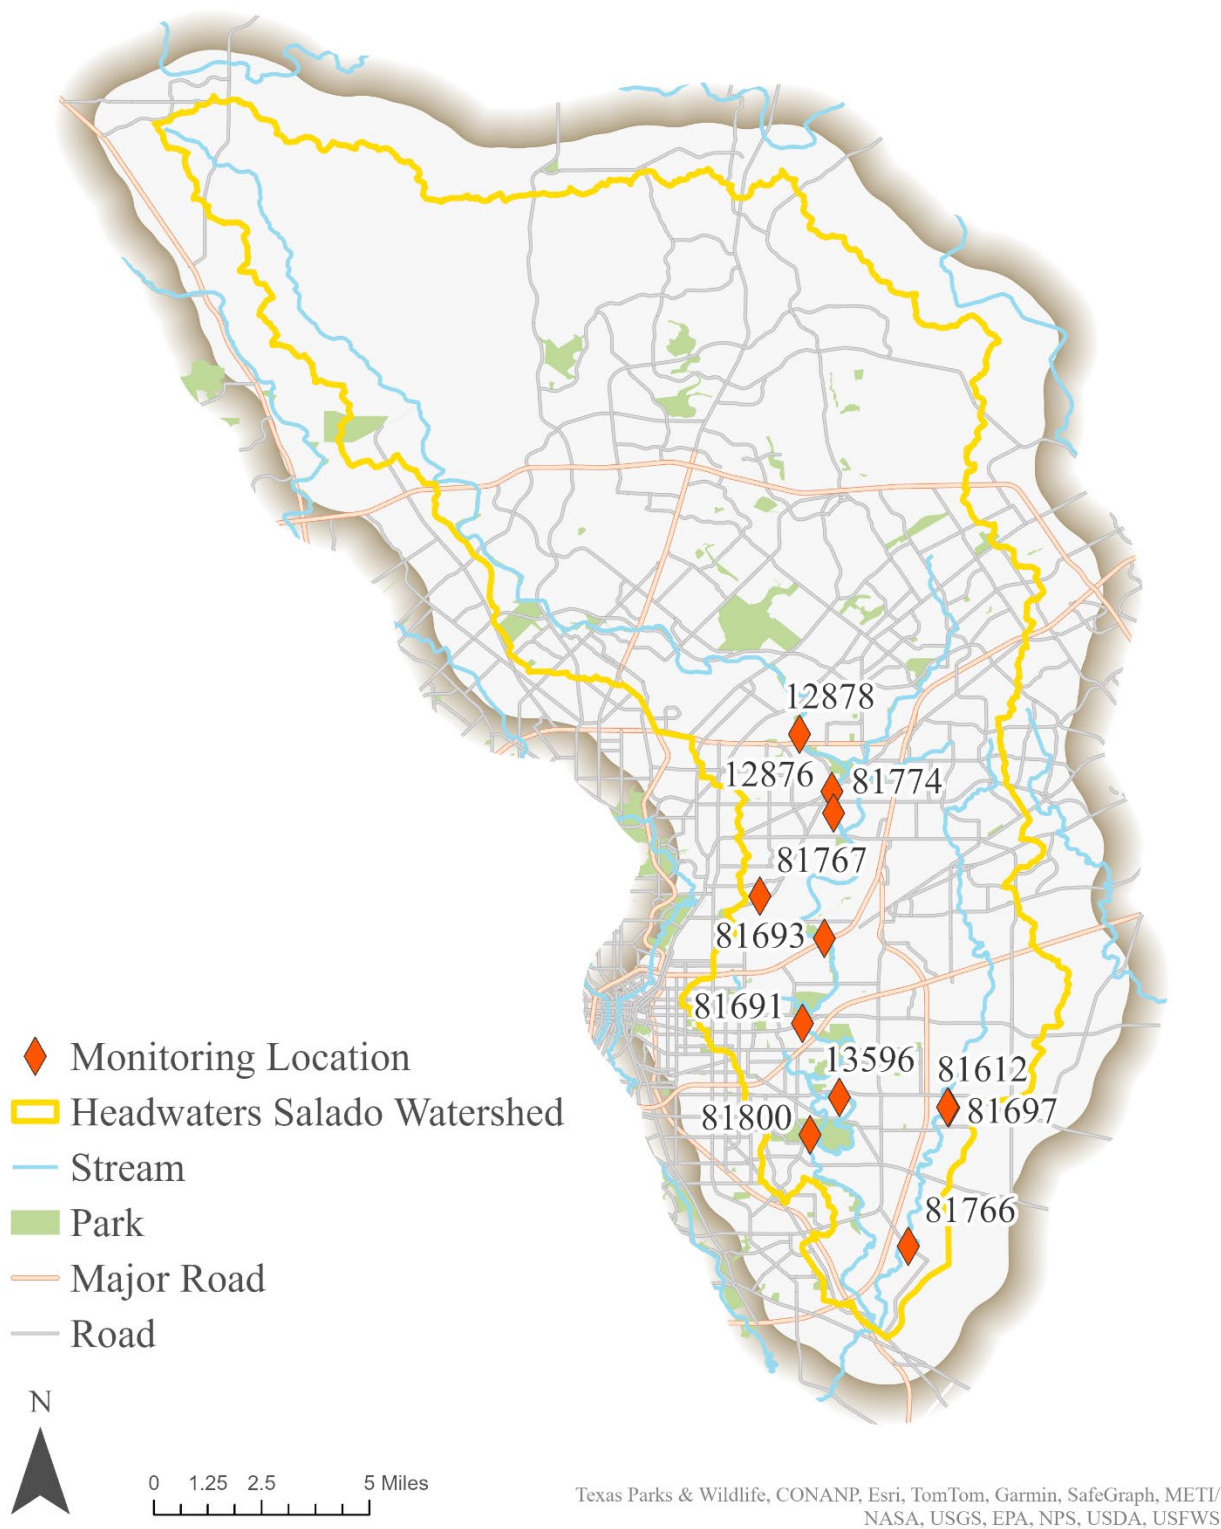
Figure 5. Texas Stream Team monitoring sites in Salado Creek watershed in Bexar County, Texas.

Water quality data from 11 Texas Stream Team monitoring sites in the watershed were acquired for this report (Figure 5).

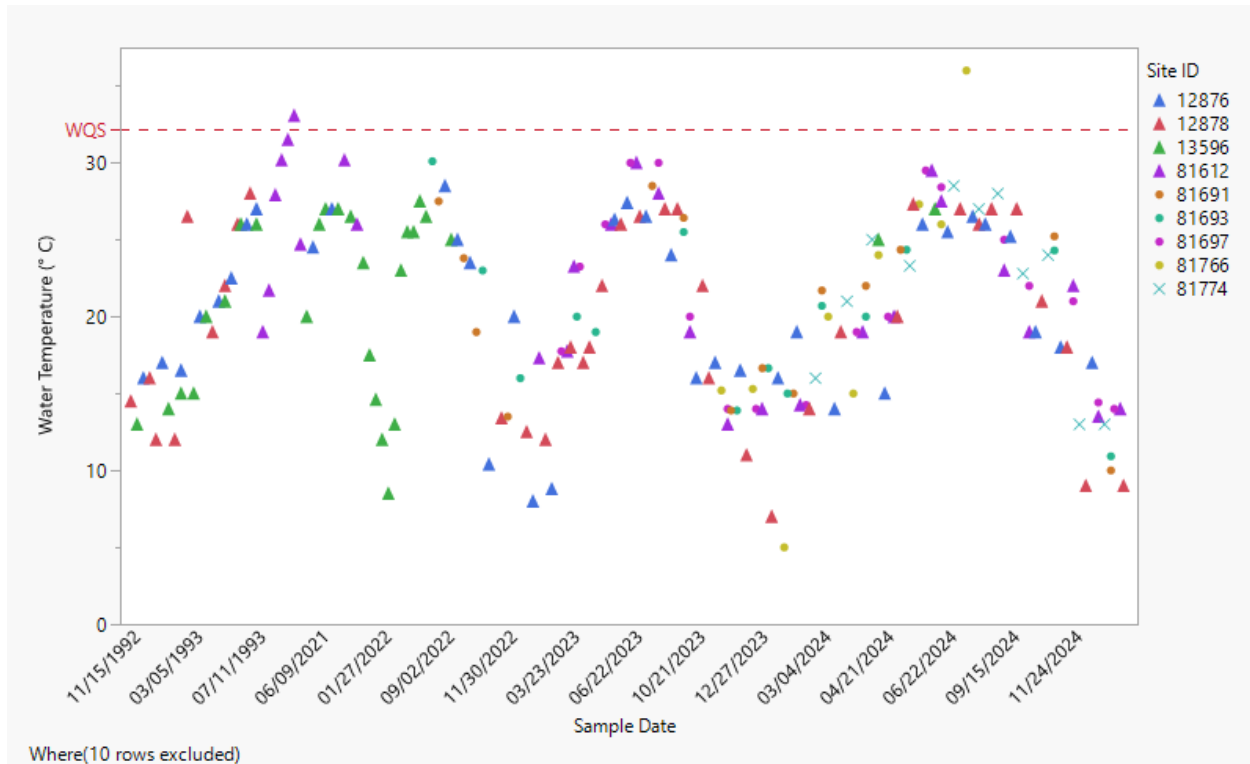
Figure 6. Water Temperature for Texas Stream Team sites in the Headwaters of Salado Creek watershed in Bexar County, Texas (November 1992 to January 2025). WQS = Water Quality Standard.

Average air temperature for all sites ranged from 19.78°C to 22.85°C (Table 6). The lowest mean air temperature (19.78°C) was observed at TCEQ Site 12877 – Salado Creek at Los Patios (site 12878) whereas the highest mean air temperature (22.85°C) was observed at TCEQ Site 13594 – Low water Xing on Salado Creek Greenway (site 81774).

The average water temperature at all sites ranged from 19.26°C to 22.66°C (Table 6). The lowest mean water temperature (19.26°C) was observed at TCEQ Site 12877 - Salado Creek at Los Patios (site 12878) whereas the highest mean water temperature (22.66°C) was observed at Lake Verda at Milam Wesley Tealer Park (site 81612). Discrete water temperature measurements met the water quality standard of 32.2°C throughout the period of record except for two occurrences. One occurrence took place at site 81612 on August 18, 2020, with a reading of 33.06°C whereas the other occurrence took place at site 81766 on July 10, 2024, with a reading of 36°C (Figure 6).

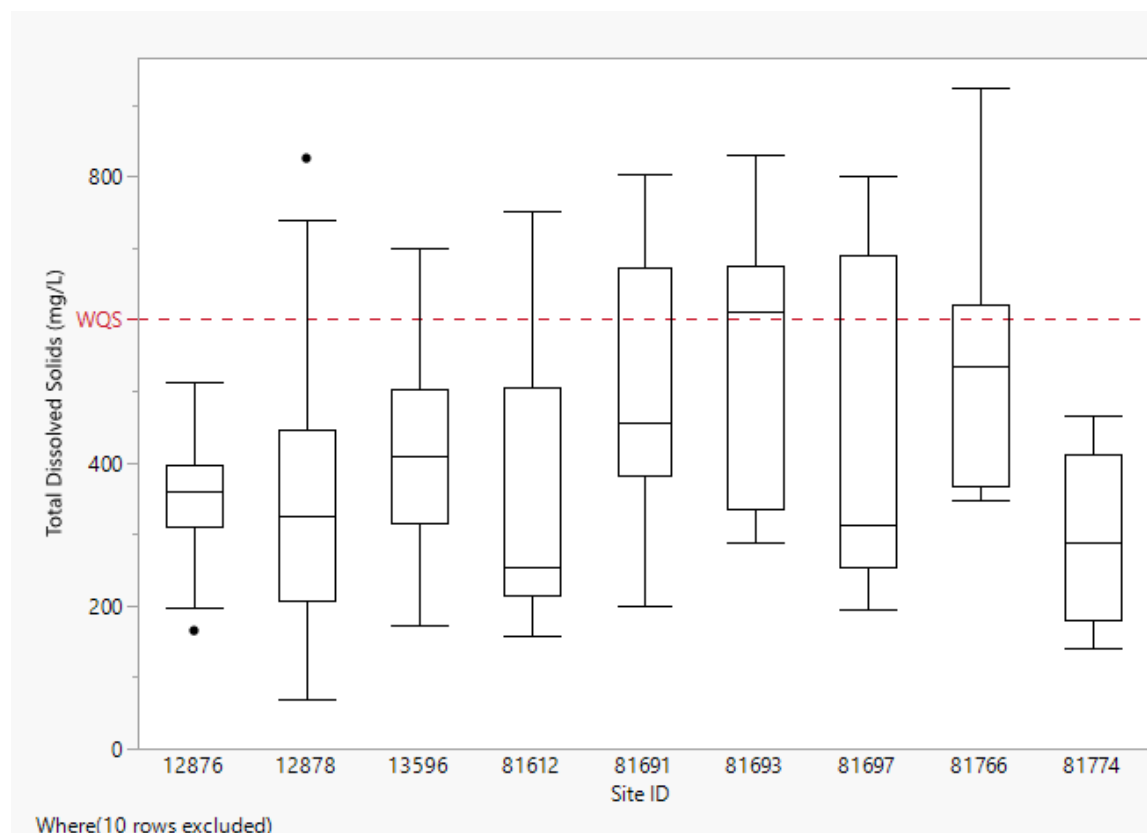
Figure 7. Total Dissolved Solids for Texas Stream Team sites in the Headwaters of Salado Creek watershed in Bexar County, Texas (November 1992 to January 2025). WQS = Water Quality Standard.

Total dissolved solids values were calculated from specific conductance measurements. The average total dissolved solids at all sites ranged from 297.44 to 561.7 mg/L (Table 6). The lowest average total dissolved solids (297.44 mg/L) was observed at TCEQ Site 13594 – Low water Xing on Salado Creek Greenway (site 81774) whereas the highest average total dissolved solids (561.7 mg/L) was observed at TCEQ Site 12871 – Salado Creek at Seguin Rd Bridge (site 81693). Each of the nine sites had discrete measurements of total dissolved solids that exceeded the water quality standard of 600 except for site 12876 and site 81774. However, the average total dissolved solids values for all sites remained below the water quality standard of 600 mg/L (Figure 7).

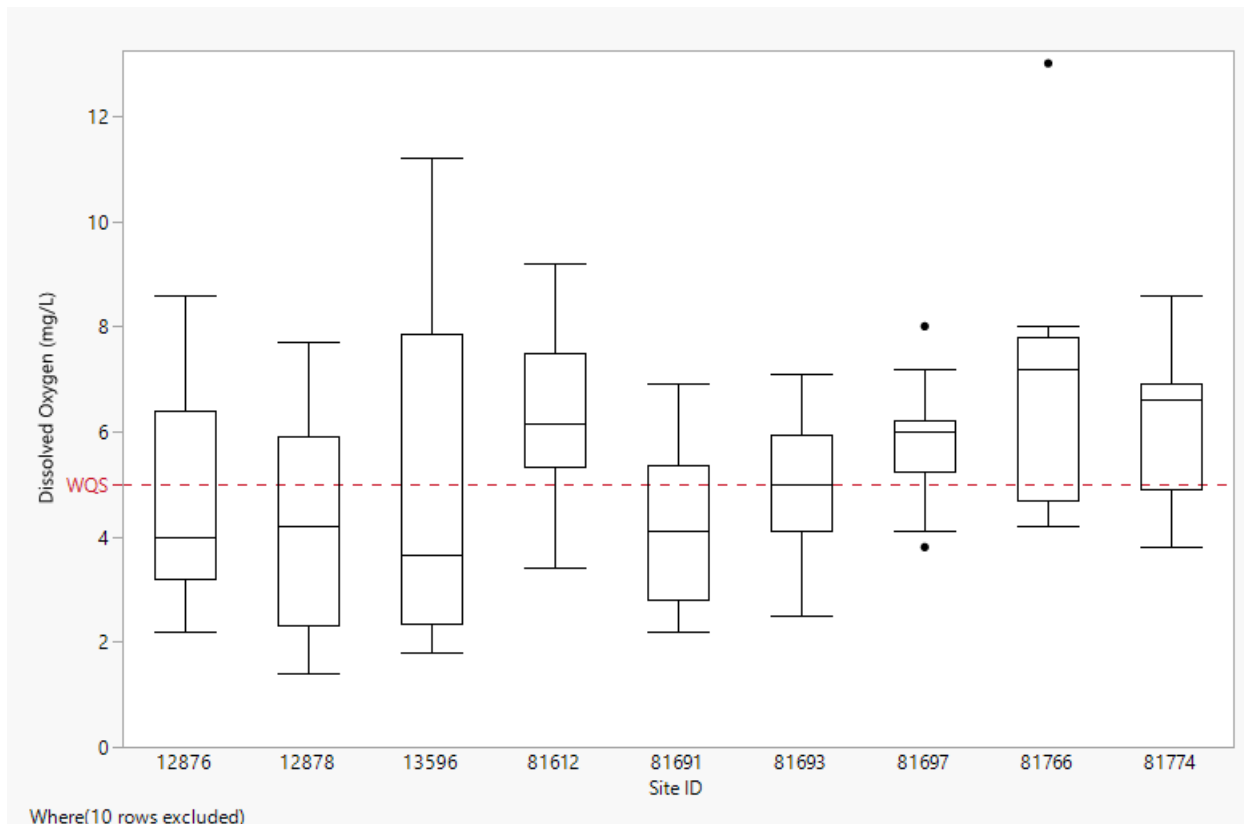
Figure 8. Dissolved Oxygen for Texas Stream Team sites in the Headwaters of Salado Creek watershed in Bexar County, Texas (November 1992 to January 2025). WQS = Water Quality Standard.

The average dissolved oxygen for all sites ranged from 4.17 to 7.0 mg/L (Table 6). The lowest average dissolved oxygen (4.17 mg/L) was observed at TCEQ Site 12877 – Salado Creek at Los Patios (site 12878) whereas the highest average dissolved oxygen (7.0mg/L) was observed at TCEQ Site ID 1269 – Rosillo Creek at WW White Rd. (site 81766). Out of the nine sites, three of the sites had average dissolved oxygen values that fell below the water quality standard of 5.0 mg/L. These sites included site 12876, 12878 and 81691. Additionally, all of the sites had discrete measurements that fell below the water quality standard on multiple occasions (Figure 8).

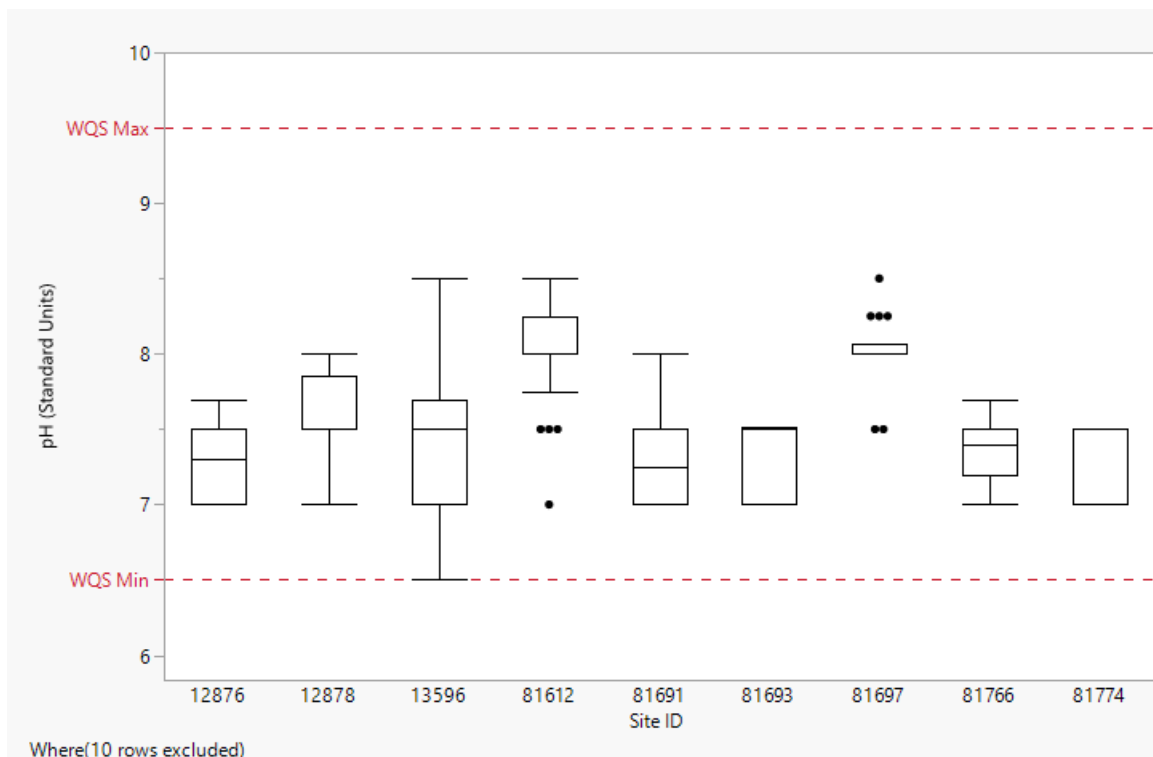
Figure 9. pH for Texas Stream Team sites in the Headwaters of Salado Creek watershed in Bexar County, Texas (November 1992 to January 2025). WQS Max = Maximum Water Quality Standard; WQS Min = Minimum Water Quality Standard.

The average pH at all sites ranged from 7.14 to 8.02 standard units (Table 6). The lowest average pH value was observed at TCEQ Site 13594 – Low water Xing on Salado Creek Greenway (site 81774) whereas the highest average pH value was observed at Lake Verda at Milam Wesley Tealer Park (site 81612). Additionally, all discrete measurements were found to be within the water quality standards minimum (6.5) and maximum (9.5) (Figure 9).

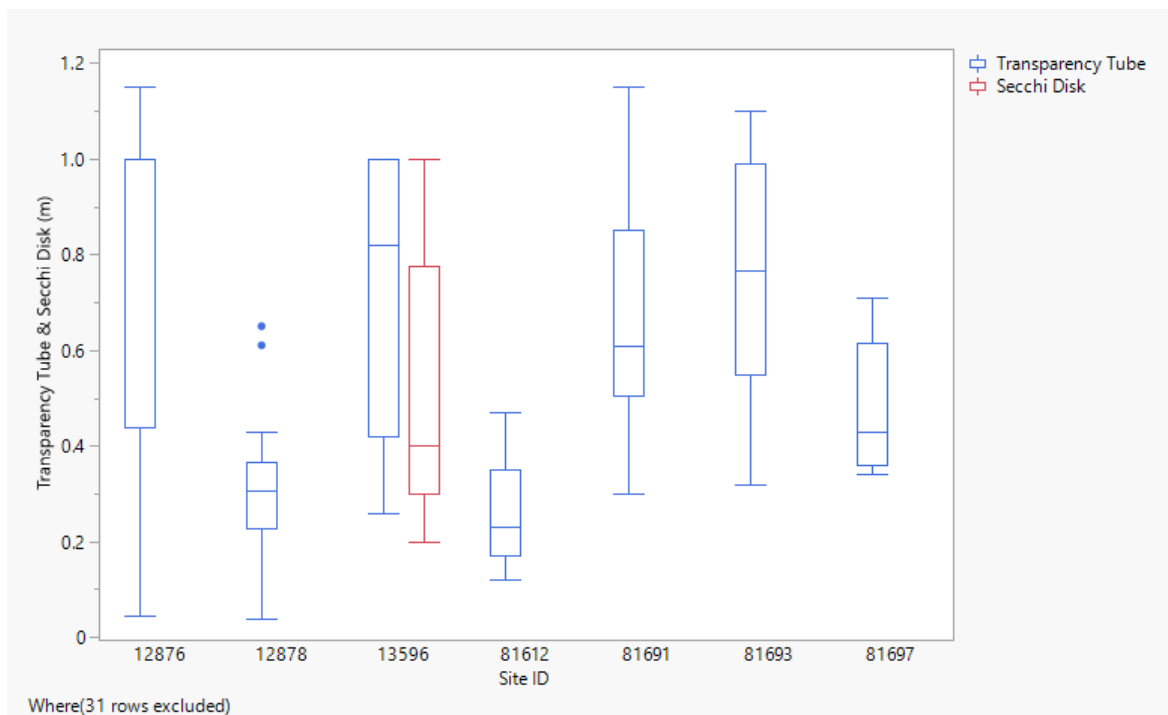
Figure 10. pH for Texas Stream Team sites in the Headwaters of Salado Creek watershed in Bexar County, Texas (November 1992 to January 2025).

The average total depth at all sites ranged from 0.15 to 3.08 m (Table 6). The largest average depth was observed at Lake Verda at Milam Wesley Tealer Park – Site #2 (site 81697) whereas the smallest was observed at TCEQ Site 13594 – Low water Xing on Salado Creek Greenway (site 81774).

Secchi disks and/or transparency tubes were used to measure transparency at all monitoring sites within the watershed. However, measurements were not analyzed for site 81766 and site 81774 as not enough discrete measurements had been gathered to qualify these sites for a transparency analysis (Figure 10). Average transparency gathered via the transparency tube ranged from 0.27 to 4.88 m with the lowest average recorded at Lake Verda at Milam Wesley Tealer Park (site 81612) and the highest at Salado Creek at Comanche Park 3851 Roland (site 13596) (Table 6).
